Mitra Prasad  
Auckland Transport  
Private Bag 92250  
Auckland 1142

23 September 2022

**Upper Harbour Drive TMP Safety Assessment**

This safety assessment has been prepared by Beca Limited (Beca) for Auckland Transport (AT) in response to a request for an independent safety review of the cycle lanes on Upper Harbour Drive. We understand that there have been issues with vehicles colliding with concrete separators between cycle lanes and the traffic lanes on Upper Harbour Drive. We understand that temporary traffic measures have been currently put in place for an interim period, however there is concern as to whether the temporary traffic measures within the Traffic Management Plan (TMP) are sufficient and safe in the current environment.

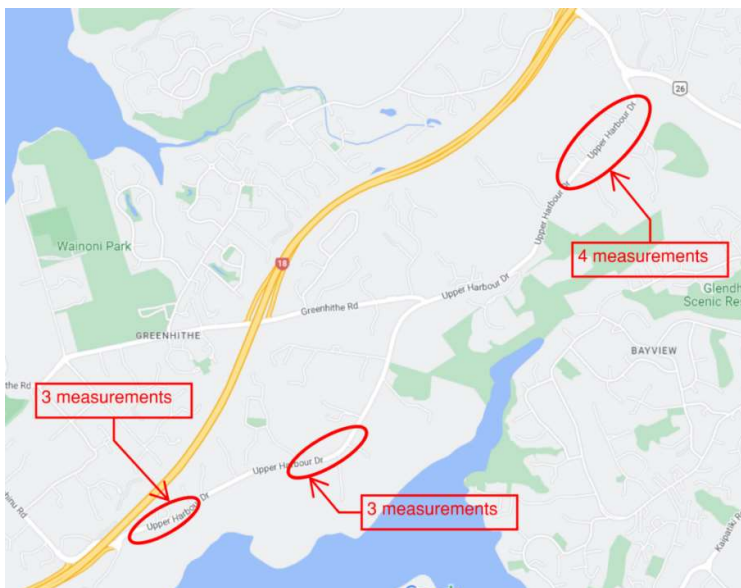
Figure 4. Lane width measurement locations on Upper Harbour Drive.

- Lighting – the route was well-lit, with the traffic cones delineating the concrete separators being visible at night.
- Line marking – some line markings were faded near the northern section of Upper Harbour Drive.
- Lane width – The lanes felt very narrow when driving along Upper Harbour Drive. On-site measurements showed most lane widths were 3.0-3.1m, in some locations up to 3.2m. These measurements were taken from the edgeline to the centreline, or to the edge of the flush median where this was present. The location of measurements taken is shown in **Figure 4**.

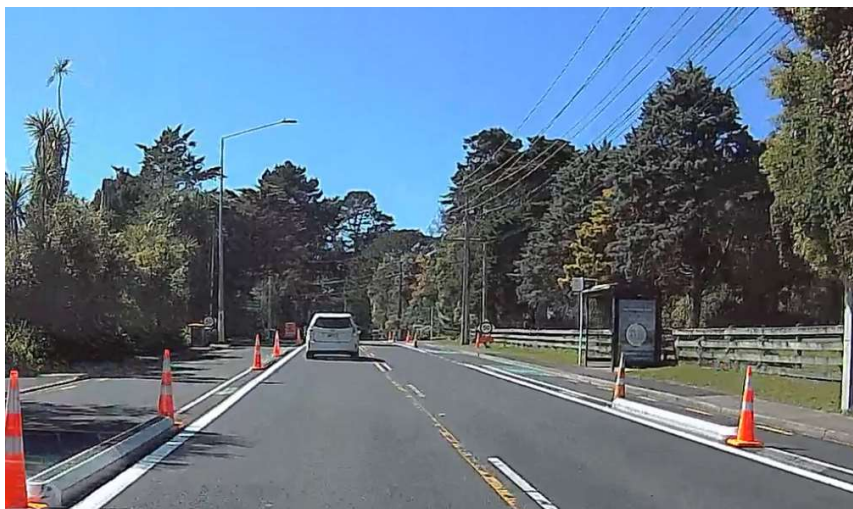
- Concrete separator position – it was perceived that concrete separators are located close to vehicle accesses along Upper Harbour Drive due to the operating speed thereby, limiting easy manoeuvring for vehicles to turn into and out of vehicle accesses.
- Concrete separator visibility – as the separators are only 0.16-0.18m above the pavement, it is difficult for drivers to see the position of the separators in relation to their vehicle.
- Operating speed – Drivers typically drove above the speed limit at approximately 60km/h.
- Traffic measure placement – most traffic cones were in their intended positions; however some had been displaced.
- Driver behaviour – When a flush median was present, drivers were observed straddling the flush median strip when travelling around curves in the road to avoid the concrete separators.

Figure 5. Faded line markings and narrow lane widths on northern section of Upper Harbour Drive.

1. The operating speeds are high for the road environment with respect to road alignment and lane width. This is especially prominent in the northern section of Upper Harbour Drive between Albany Highway and Greenhithe Road, where some sections have narrow lane widths and no flush median with concrete separators on both sides of the road. This creates an environment which is unforgiving for vehicles, leaving little room for driver error and increased probability of drivers colliding with the concrete separators.

To address the key issues of excess speed and limited visibility of concrete separators, we recommend that AT consider introducing safe-hit delineator posts (in close proximity) next to the edgelines along Upper Harbour Drive and on the centrelines where a flush median is not present. In the event of a collision, these posts result in minimal damage to vehicles and are therefore forgiving of user error when driving. They are also semi-permanent, meaning they cannot be easily moved from their intended position.

The primary purpose of the safe-hit delineator posts is to provide drivers with a vertical “frame of reference” to improve awareness of where the edge of the lane is, which is especially important with the narrow lane widths. On the sections of Upper Harbour Drive where there is no flush median, the safe-hit delineator posts being both on the edgeline and centreline are expected to make drivers perceive their lane as being narrow, creating a shy effect. This is expected to reduce operating speeds and therefore the severity of crashes, bringing operating speeds further below 70km/h and reducing the risk of death or serious injury in head-on crashes. Furthermore, it is recommended that AT should consider implementing electronic driver feedback speed signs to increase drivers’ awareness of their speed.
