WAITEMATA GREENWAYS PRE-OPENING ROAD SAFETY AUDIT

PREPARED FOR AUCKLAND TRANSPORT

20 December 2017

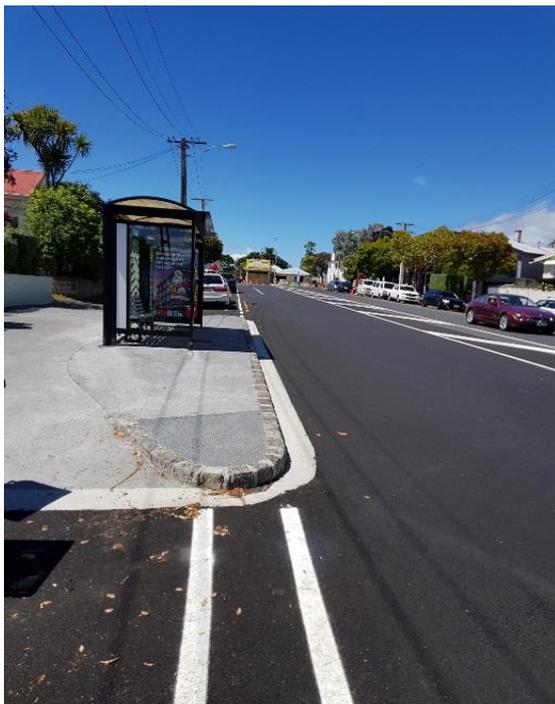
Figure 1 - Bus stop at 554 Richmond Road

Floating bus stops are proposed at a number of locations on each route. Some of these stops have Adshel bus shelters located on the island, but not all. The safety concern is that the shelters block inter-visibility between cyclists travelling behind the shelter and a bus patron walking around the end of the shelter. This could lead to collisions between cyclists and pedestrians.

Frequency Crashes are likely to be common	Severity Death or serious injury is likely	Rating The safety concern is significant
Designer response	Designer (AECOM) Response: <ul style="list-style-type: none"> - Disagree with SAT recommendation 1, Adshell shelters are required to remain along the route as per AT instruction. - Agree with SAT recommendation 2, the detailed design drawings detail (drawing C3412 sheets 1 and 2) an AT fence type E to be installed on the upstream side of the bus shelter to discourage pedestrians from crossing behind the shelter. - Agree with recommendation 3, install the cycle lane paint markings as per the latest detailed design drawings

<p>Safety Engineer comment</p>	<p>Agree with SAT comments. Floating bus stop should be consistent and the following design should be adopted.</p>

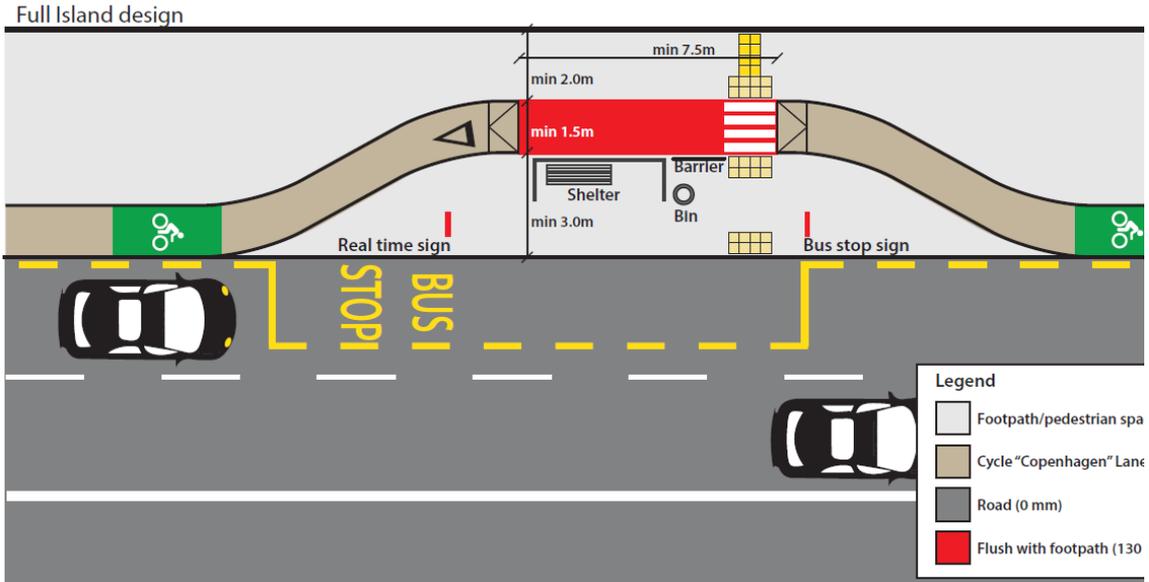
<p>Full Island design</p> <p>min 2.0m</p> <p>min 1.5m</p> <p>min 7.5m</p> <p>Shelter</p> <p>Barrier</p> <p>Bin</p> <p>Real time sign</p> <p>Bus stop sign</p> <p>Legend</p> <ul style="list-style-type: none"> Footpath/pedestrian space Cycle "Copenhagen" Lane Road (0 mm) Flush with footpath (130)
<p>Client decision</p>	<p>We agree with the installation of coloured surfacing and fencing as per SAT Comments 2 and 3.</p> <p>The floating bus stop design provided by the safety engineer does not provide further detail on the type of shelter. We note that the shelter at 474 Richmond Road is the most transparent shelter available with Adshell, AT's shelter provider.</p> <p>With the coloured surfacing and barrier, we do not believe a fully transparent shelter is required. This suggestion will be considered as the shelters reach the end of their life cycle and require replacement.</p> <p>We note that there have been floating bus stops installed where the cycling facility is not considered open for use. Coloured surfacing and barrier installation will not be implemented in these locations until the route is considered open.</p>

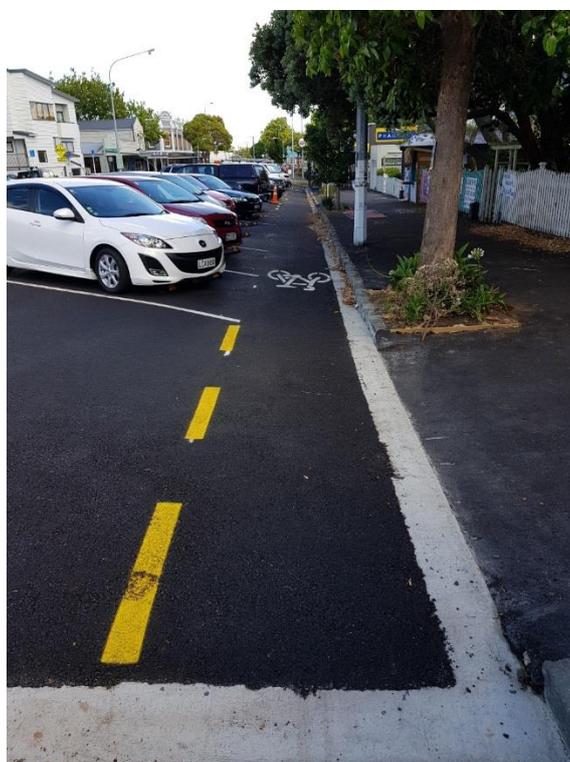
Figure 3 – Vehicle Access at 466 Richmond Road

There is also a concern that people alighting from parked vehicles may not see approaching cyclists as they cross the cycle lane to the footpath.

Where the number of parking spaces adjacent to the cycle lane is limited to only one or two consecutive spaces drivers and alighting passengers have an opportunity to see behind the parked vehicles and see cyclists as they approach the vehicle crossing. A crash is most likely to occur when there are three or more parked vehicles without a gap.

Frequency Crashes are likely to be occasional	Severity Death or serious injury is likely	Rating The safety concern is moderate
Designer response	Designer (AECOM) Response: <ul style="list-style-type: none"> - Agree with both SAT recommendations - Install cycle greening as per latest detailed design drawings - Install 50mm vanguard or similar speed hump as proposed at other high turnover vehicle accesses across the route 	
Safety Engineer comment	Agree with the installation of a coloured surface where there is angled parking to highlight the presence of the cycle lane. Vertical deflections at entrances should only be used where there is a high number of turning movements and the drivers are not regular users. If the entrance is to a private property with space for a few vehicles, then a vertical deflection is not considered necessary.	
Client decision	Agree with the recommendation for coloured surfacing. Safety Engineer comment is noted regarding the frequency of vehicles typically using a private driveway. However, the town centre is subject to numerous vehicles illegally parking in front of the entrances, with the nose of their vehicles impeding on the cycleway. Given the context, a vertical deflection is recommended

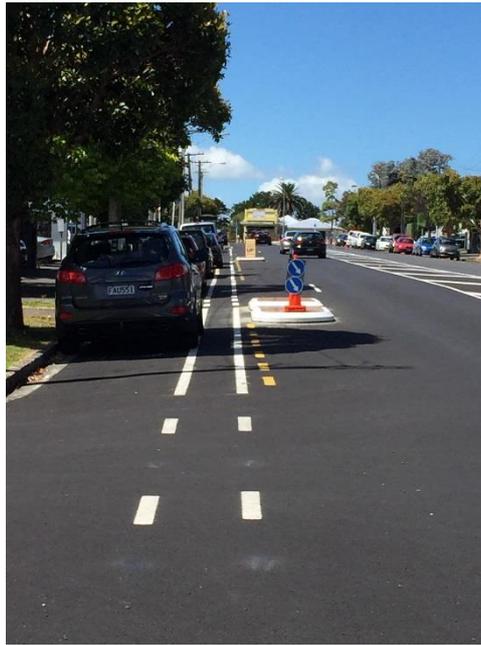
Figure 4 – Double line acting as a narrow cycle lane

There is currently a lack of delineation markings such as edge lines and cycle lanes lines along Richmond Road due to the construction being incomplete. The double white lines as shown in Figure 4 below is ultimately intended to be a buffer zone providing clearance between vehicle passenger doors and passing cyclists. The cycle lane is intended to be kerbside and the parking mostly removed or relocated to the other side of the buffer zone. Because the line marking has not been fully implemented vehicles are effectively parking in the cycle lane and cyclists appear confused as to where they should ride. For example, during the safety audit the SAT observed cyclists riding between the buffer zone markings using it as a cycle lane. This included riding between the side islands and the parked vehicles. This places cyclists in a very risky 'door' zone.

There are multiple areas along the route where there is currently no clear distinction between the cycle way, the footpath, the buffer zone and the traffic lane which creates significant confusion for road users and may lead to collisions.

Frequency Crashes are likely to be common	Severity Death or serious injury is very likely	Rating The safety concern is serious
Designer response	Designer (AECOM) Response: <ul style="list-style-type: none"> - Agree with SAT recommendation 1, install paint markings as per latest detailed design drawings - The cycle lane is proposed to be closed just south of the community centre, if line markings and greening are not proposed to be installed outside of this, then measures (i.e flexi posts) should be installed to deter parking and discourage cyclists from using cycle lane around pinch points such as traffic islands - Disagree with SAT recommendation 2, removal of the road markings will cause confusion and significant "ghost" markings (on new surfacing in some areas) which could create an unsafe environment 	
Safety Engineer comment	As the scheme is not completed it is causing confusion for road users. On a site visit vehicles were observed parking in the cycle lane and the side islands protruded into the carriageway creating a road safety concern. The cycle lane markings need to be installed as designed and road markings are required to guide vehicles past the side island. If parking is to be provided between the cycle lane and traffic lane then this needs to be marked accordingly.

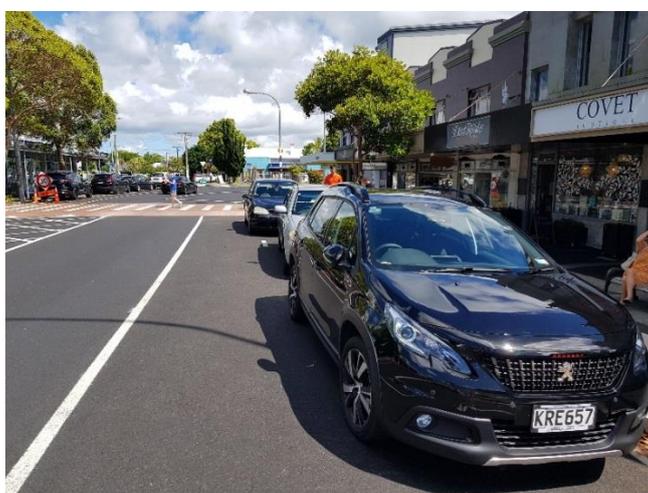
Figure 5 - Parking bay at 436 Richmond Road

In more than one location along the route, there appears to be little to no separation between the cycle lane and the parallel car parking spaces. The width marked (parking plus cycle lane) appears to be narrower than the widths specified on the drawings that were reviewed for the detailed design road safety audit. If a narrower than intended/endorsed facility has been installed this could create safety issues.

In addition to the potential misperception of the road markings, cyclists are currently riding along the door zone of the parking spaces which is a hazard if vehicle occupants open a door without seeing the cyclist. This applies when a driver pulls out of a parking space as well. The lack of separation and delineation also increases the likelihood of vehicles parking further out from the kerb and intruding into the cycle lane.

Frequency Crashes are likely to be occasional	Severity Death or serious injury is very likely	Rating The safety concern is significant
Designer response	Designer (AECOM) Response: - Agree with SAT recommendation – install all markings as per latest design drawings prior to opening the facility	
Safety Engineer comment	Agree with SAT recommendations.	
Client decision	Agree with SAT recommendations	
Action taken	Complete town centre paint and coloured surfacing per current design.

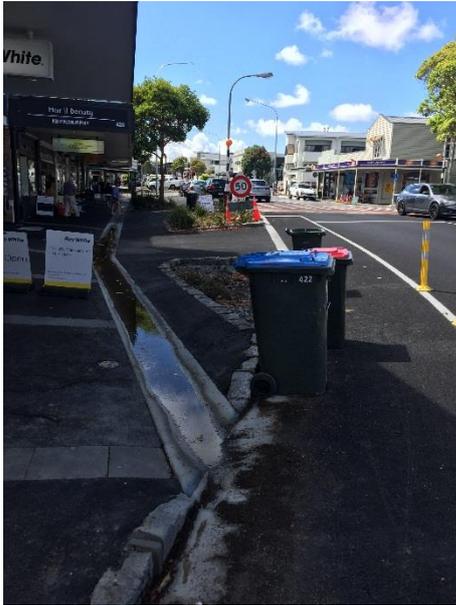
Figure 6 – Bins in cycle lane at West Lynn shops

Residents are placing their refuse bins in the cycle lane creating not only pinch points, but also collision hazards for cyclists.

Frequency Crashes are likely to be occasional	Severity Death or serious injury is unlikely	Rating The safety concern is minor
Designer response	Designer (AECOM) Response: - Agree with SAT recommendation. Recommend AT liaise with Auckland Council Waste Management team as well.	
Safety Engineer comment	Agree with Designers response.	
Client decision	Agree. Consideration of bins will be a key part of future facility design.	
Action taken	Liaise with AC Waste management to determine go forward strategy for bin placement. Boffas are now undertaking a review of the project.

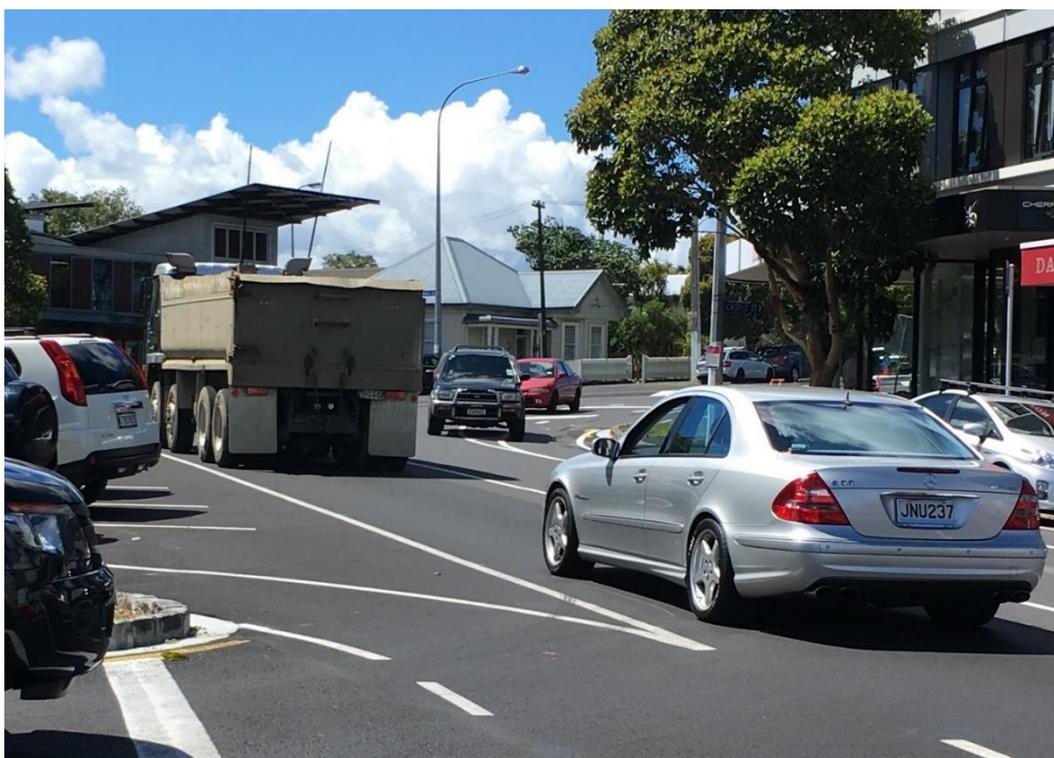
Figure 8 - Bend near the intersection of Castle Street and Richmond Road

No physical separation measures are in place at the bend. The cycle lane is not fully marked and there is no clear distinction to whether the area outside of the edge line is a cycle lane or a road shoulder.

The safety concern is that the lack of delineation allows drivers to maintain a high speed by cutting the corner into the cycle lane. The risk of a collision with cyclists and/or vehicles exiting parking spaces is increased by the tree and streetlight at the apex of the bend, partially obstructing driver visibility.

Frequency Crashes are likely to be occasional	Severity Death or serious injury is likely	Rating The safety concern is moderate
Designer response	Designer (AECOM) Response: - Agree with SAT recommendations, install all proposed road markings and separation measures as per the latest detailed design drawings	
Safety Engineer comment	Installing the green surfacing and flexi-posts will assist cyclists, however vehicles are still likely to drive over the hatching as this is the driving line. Suggest that this intersection be reviewed to protect cyclists and guide traffic round the bend in a smooth alignment.	
Client decision	Agree with SAT recommendations. Flexi post have been installed and paint to be implemented shortly.

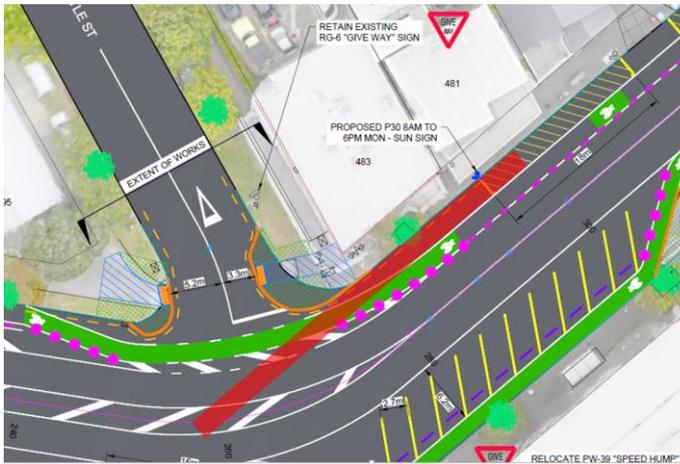
Figure 9 - Plan showing visibility to/from parked vehicles

The parking restriction at this location is assumed to be P60, therefore a higher vehicle turnover is expected which increases the risk for cyclists. In addition, cyclists will be riding in the door zone where there are no separation measures in place between the cycle lane and the parallel car parks.

Frequency Crashes are likely to be common	Severity Death or serious injury is likely	Rating The safety concern is significant
Designer response	<p>Designer (AECOM) Response:</p> <ul style="list-style-type: none"> - Agree with SAT recommendation 1, install all road markings as per the latest detailed design drawings – These have been revised to provide a 400mm buffer zone both on the inside of the cycle lane and on the outside of the cycle lane. This provides a greater refuge for cyclists - Agree with SAT recommendation 2, additional signage is a good idea. 	
Safety Engineer comment	See comments in 2.2.1.	
Client decision	Agree with implementation of green coloured surfacing. Signage to be reviewed as part of the greater town centre design process.	
Action taken	Complete coloured surfacing and review signage requirements

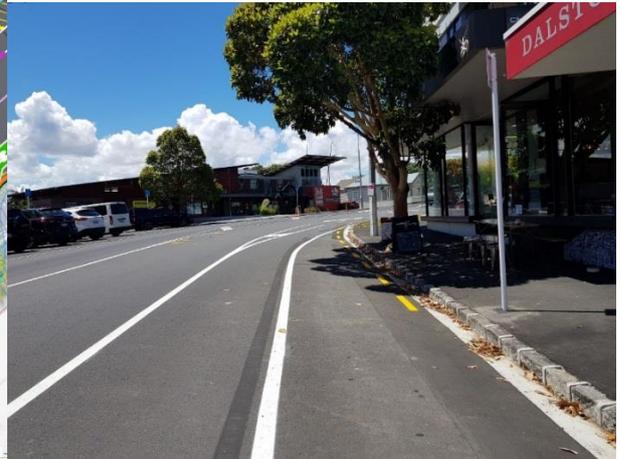
Figure 10 - Visibility from parked vehicles towards the bend

The tree and street light post contributes to the obstruction of visibility significantly, refer to Figure 10

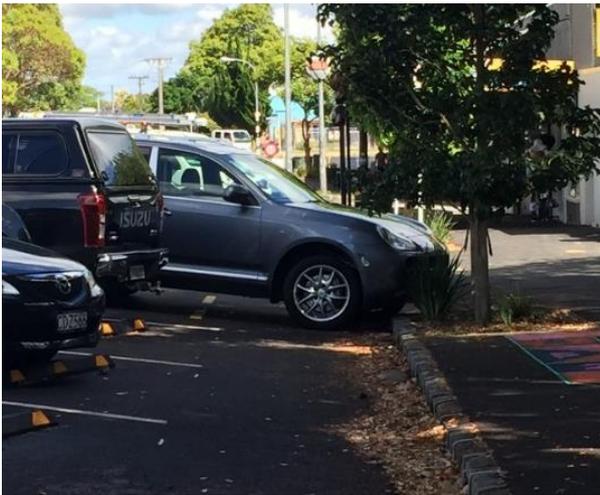
Figure 11 - Vehicle parked over cycle lane at 452 Richmond Road

The safety concern is that this will force cyclists to divert behind the angled car parks into an area that has less than desirable separation between parked vehicles and passing traffic. The SAT expects that, in this situation, confident cyclists would likely cycle along the edge line of the traffic lane whereas inexperienced cyclists would tend to ride further away from the moving traffic and closer to the parking spaces. This would expose inexperienced cyclists a potential collision with a reversing vehicle.

It was observed that this issue is primarily due to a lack of clarity of whether parking is permitted.

1. Complete the proposed road marking, green coloured surfacing and cyclist symbols as per the design plans to provide better delineation and distinction between the cycle lane and the parking spaces.
2. Implement the designed separation measures (e.g. flexi posts) at the ends of the angle parking sections, refer to Figure 12.

Frequency Crashes are likely to be occasional	Severity Death or serious injury is likely	Rating The safety concern is moderate
Designer response	Designer (AECOM) Response: <ul style="list-style-type: none"> - Agree with both SAT recommendations, install all road markings, greening and separation measures as per the latest detailed design drawings. - Additional recommendation for both accesses close to 452 Richmond Road (figure 11) would be to install NSAAT lines across vehicle accesses and 50mm speed humps along the edge of the cycle lane as per section 2.1.2 of this report 	
Safety Engineer comment	Agree with SAT recommendation 1. SAT recommendation 2 of installing flexi-posts have been installed, as shown below.

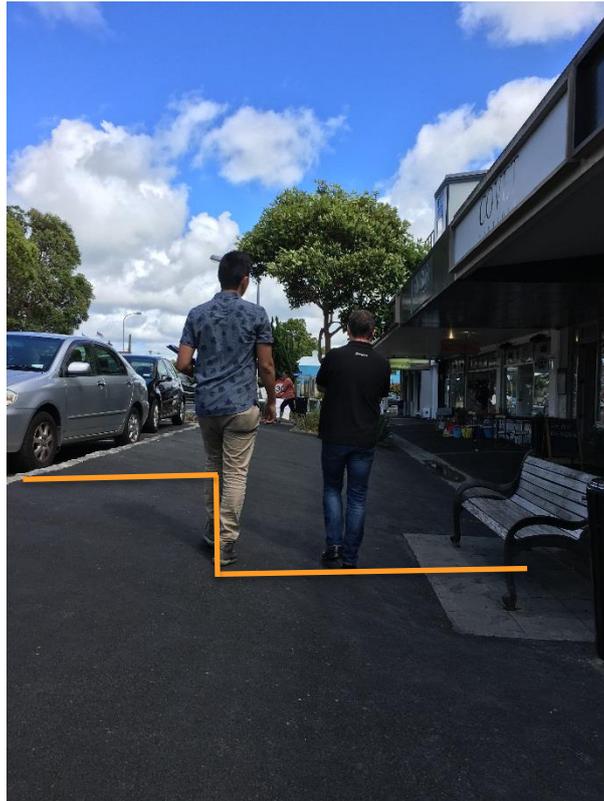
Figure 14 - Cross fall between the kerb and the footpath outside 436 Richmond Road

Figure 14 shows a steep grade from the kerb to the footpath at the parallel parking bay outside 436 Richmond Road.

The safety concern is people with mobility challenges such as wheel chair users, the elderly, or parents with prams may have difficulty accessing parked vehicles and could fall/topple. This can lead to serious injuries, especially for the elderly (e.g. broken hips).

Frequency Crashes are likely to be common	Severity Death or serious injury is likely	Rating The safety concern is significant
Designer response	Designer (AECOM) Response: - Agree with SAT recommendation, this has already been identified as a high priority action and is being worked through by AT with the community liaison group at present.	
Safety Engineer comment	Agree that the gradient adjacent to the parking area is too steep and needs to be reviewed to reduce the gradient to current standards.	
Client decision	Addressing the gradient in this location is a key component of the greater town centre design review.	
Action taken	Boffas are now undertaking a review.

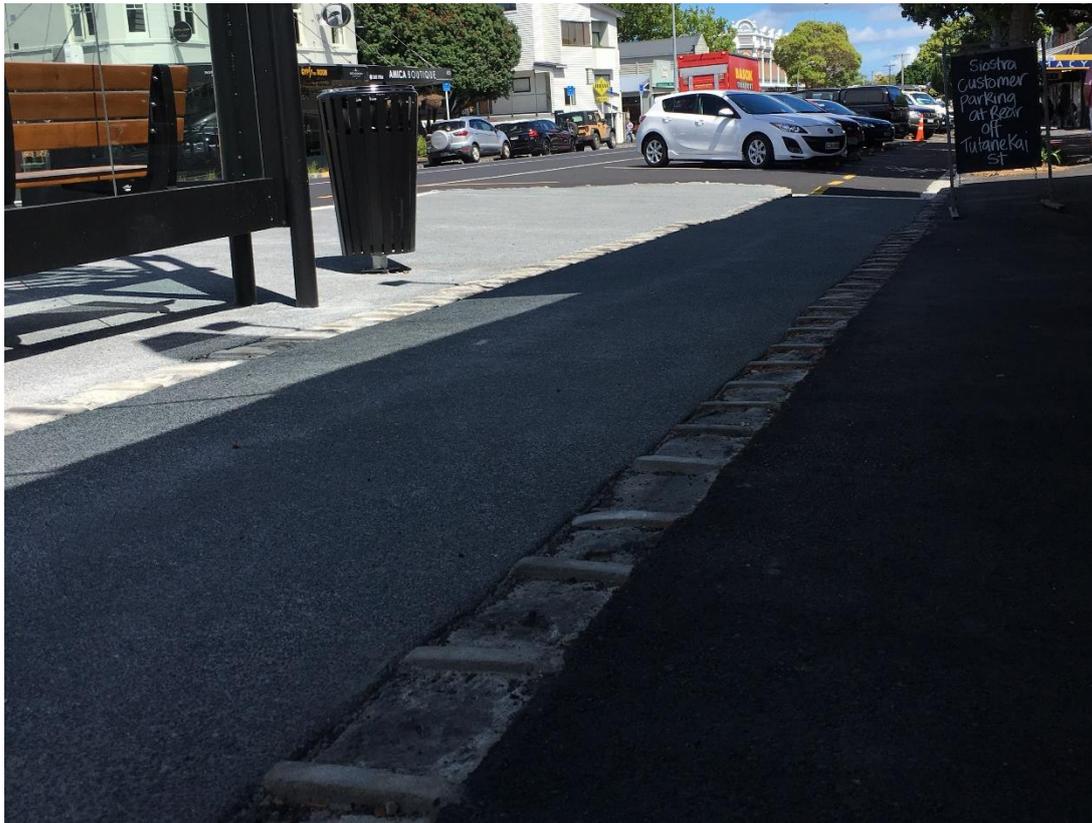
Figure 15 - High kerb pointers outside 474 Richmond Road

The safety concern is the excessive height of the pointing between the kerb blocks which creates a tripping hazard for passing pedestrians and bus patrons, especially given the cycle lane is not visually

distinct from the bus waiting area. Pedestrians may not perceive the area set aside for cyclists to be a cycle lane.

Reduce the height of the pointing to reduce the tripping hazard. Visually demarcate the cycle way by applying a contrasting material (colour or finish) to the cycleway to raise awareness of its presence.

Frequency Crashes are likely to be occasional	Severity Death or serious injury is likely	Rating The safety concern is moderate
Designer response	Designer (AECOM) Response: <ul style="list-style-type: none"> - Agree with SAT recommendation, grind the pointing where considered a significant trip hazard and install all proposed coloured surfacing and line marking as per latest detailed design drawings. The kerbs should be retained as they provide good delineation between the footpath and cycle path. 	
Safety Engineer comment	Agree with SAT comments.	
Client decision	Agree with SAT comments	
Action taken	Contractor to be instructed to correct.

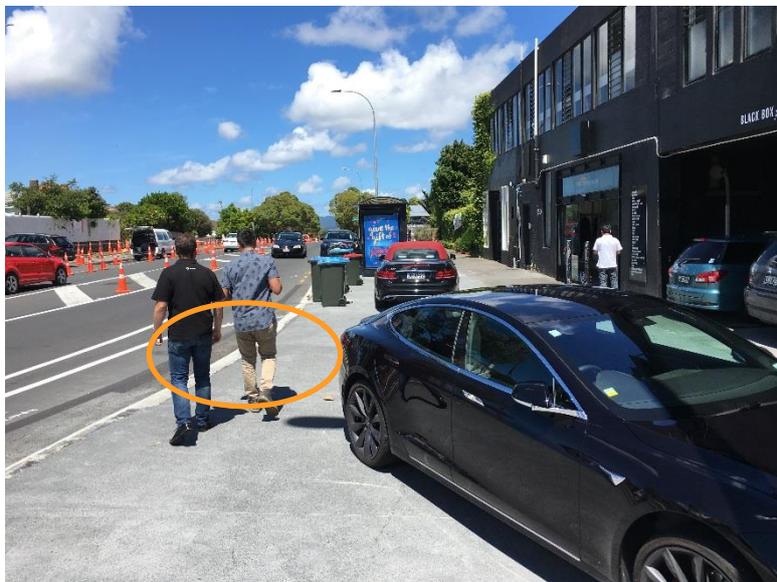
Figure 16 – Cycle path dropped crossing immediately in front of bus stop

The eastbound cycle lane on Surrey Crescent is proposed to transition from the road into the berm area, around the back of a bus shelter on the corner of Surrey Crescent and Richmond Road, and back into the road space. Eastbound cyclists will be re-joining the carriageway immediately in front of the bus box at a point approximately 10 m before the Richmond Road intersection. This issue has been raised in two previous audits and the SAT remain concerned that the late transitioning of cyclists into the road space is a significant conflict with traffic turning left into Richmond Road, especially when there is a stopped bus, but also when there is no bus present.

Significantly exacerbating the concern at this location is the fact that the 020 bus route that uses Surrey Crescent makes a left turn into Richmond Road at this location. Bus drivers leaving this stop will almost certainly drive straight ahead and over the cycle lane area. Furthermore, as they set off they will most likely be looking in their right hand mirror for vehicles approaching from behind. Bus drivers will not be checking for cyclists popping out in front of them on their left hand side. Cyclists may be attempting to re-join the carriageway, in their dedicated cycle lane immediately in front of a departing bus, or just as a bus has set off, leaving the cyclist in the situation of an unavoidable collision.

Frequency Crashes are likely to be common	Severity Death or serious injury is very likely	Rating The safety concern is serious
Designer response	Designer (AECOM) Response: <ul style="list-style-type: none"> - Agree with SAT that this requires further attention. This was a design decision made and dictated by the previous AT project manager. The SAT recommendation and AT safety engineer were over-ruled in the Detailed Design RSA. AECOM considered the SAT recommendation and provided AT an option for this, however, it was considered unacceptable by AT W&C to cross cyclists at the pedestrian refuges from a LOS stand point

- AECOM recommend that the AT Decision be reconsidered to improve the safety of this location
- Flexi posts have been installed in the interim to close cyclist access to the bus stop area

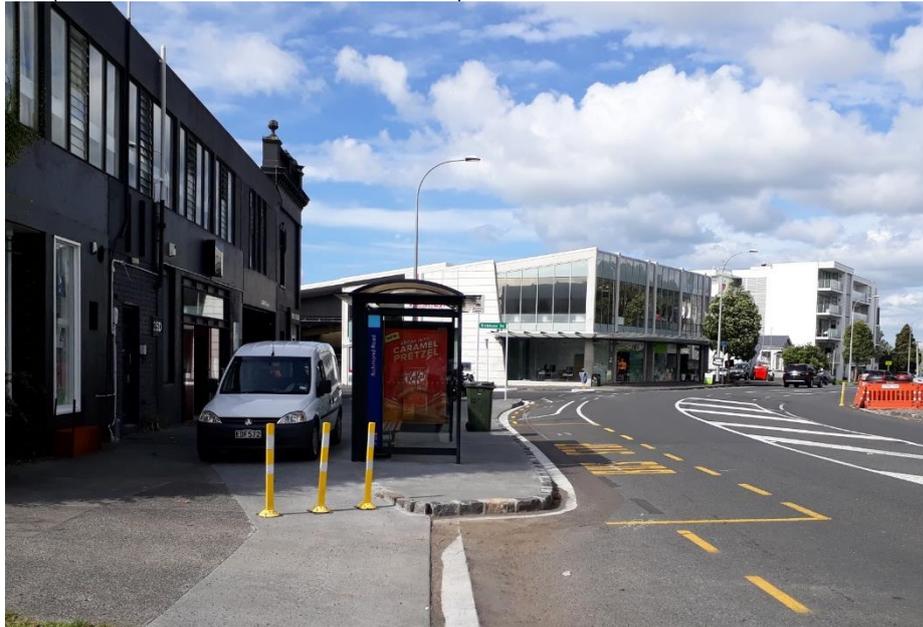
The photo below shows that during the site visit on 26th February 2018 that the cycle ramp was closed with the use of flexi-posts.

Client decision	The cycling facility at this intersection has been closed. A greater review of the entire Richmond Surrey intersection is underway and addressing this component is a key consideration.
Action taken	Cycling facility closed. Boffas are now undertaking a review.

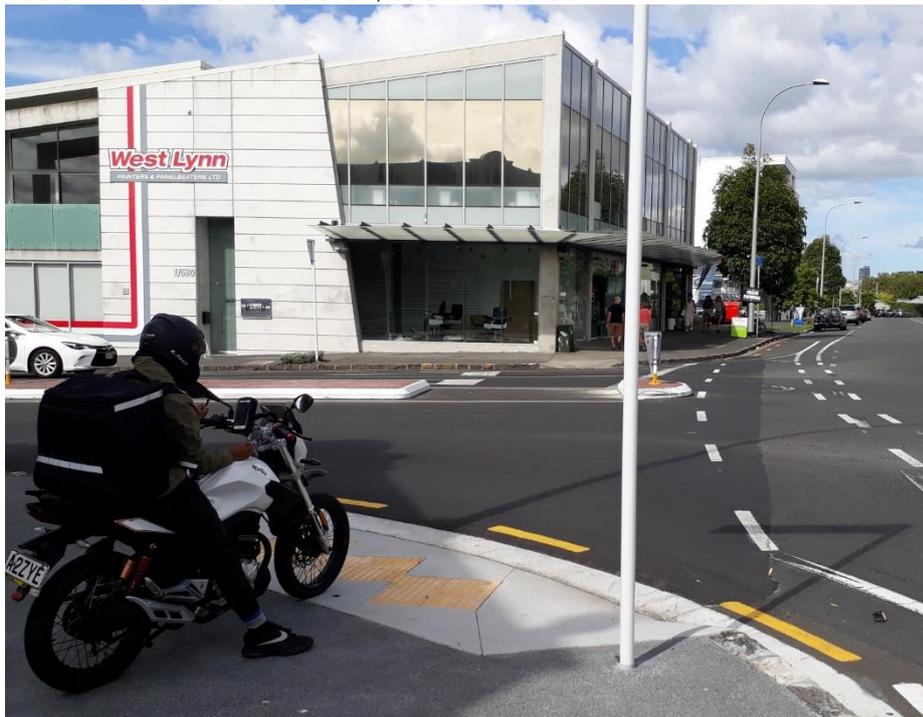
It was also noticed that the tactile paving was not installed on the central island and eastern side of the intersection, as shown below.

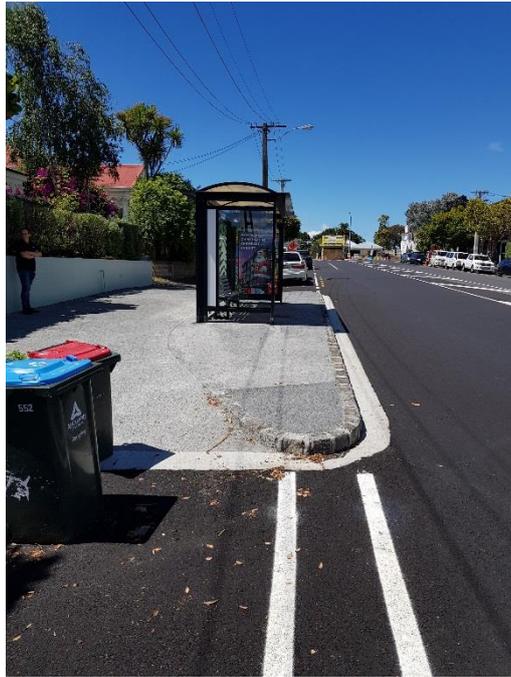
Figure 17 - Parking bay at 436 Richmond Road

Figure 17 below shows the cycle ramp at the bus stop outside 552 Richmond Road. As mentioned above, the buffer zone is currently functioning as an informal cycle lane and the buffer zone ends at the point of a kerb. The safety concern is that cyclists riding in this area may make a late decision to use the ramp or swerve into the traffic lane despite potential adjacent obstructions (e.g. refuse bins, vehicles, buses pulling into the bus stop, etc). This could result in the cyclist losing control and/or a collision.

1. Complete the road markings (including the bus box markings) as per the design to ensure clear delineation between cycle lane, footpath, buffer zone, bus stop and vehicle lane. Ensure clear and visible distinction between the cycle lane and footpath between the two cycle ramps.
2. If the construction of the cycle lane is not to proceed, consider closing the cycle ramps at this location to prevent cyclists from accessing the footpath.

Frequency Crashes are likely to be occasional	Severity Death or serious injury is likely	Rating The safety concern is moderate
Designer response	Designer (AECOM) Response: <ul style="list-style-type: none"> - Agreed with SAT recommendation to install bus box markings as per latest detailed design drawings as this is to remain a functioning bus stop - As the cycle lane at this location is likely to be closed until further consultation is completed, we recommend temporarily closing the cycle ramps to deter use of the facility. A formal closure of the cycle lane and merge into general traffic is to be provided just south of the community centre 	
Safety Engineer comment	Agree with SAT recommendations. Also see 2.1.1.	
Client decision	The cycle lane buffer line closest to the kerb will be removed, reducing confusion for road users. This will effectively close the cycling facility and promote Kerb side parking.

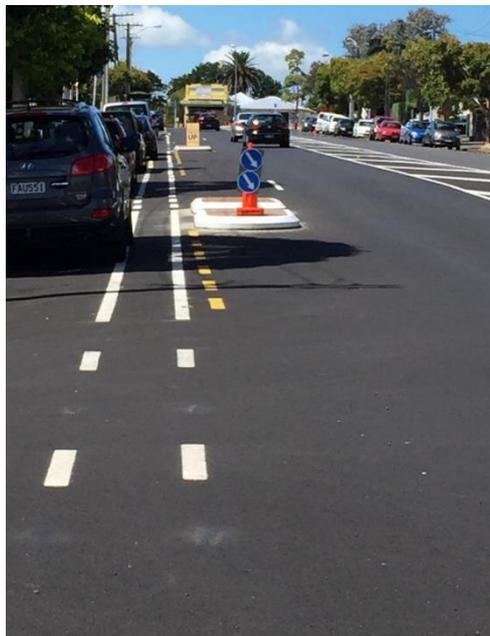
Figure 18 - Refuge crossing and side island outside 522 Richmond Road

- The lack of delineation lines increases risk of vehicles hitting the traffic islands, especially during periods of low congestion and/or low visibility (e.g. night time, rain, fog, etc.)
- The incomplete markings mislead cyclists into using the buffer zone as a cycle way which creates a significant pinch point at the crossing. In addition, riding in the buffer zone places cyclists in the door zone of the on street car parks, exposing them to a hazard.
- The regulatory signs placed on temporary road cones may be accidentally (e.g. wind) or deliberately moved resulting in poor conspicuousness of the islands and subsequent collisions.

Frequency Crashes are likely to be occasional	Severity Death or serious injury is unlikely	Rating The safety concern is minor
Designer response	Designer (AECOM) Response: <ul style="list-style-type: none"> - As this portion of the cycle lane is going to be a closed facility until further consultation is undertaken. We would recommend installing the edge line detailed below (in Red) in addition to the installation of the permanent regulatory RG-34 signs on the traffic island. This will ensure the traffic lane is clearly delineated through this section. - We disagree that the remainder of the proposed markings be installed as they are ineffective unless the entire design is implemented – recommend that flexi

posts are installed on kerb side of island to prevent parked cars creating a pinch point

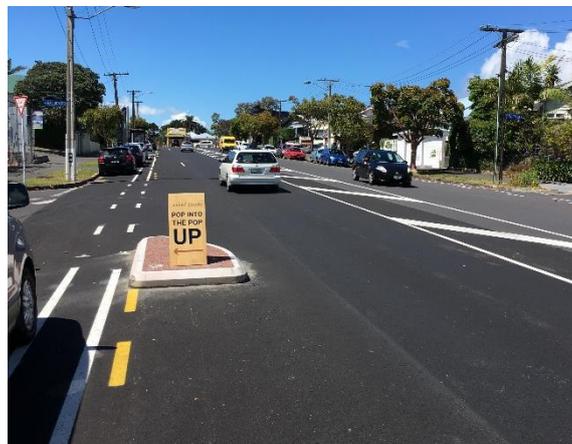
Figure 19 - Island at the intersection of Baildon Road and Richmond Road

- The lack of delineation lines and regulatory signage increases risk of vehicles hitting the traffic islands, especially during periods of low congestion and/or low visibility (e.g. night time, rain, fog, etc.)
- The incomplete markings misleads cyclists into using the buffer zone as a cycle way which creates a significant pinch point. In addition, riding in the buffer zone places cyclists in the door zone of the on street car parks, exposing them to a hazard.

Frequency Crashes are likely to be occasional	Severity Death or serious injury is unlikely	Rating The safety concern is minor
Designer response	Designer (AECOM) Response: <ul style="list-style-type: none"> - As this portion of the cycle lane is going to be a closed facility until further consultation is undertaken. We would recommend installing the edge line detailed below (in Red) in addition to the installation of the permanent regulatory RG-34 signs on the traffic island. This will ensure the traffic lane is clearly delineated through this section. - We disagree that the remainder of the proposed markings be installed as they are ineffective unless the entire design is implemented – recommend that flexi posts are installed on kerb side of island to prevent parked cars creating a pinch point

Safety Engineer comment	All traffic island within the carriageway need the correct signing. Also see 2.1.3. and 2.3.3.
Client decision	The cycle lane buffer line closest to the kerb will be removed, reducing confusion for road users. This will effectively close the cycling facility and promote Kerb side parking. Permanent signage on the island will be installed.
Action taken	Contractor to be instructed.

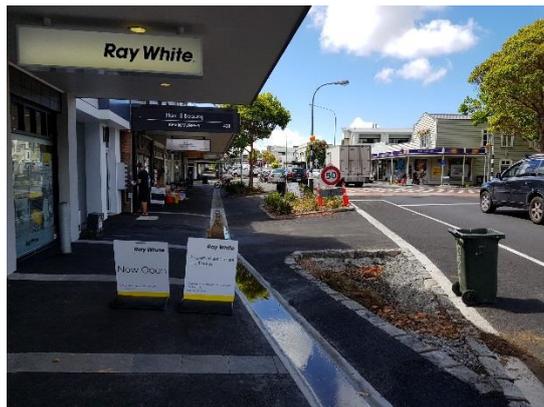
Figure 20 - Ponding between 422 and 436 Richmond Road

The catch pit at the cycle ramp outside 398 Richmond Road appears to not be at the low point of the channel. There is also an apparent drainage issue between 422 and 436 Richmond Road.

Designer response	Designer (AECOM) Response: <ul style="list-style-type: none"> - Observation noted, this is an action being addressed as part of the urban design/landscape re-scope of the project. This is being worked through with the community liaison group
Safety Engineer comment	Agree with SAT and note designers response.
Client decision	Drainage considerations are a key component of the town centre design review.
Action taken	Becas are now undertaking a design change to be implemented shortly.

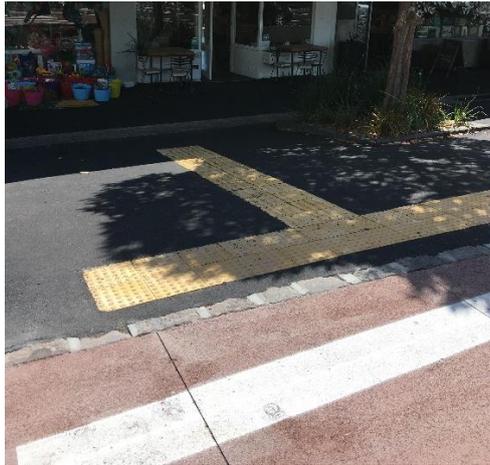
Figure 21 – Tactile paving at the speed table outside 428 Richmond Road

The tactile paving at the zebra crossings should intersect the footpath in order to direct visually impaired pedestrians to the crossing location. Refer to Figure 21.

Designer response	<p>Designer (AECOM) Response:</p> <ul style="list-style-type: none"> - Observation noted. This is an action being addressed as part of the urban design/landscape re-scope of the project. This is being worked through with the community liaison group
Safety Engineer comment	All tactile paving should comply with RTS 14.
Client decision	Tactile paving will be a consideration of the town centre design review
Action taken	To be addressed by Boffas in the review.

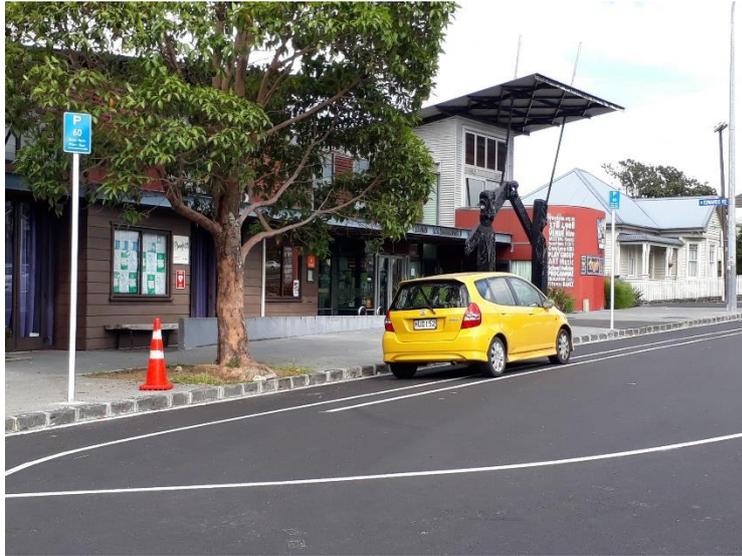
The SAT noted informal use of driveways by vehicles stopping to pick up or drop off passengers. These vehicles often obstructed the cycle lane. Vehicles were also observed parking in the cycle lane.

Designer response	<p>Designer (AECOM) Response:</p> <ul style="list-style-type: none"> - Observation noted. All cycle greening, road markings and separators should be installed as per the latest detailed design drawings to provide the visual cues to deter vehicles from parking across the cycle lane. - Refer item 2.2.3 for further mitigation options proposed at similar locations
Safety Engineer comment	Due to the scheme being incomplete it causing confusion for drivers as to where they are entitled to park. The photo below show car parked in the cycle lane, and the signs indicate that vehicles can park for an hour. The cycle scheme need to be completed or removed to avoid any confusion.

Client decision	Agree. Proposed paint and coloured surfacing will address this issue.
Action taken	Boffas are now undertaking a review.
