West Lynn Town Centre
Waitemata Safe Routes
Grey Lynn

Accessibility Audit

January 2018

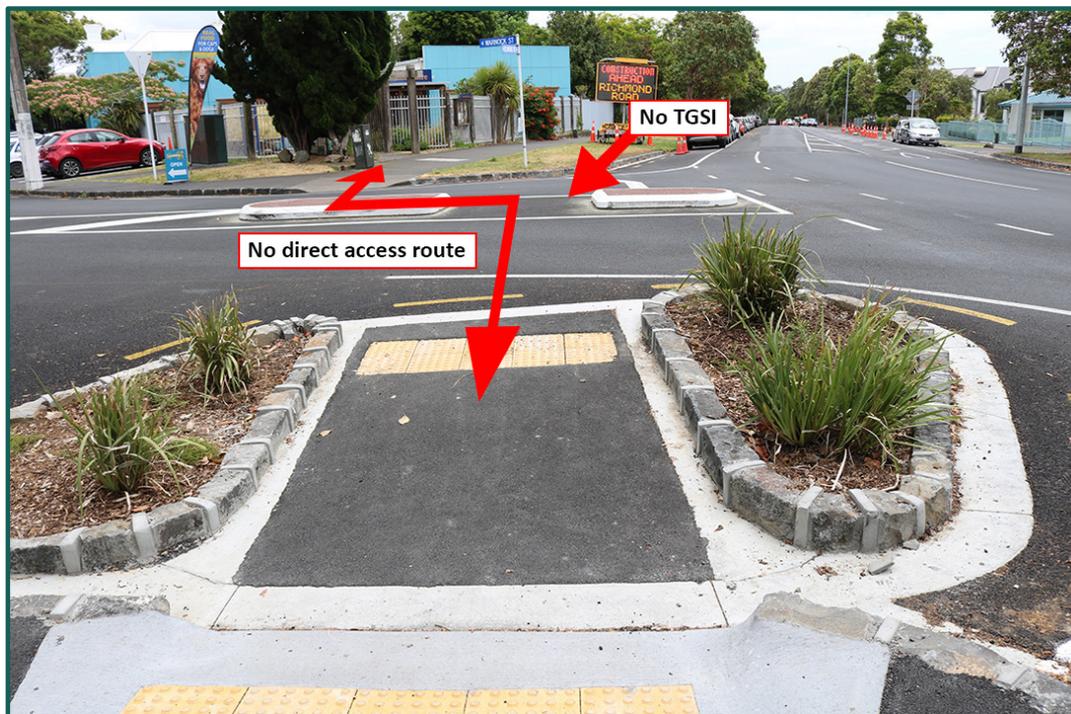
The crossing point at Warnock Street is identified in the Aecom design drawing number 60525529-SHT-RC-C-1204 to have a direct alignment created with adjustments to the footpath on the northern side of Warnock Street to align with the newly created extension on the southern side. At the time of the audit, this had not been implemented.

Figure 2 - Photo showing lack of alignment to footpath at crossing point and TGSI at bottom not required

Providing either a dog leg island or direct alignment as proposed in design drawings will need to be implemented. The design drawing shows warning indicators but does not have any directional provided on either side of the road crossing. Given that the alignment of the footpath angle changes on the north and southern sides in order to facilitate the crossing alignment there will be a need to provide directionals that extend into the line of travel along the footpath to guide users to the crossing points.

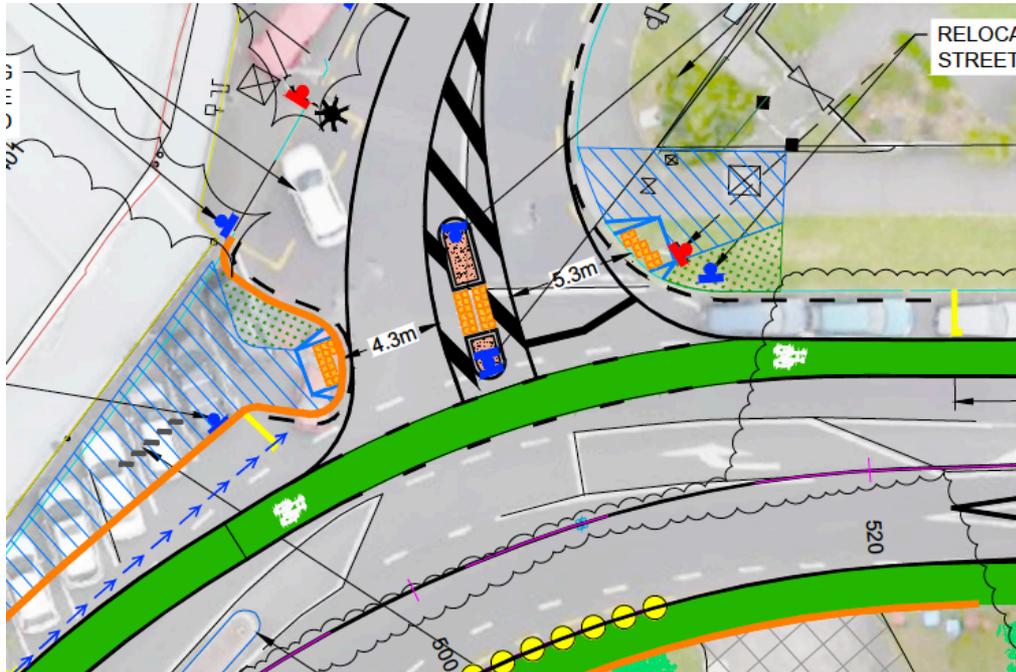
Figure 3 - Image taken from Aecom drawings showing proposed alignment of crossing point (note TGSIs shown do not appear to have the 300mm minimum set back required)

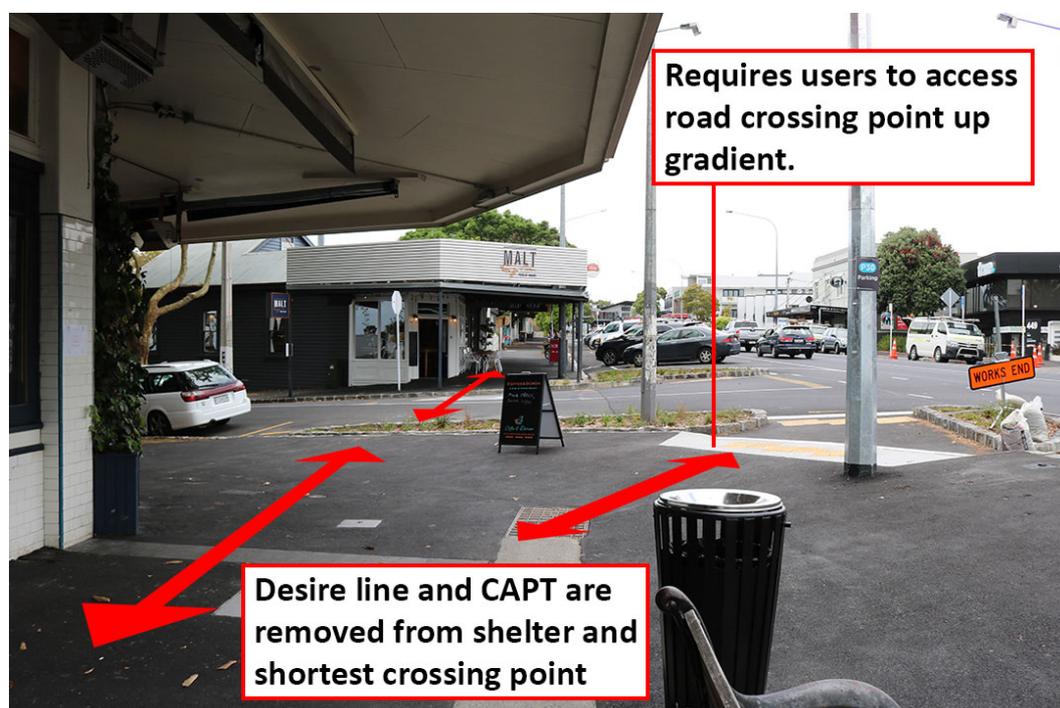
At both Hakanoa Street and Tutanekai Street, the crossing point has been extended out to the widest part of the road to provide for better visibility for pedestrians crossing the road.

Figure 4 - Photo showing desire line and existing crossing point at Hakanoa Street with no directional guidance to approach the crossing point from both approaches

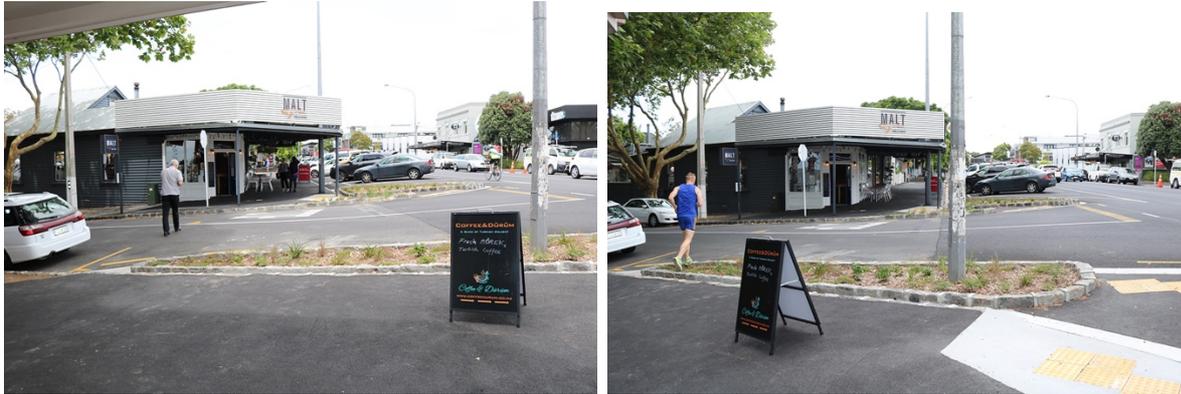
Figure 5 - Photos showing users crossing road at desire line and retail signs as hazard for pedestrians

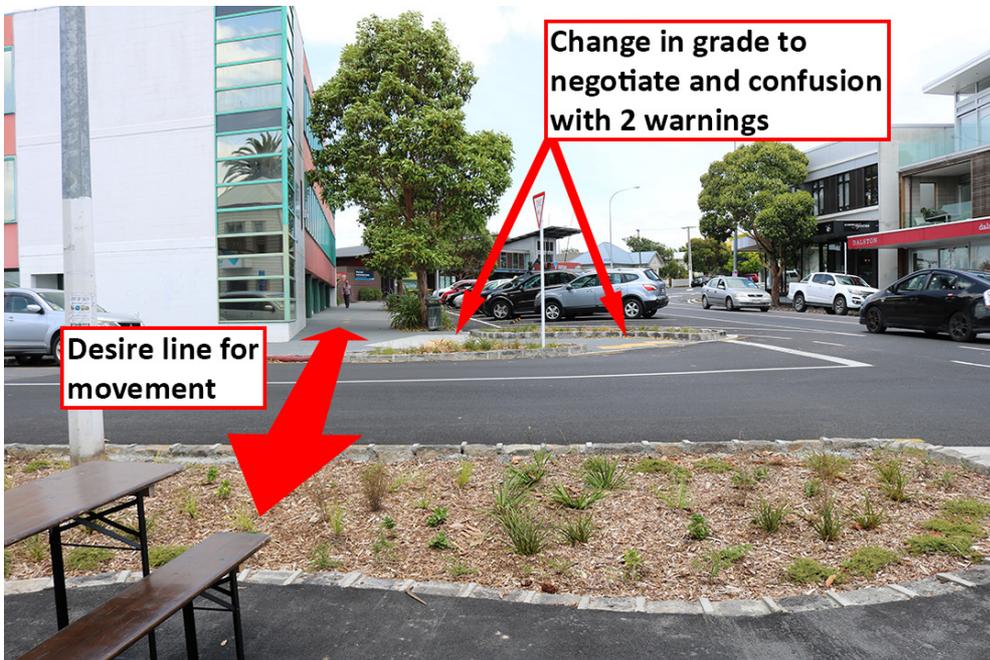
Figure 6 - Photo showing desire line for crossing at Tutanekai Street

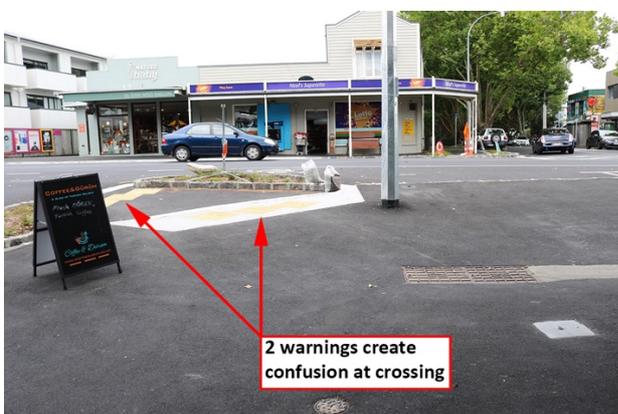
Figure 7 - Photo showing two warning TGSIs at Hakanoa Street Build-out crossing, visual contrast to pole in CAPT would be beneficial

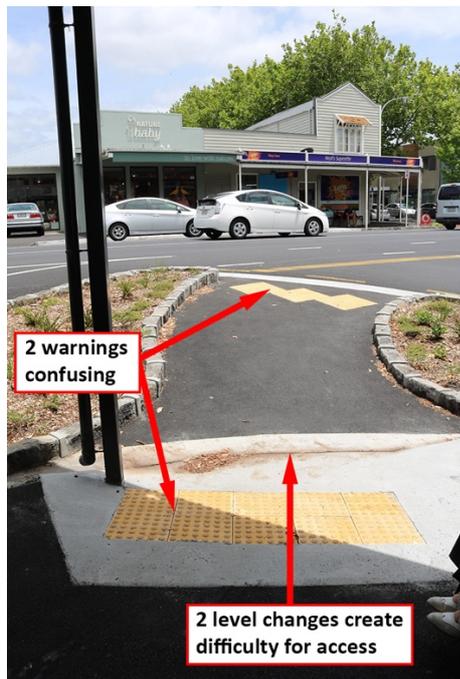
Figure 8 - Photo showing 2 warning TGSIs and gradient change at Tutaneikai Street build-out. Note also that the TGSIs at crossing point have been installed incorrectly as they can be stepped through (refer RTS 14 figure 5.11 page 49)

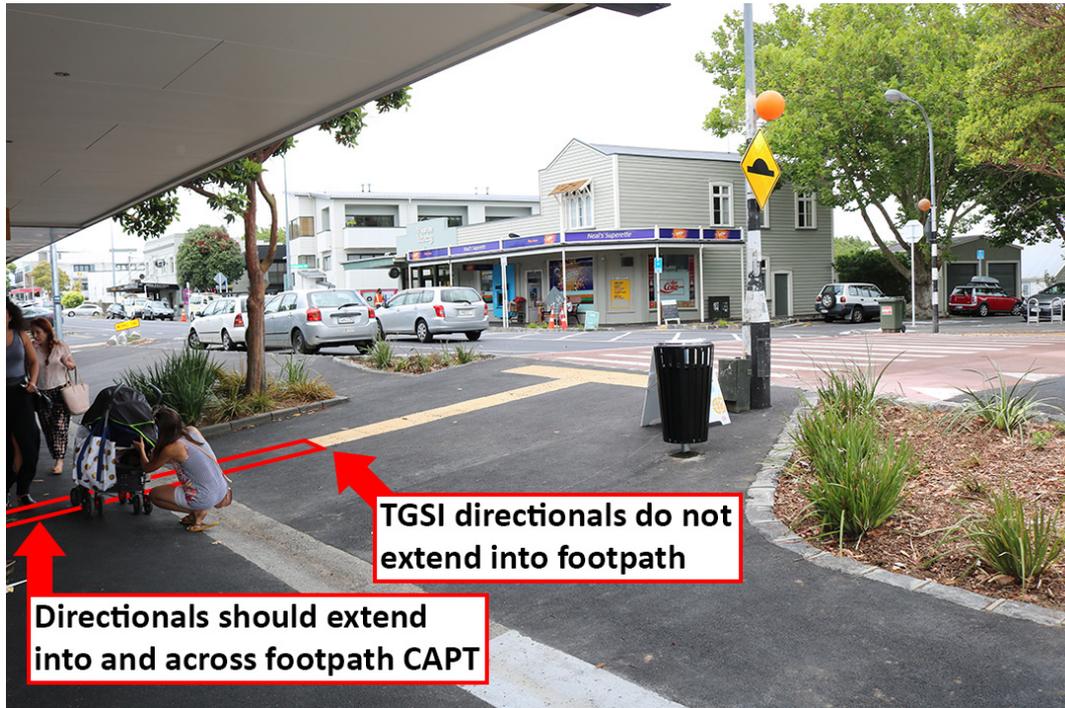
TGSIs have been included in both design drawings and have been implemented on site. It appears that with a number of TGSIs locations the directionals have not been implemented adequately to provide guidance to users for movement from the CAPT to the crossing points. The directional often stop short of entering the line of travel which means that users will not be guided to the crossing points or know when or where crossings have been provided. Warning tgsi have also not all been installed correctly.

Figure 9 - Photo showing TGSi directional requirements at crossing point adjacent to Francis Street

- That a representative from the Blind Foundation be present on site at time of installation of TGSi to ensure that RTS requirements are implemented appropriately.
- That TGSi directionals are provided in areas indicated to ensure appropriate guidance of users to crossing points.

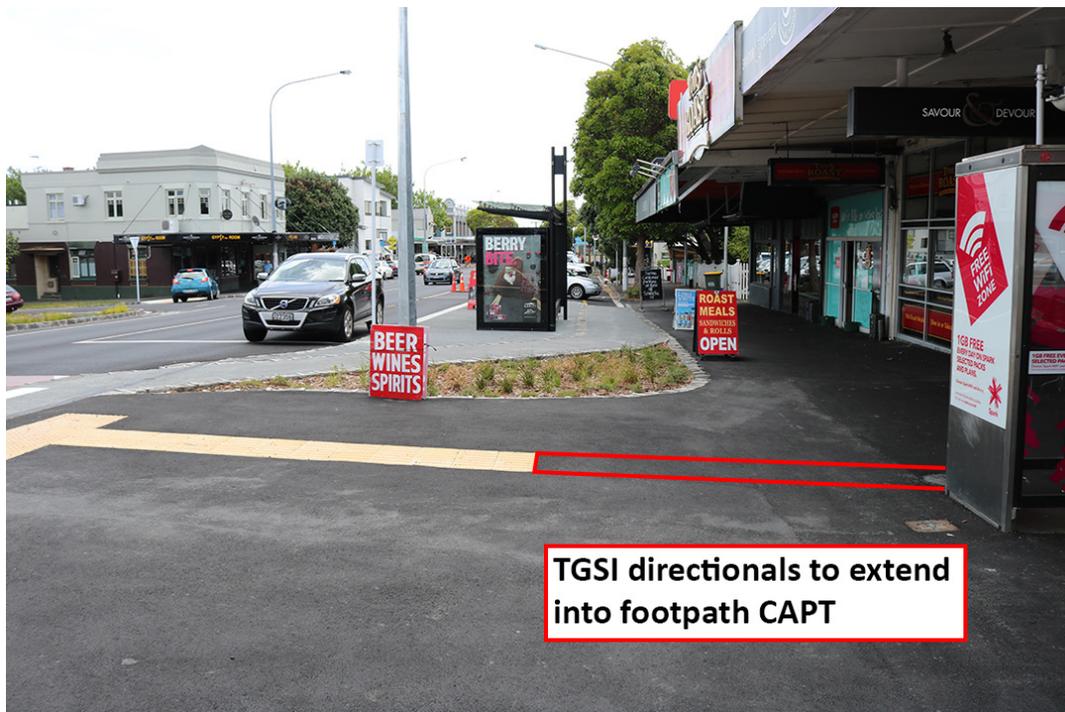
Figure 10 - Photo showing TGSi directional requirements at crossing point adjacent to new bus stop location

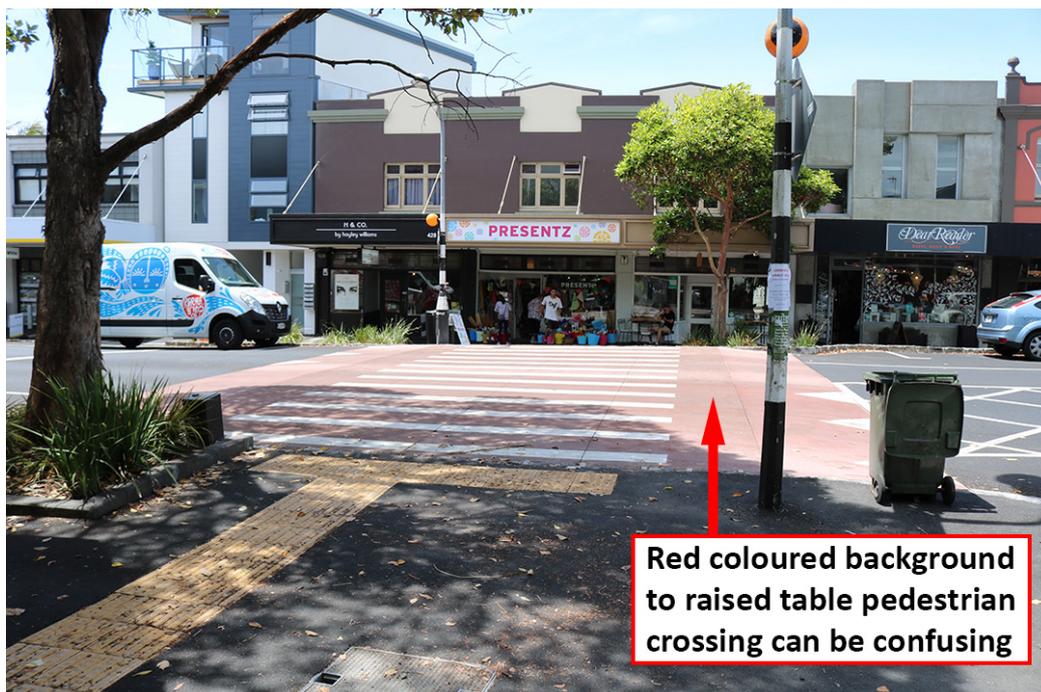
One of the issues identified within the audit in relation to visual contrast is the use of red coloured concrete at the raised table pedestrian crossing points. Normal pedestrian zebra crossings of white on dark asphalt have a high level of contrast. The use of red changes the contrast and makes it harder to interpret for a person who has low vision. Some people who have vision impairment cannot see red. Zebra crossings are known to be white on the dark roading background not on red. It is a challenge for those who also have cognitive impairments (such as dementia) to interpret.

At the West Lynn Town Centre, this lack of contrast is further complicated with the existing trees at both raised table crossing points providing shade over part of the crossing. This shading changes the lighting and makes the crossing point harder for people to see and the lower contrast with the red compared to white on black asphalt, increases the difficulty in readability and interpretation. In addition there is some concern at the crossing point that comes directly towards the tree as those finding the directional tgsi are then led into the tree. Particularly with the long adaptation to change in lighting level.

Figure 11 - Photo showing shading and lower contrast levels on raised table zebra crossing

- The audit team are aware that the use of this colour for raised tables has been implemented in other locations in Auckland. It is recommended that consideration be given to reviewing the use of red concrete for zebra crossings due to the impact on usability from a visual contrast perspective.

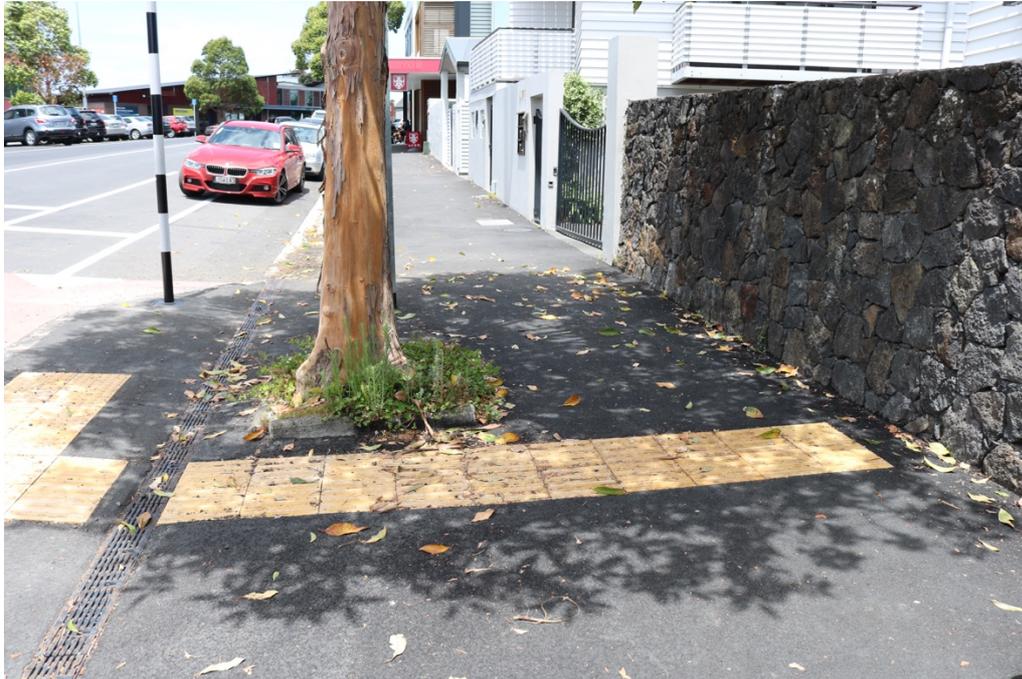
Figure 12 - Photo showing shading and reduction in contrast at second crossing point and directional leading into tree when coming from south

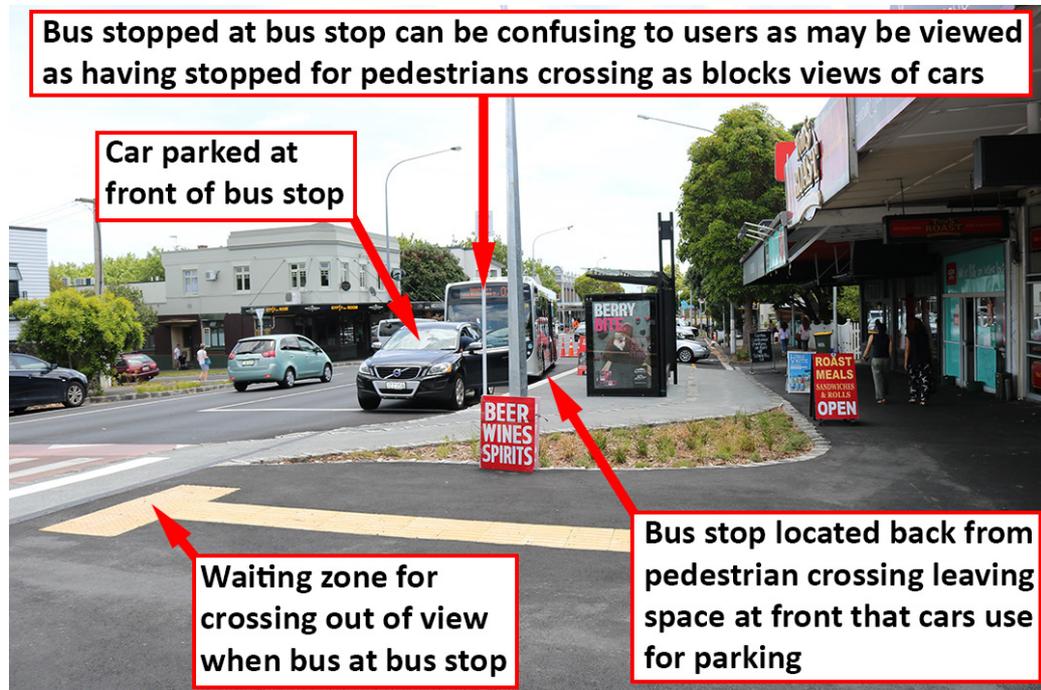
The current design as implemented has little indication of who has priority and there are no directional to guide users to the bus stop. In the design drawings, the cycle way in this location is indicated to have red colouring and striped red indicators to cyclists to watch for pedestrians. To cross over to the bus stop, users have to cross two bluestone kerb edges to the cycle way. These edges have a significant number of inconsistent surface texture and the concrete grout is raised and creates a trip hazard. The edge of the cycle way needs to be tactile, but not so tactile as to create a trip hazard.

There are no TGSIs to located the boarding position for the bus.

The warning TGSIs at the zebra crossing do not cover the full width of the crossing.

- That consideration be given to provision of one controlled crossing point at West Lynn Town Centre.
- Reconsider location of bus stop to remove visibility issues with pedestrian crossing. If not, removed, address lack of warning and TGSIs for the bus stop.

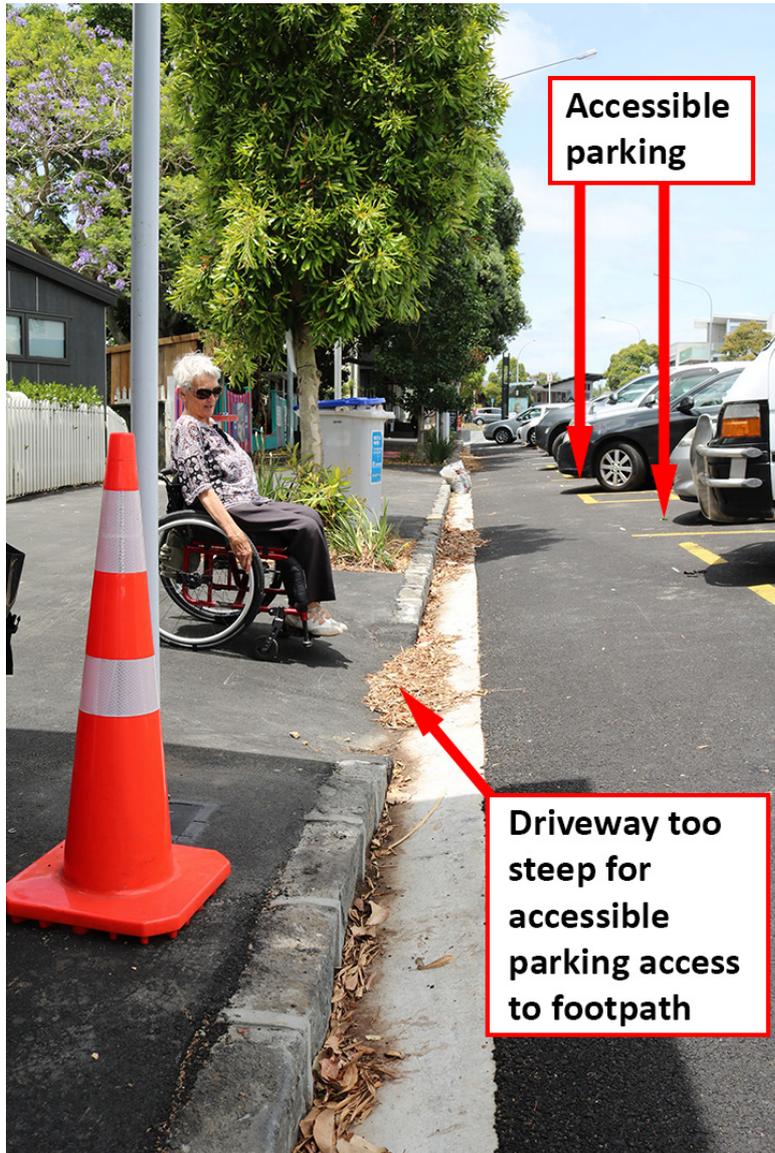
There are a few locations on the east side of the audit area where the approachability is difficult for users. Outside the medical centre there are the only two accessible parking spaces in the Town Centre. Access from these across the cycleway and then onto the footpath requires using one of two driveway entries. The driveway entries are not designed for good accessibility and there are no designated kerb ramps that are adequate.

Figure 13 - Photo of existing driveway entry with steep gradient

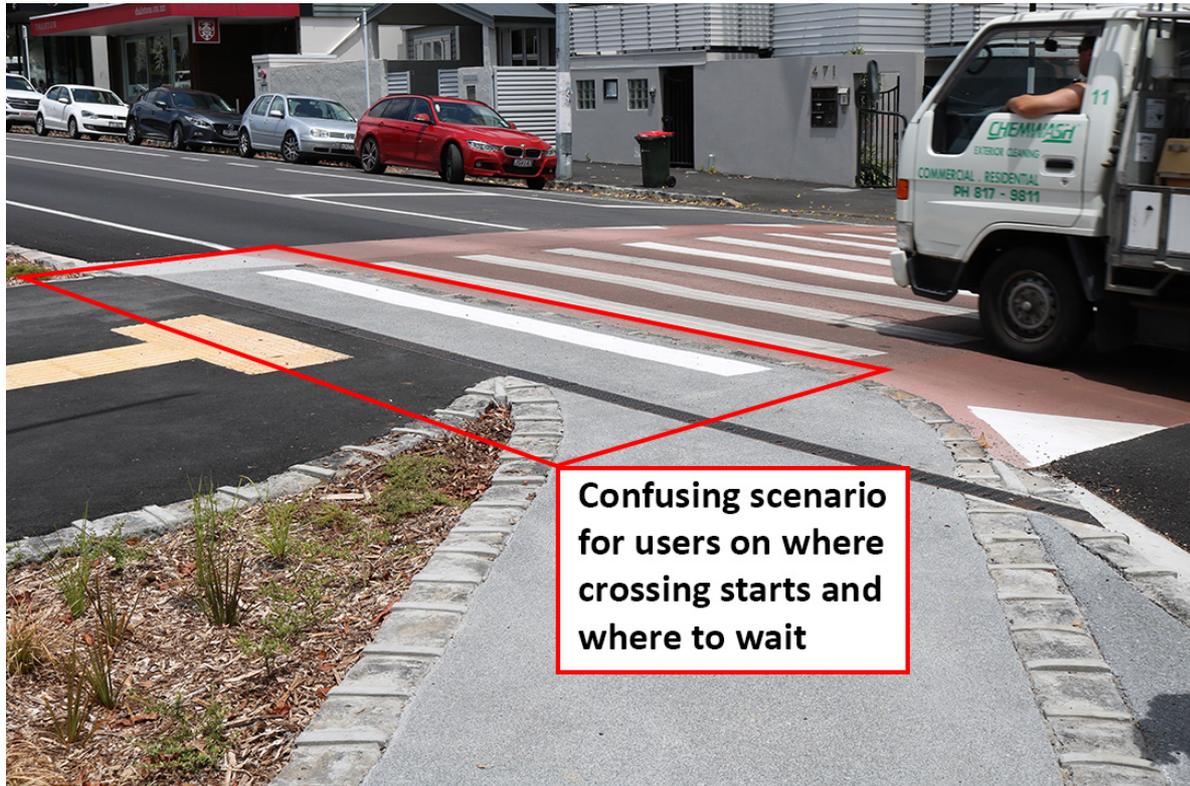
At the pedestrian crossing adjacent to Tatanekai Street, the pedestrian crossing marking enters into the cycleway. This creates some confusion for users as to where the pedestrian crossing waiting point is. For those that don't use the warning TGS1 the waiting point could be interpreted as adjacent to the white line and halfway into the cycleway – thus creating a potential hazard between pedestrians and cyclists. Once the red colouring on the cycleway is implemented as per the design drawings, this will create further confusion visually and the approachability cues for the crossing point are no longer simple and intuitive.

Figure 14 - Photo showing pedestrian crossing moving into cycleway and confusing crossing waiting location also the warning tgsi need to cover the full width of the kerb otherwise can be missed.

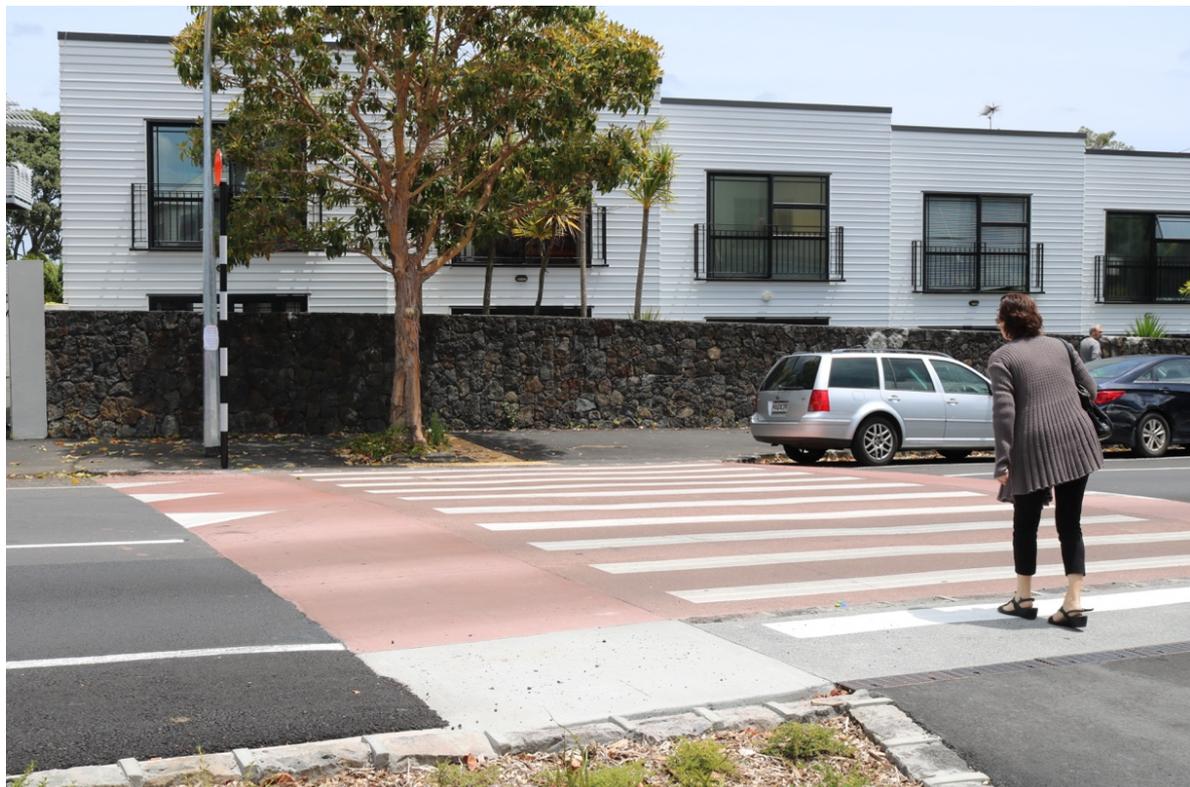
Figure 15 - Example of pedestrian moving into cycleway for waiting location for pedestrian crossing (Note the tree may cause those who are long cane travellers to spend more time in the road way after encountering the tree to navigate their way around)

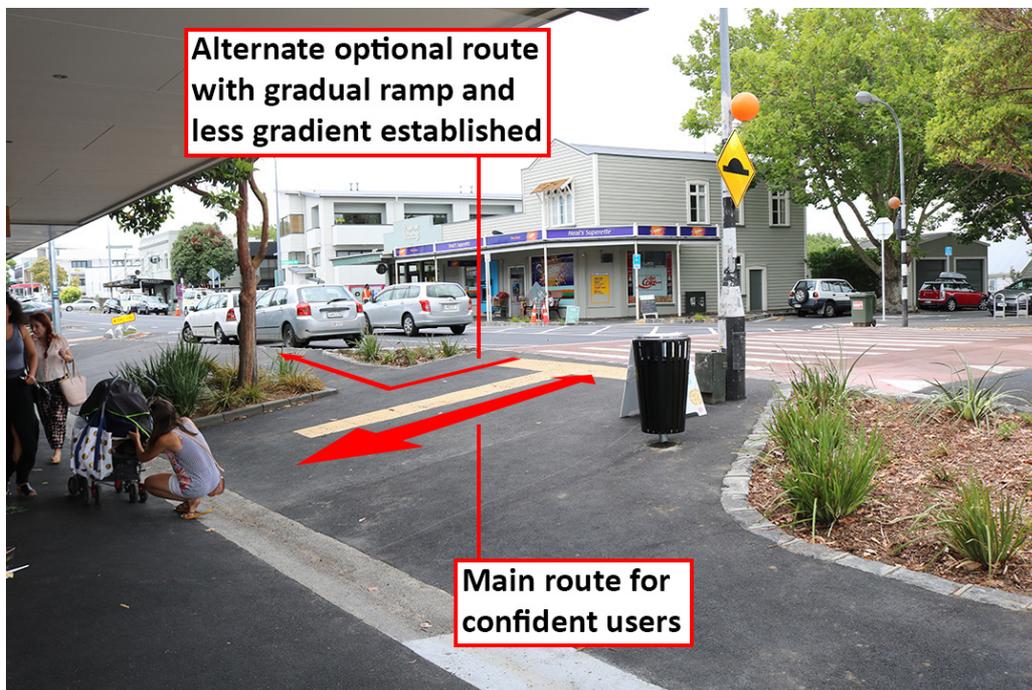
At the crossing point adjacent to Warnock Street, the approachability on the eastern side is compromised due to the significant gradient issues.

Although the existing gradient is manageable for some with limited mobility, for anyone that is less confident, has low energy or is slow moving, the steep grade will be extremely difficult to navigate. This is further exacerbated by the raised table that has further increased the gradient to be navigated. This is also a forced crossing point, as there are no other nearby options for crossing.

Figure 16 - Alternate route options for less confident users and directional TSGI should be extended to building line and ensure warning TSGI cover the full width of the crossing and match other side.

There is a large expanse of sloped asphalt footpath adjacent to the crossing point that could facilitate provision of some form of extended length of gradient or ramp that will provide for users that have less ability and require lower effort.

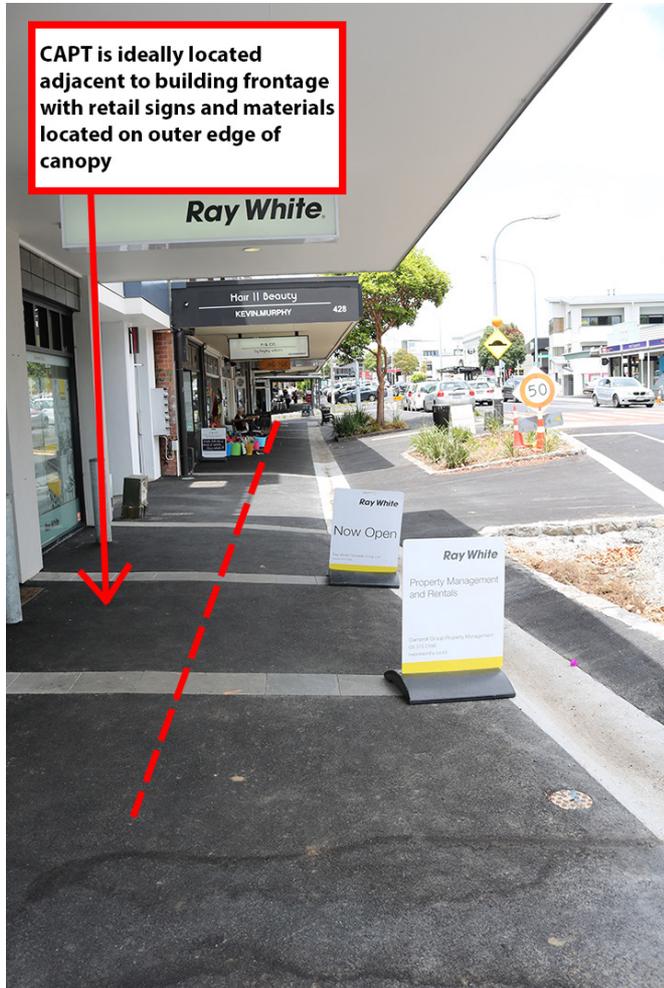
Figure 18 - CAPT alignment in first block of eastern side of West Lynn Town Centre

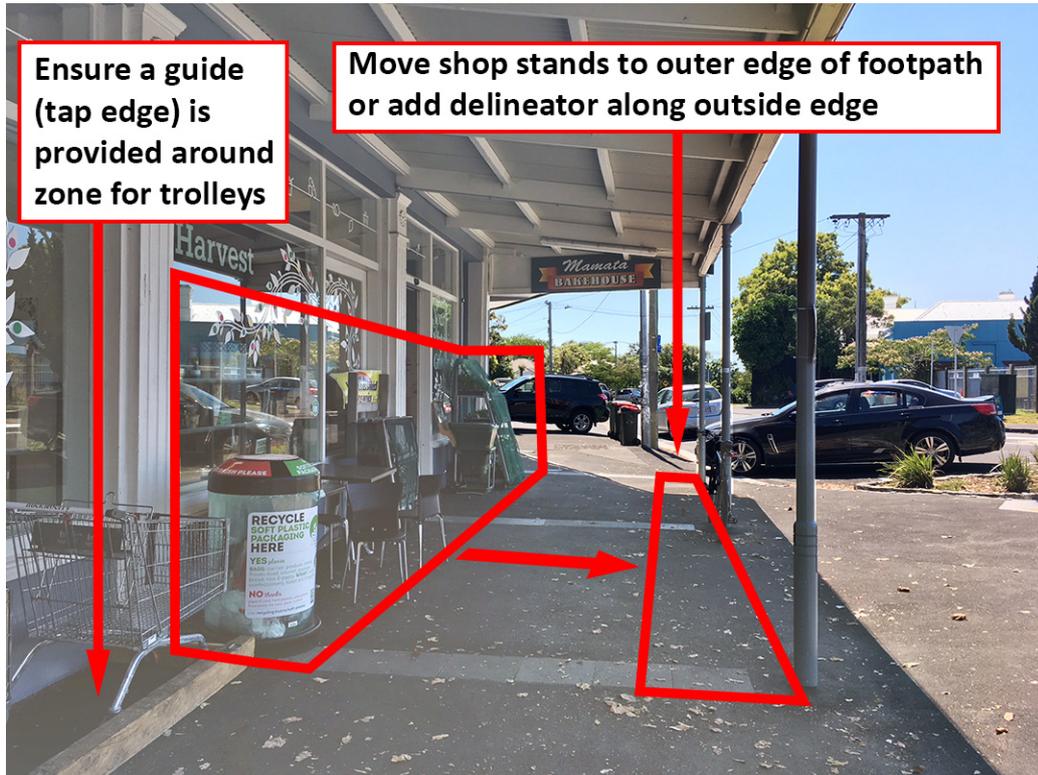
Figure 19 - CAPT alignment on western side of first block of West Lynn Town Centre

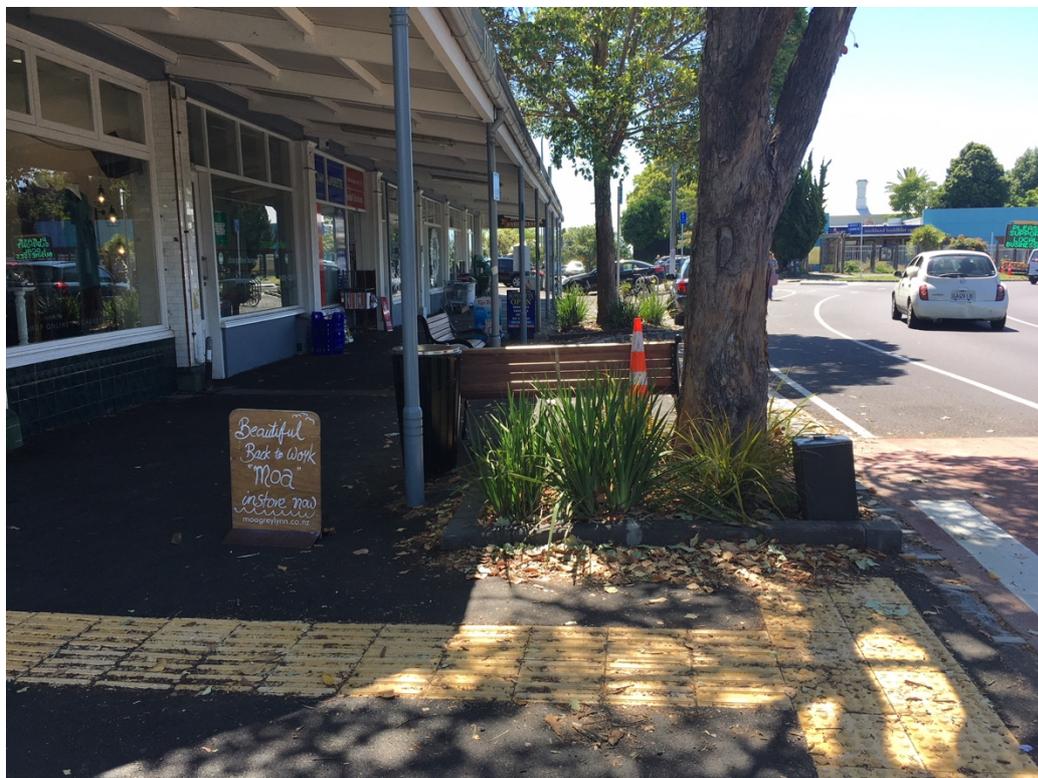
Figure 20 - Photo showing existing signage and furniture along outside edge of footpath (preferred location for retail furniture to ensure CAPT consistently runs adjacent to building frontage)

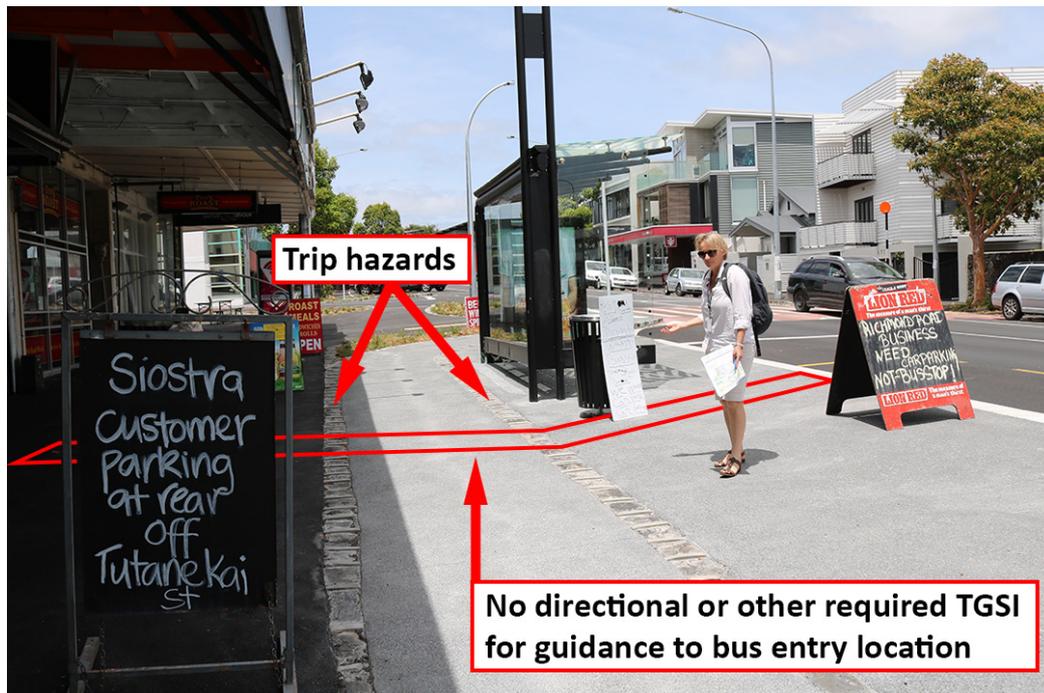
Figure 21 - Photo showing relocated bus stop with no directionals or guidance for bus users

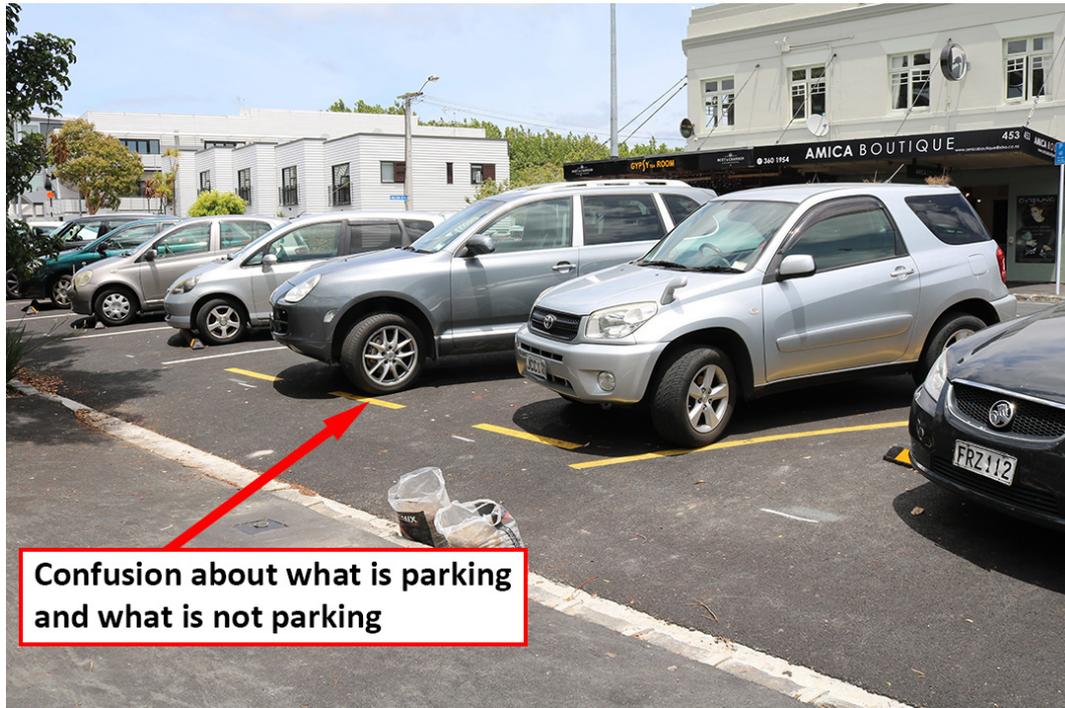
At the audit site there are examples of the usability of the site being compromised by confusion for vehicles and pedestrians over what should be happening in certain locations. Examples of this tend to be in locations where road markings are ambiguous in terms of guiding the type of use that should be occurring. In some locations in front of driveways for example, it is not clear that these are no car parking spaces. There are many observed instances of vehicles parking over the cycleway and/or vehicles parking over the wheel stops and therefore projecting into the cycleway. In some instances this situation may be addressed once the cycleway is more clearly identified (at the time of the audit the green colouring and markings had not been implemented).

Figure 22 - Photo of parking confusion

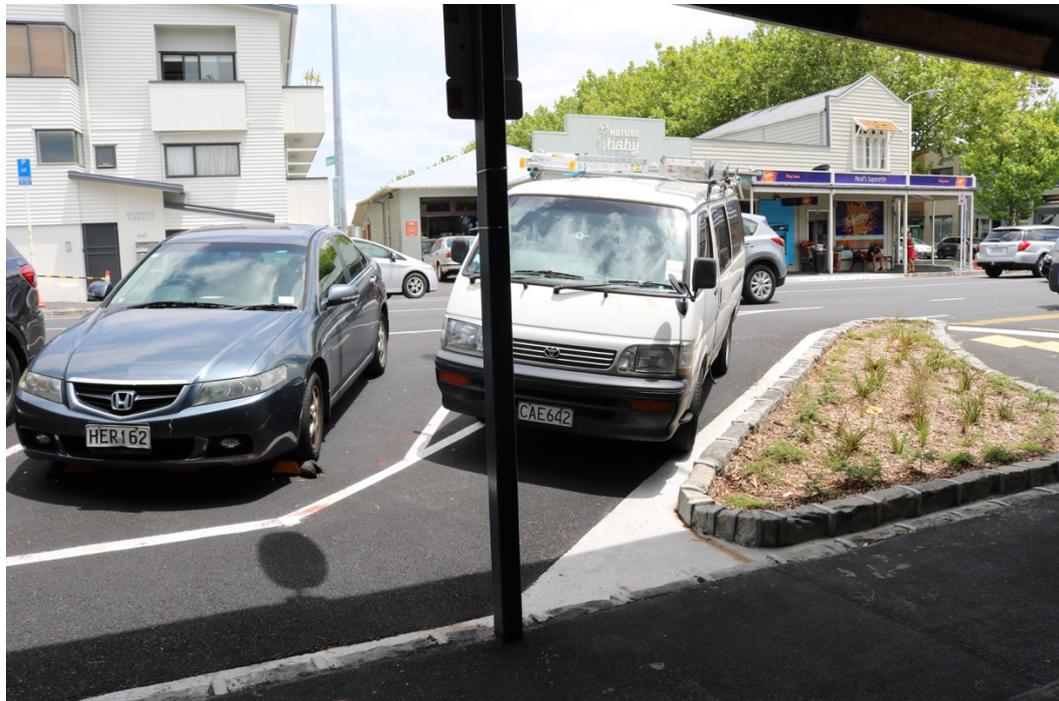
Figure 23 - Example of lack of clarity on use with vehicle parking in cycleway due to alignment

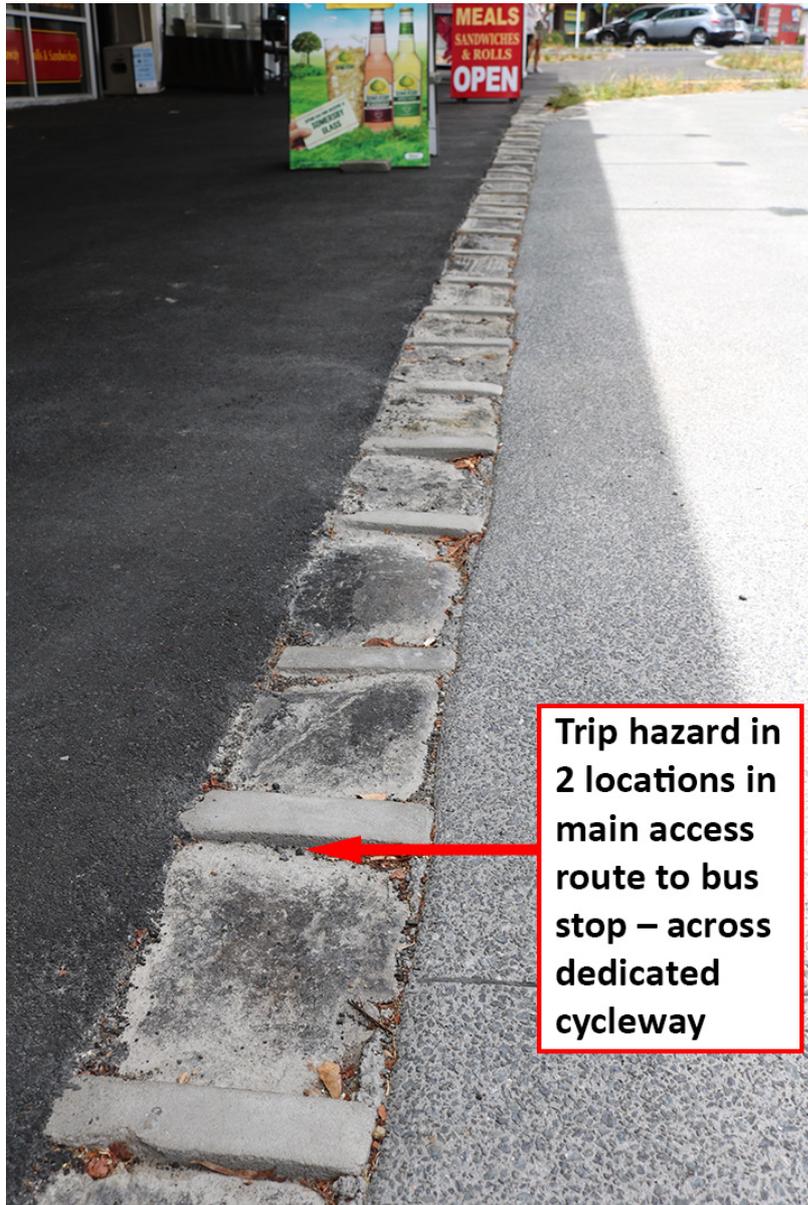
Trip hazard in 2 locations in main access route to bus stop – across dedicated cycleway

Figure 24 - Photo showing bluestone edging to cycleway with trip hazard at crossing point to bus stop

- That use of bluestone kerbing with raised grout lines flush with asphalt and concrete surfaces be reconsidered due to inconsistency and trip hazard.
- Consider clearer and consistent marking of car parking and non-parking zones to ensure clarity of usability for all users – pedestrian, cyclist and vehicular.
- That consideration be given to provision of additional accessible parking within the Town Centre location.
- The eastern side of the footpath at the Warnock Street crossing point be re-designed to provide better gradient changes that will accommodate a wide range of individual preferences and abilities.

- 9) That use of bluestone kerbing with raised grout lines flush with asphalt and concrete surfaces be reconsidered due to inconsistency and trip hazard.
