Tree Protection and Management Plan

**AMETI Eastern Busway
Stage 1 –
Panmure to Pakuranga
March/2019**

ARBORICULTURAL ASSESSMENT

Project: AMETI Stage 2a

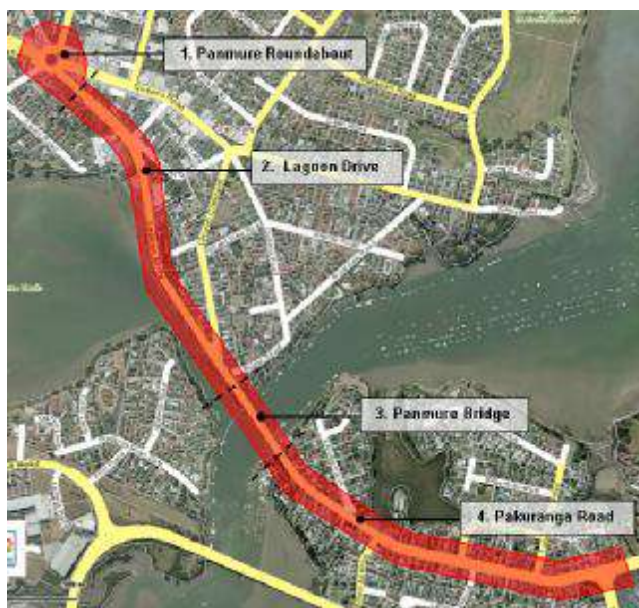
Figure 1 Extent of Project Area. (*Auckland Council GIS Viewer, 2015*).

As noted above, this report relates specifically to Stage 2A. The Stage 2A Project Area ('the Project Area') comprises Panmure Roundabout in the north, Lagoon Drive and Panmure Bridge, and Pakuranga Road to Ti Rakau Drive in the south. Figure 1 below shows the Project Area.

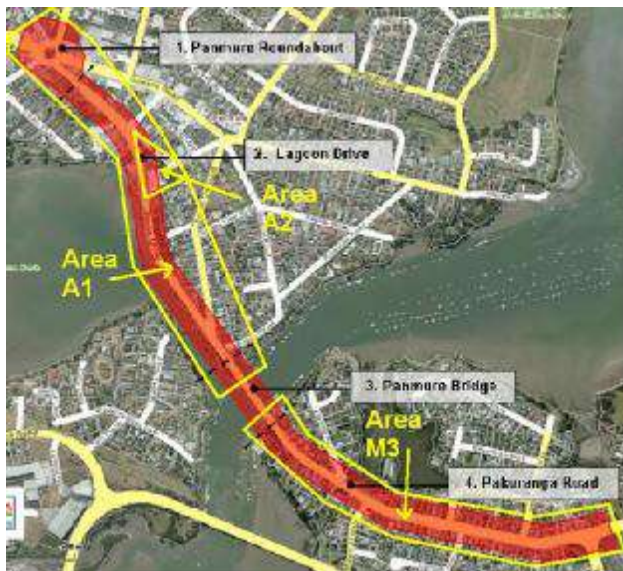
Figure 2 - Tree assessment areas in the Project Area (*Auckland Council GIS Viewer, 2015*)

The route of the new busway, cycleway, footpaths and other associated work has been split into the following areas in order to address removals and any appropriate tree protection measures (see Fig. 2 below):

- **Area A2:** Panmure side of the Tamaki River – Notable trees in Domain Reserve. The relocation of the car park access, the relocation of the vehicular access to residential properties on the southern boundary of Domain Reserve and construction of a retaining wall at the end of the right of way at 54 Lagoon Drive have the potential to affect these trees

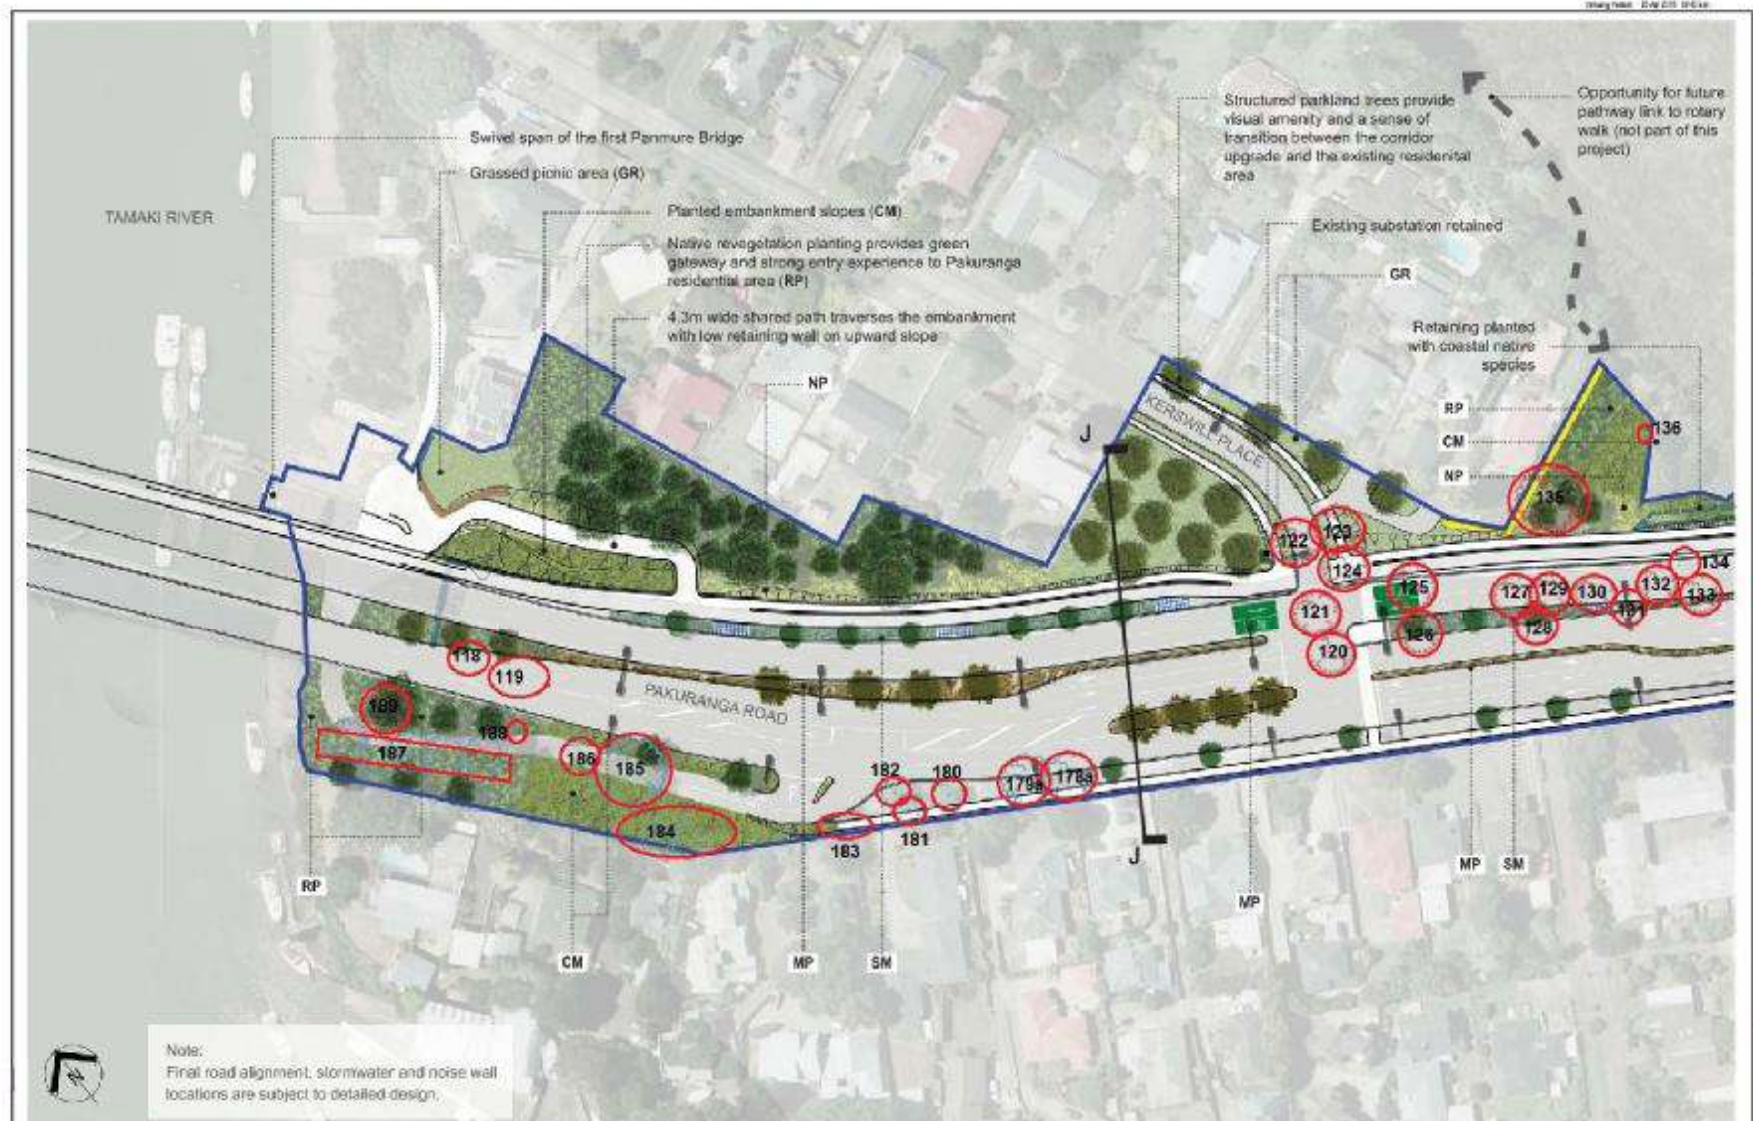
TREE LOCATION PLAN - SHEET 6

Earthworks within 30m of a Kauri tree are restricted, and subject to the guidelines set out in Appendix 7

Refer to Appendix 7 for specific guidelines for Kauri Dieback prevention measures

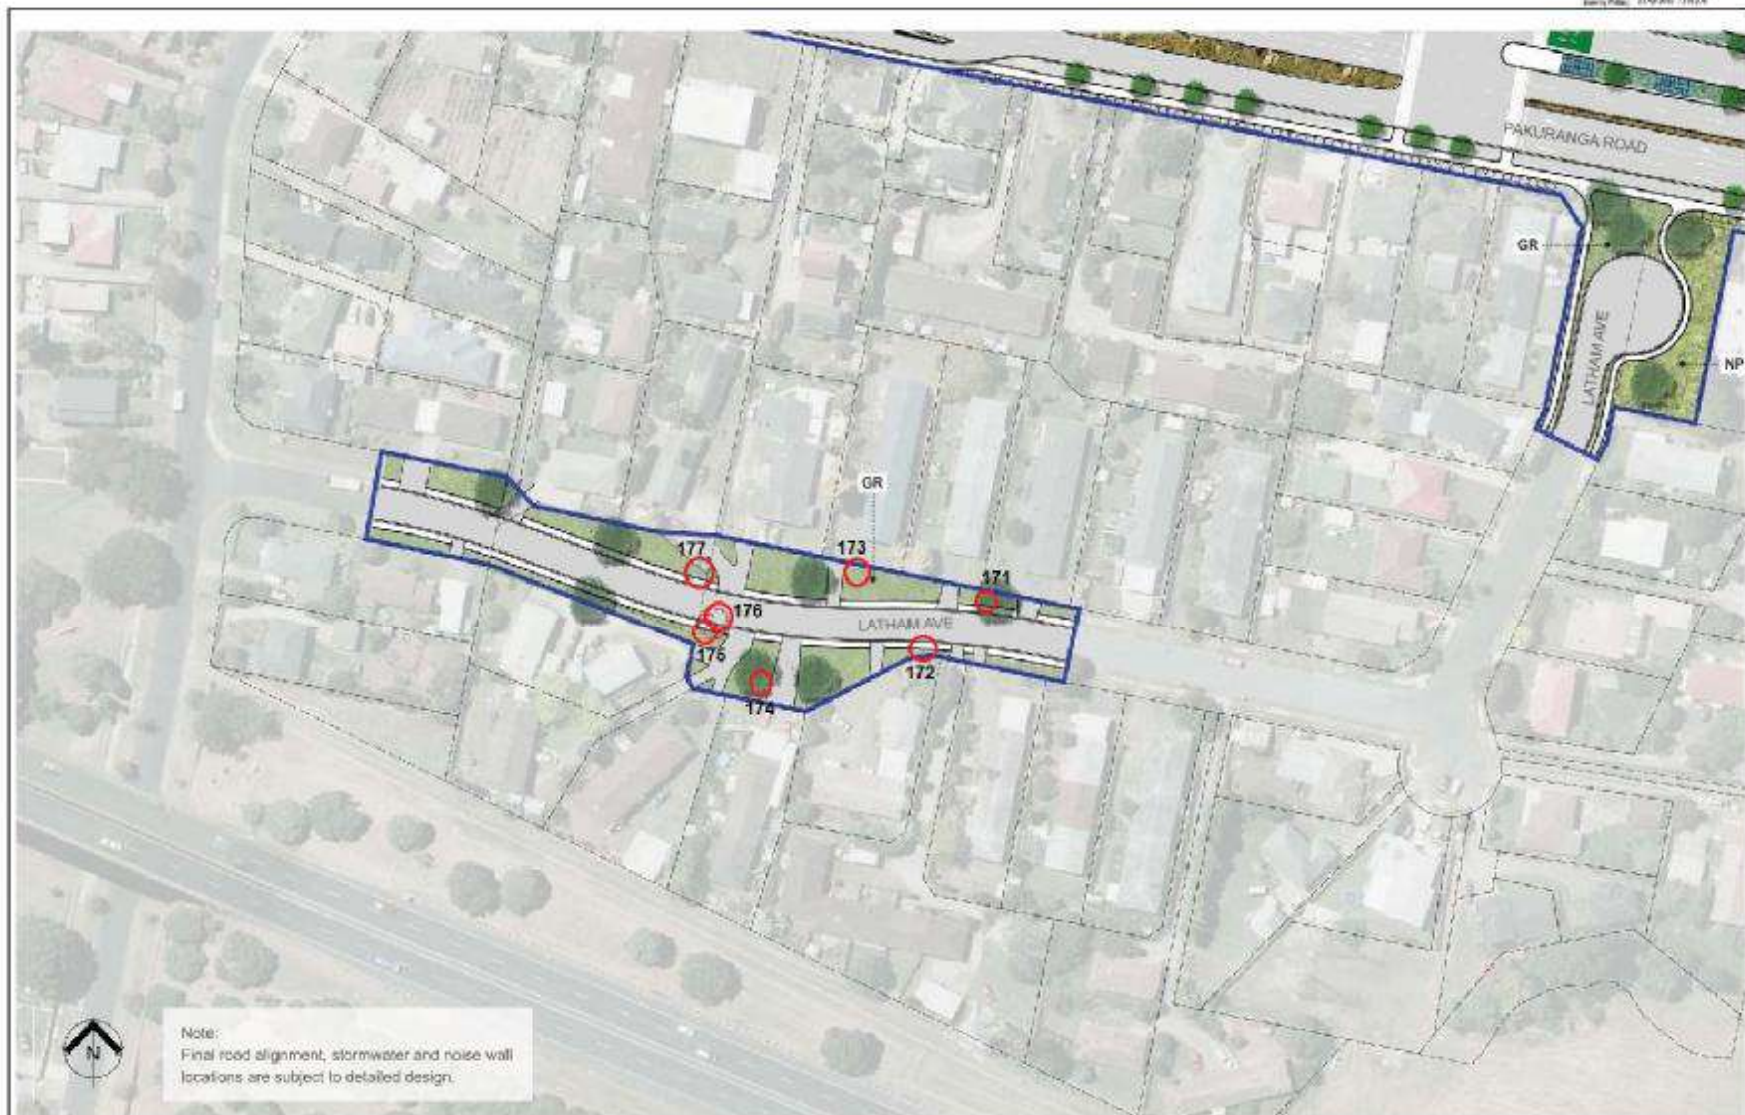
TREE LOCATION PLAN - SHEET 10

Note:
Final road alignment, stormwater and noise wall
locations are subject to detailed design.
