Speed Limits along Airport to Botany
Mass Rapid Transit Corridor

Technical Note

To	Auckland Transport	From	
Copy		Reference	502334-7000-TEC-KK-0040
Date	11/03/2021	Pages (including this page)	17
Subject	Speed Limits Along the Airport to Botany Mass Rapid Transit Corridor

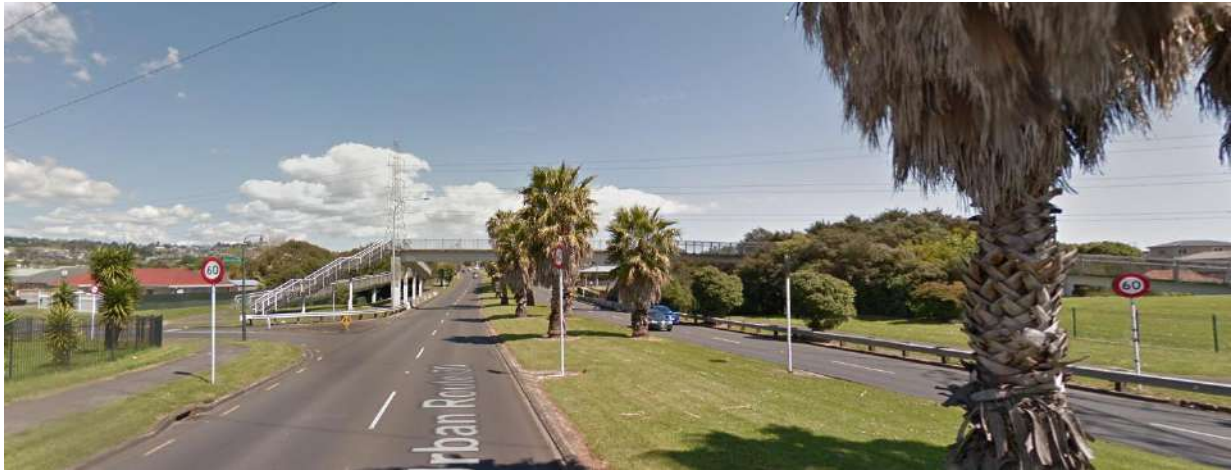
Figure 4: Google Street View Image captured October 2018 showing where the posted speed limit on Te Irirangi Road changes from 80km/h to 60km/h at Whetstone Road

Table 2, there are sections of the A2B corridor, particularly the northern end of Te Irirangi Drive where the 85th percentile vehicle speeds are significantly lower than the posted speed limit. This area comprises the Botany Town Centre and a number of retail outlets which generate high turning movements. This is in contrast to further along Te Irirangi Drive, where high percentages of vehicles are exceeding the posted speed limits. This, in part, could be due to the fact that the change in the posted speed limit at Whetstone Road, from 80km/h to 60km/h, does not correspond with a change in the road environment. This can be seen in Figure 4 below, in that the lane arrangements, solid median and land uses either side are not discernibly different after the 60km/h signs.

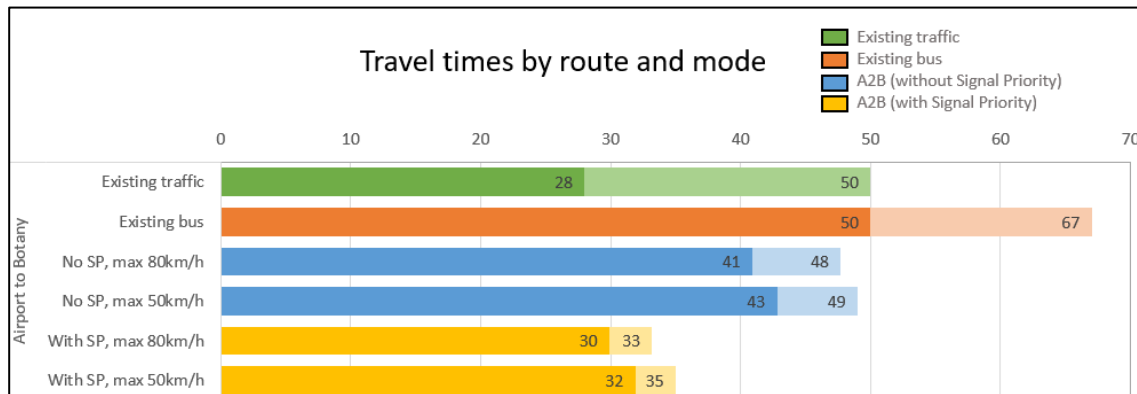
The model found that the difference between running the line with a speed limit of 80km/h or 50km/h differed by only a few minutes, due to the amount of time spent accelerating/decelerating around stations and intersections. The model compared travel time estimates for A2B without signal priority and with signal priority at 50km/h and at 80km/h and compared these estimates to existing car travel times on the corridor, and bus travel times on equivalent corridors. The model found that when comparing speed limits of 50km/h with 80km/h, maximum and minimum travel time only differed by a couple of minutes – this small effect of differing speed limits was observed both with and without signal priority for A2B.

The effect of providing signal priority, on the other hand, is significant: with no signal priority the maximum travel time for a 80km/h posted speed was found to be 48 minutes, whereas if signal priority is provided the maximum travel time with a 80km/h was only 33 minutes. This is primarily due to the reduction in the instances of having to decelerate and accelerate again for red signals at intersections.

Figure 7: The A2B MRT runtime model results

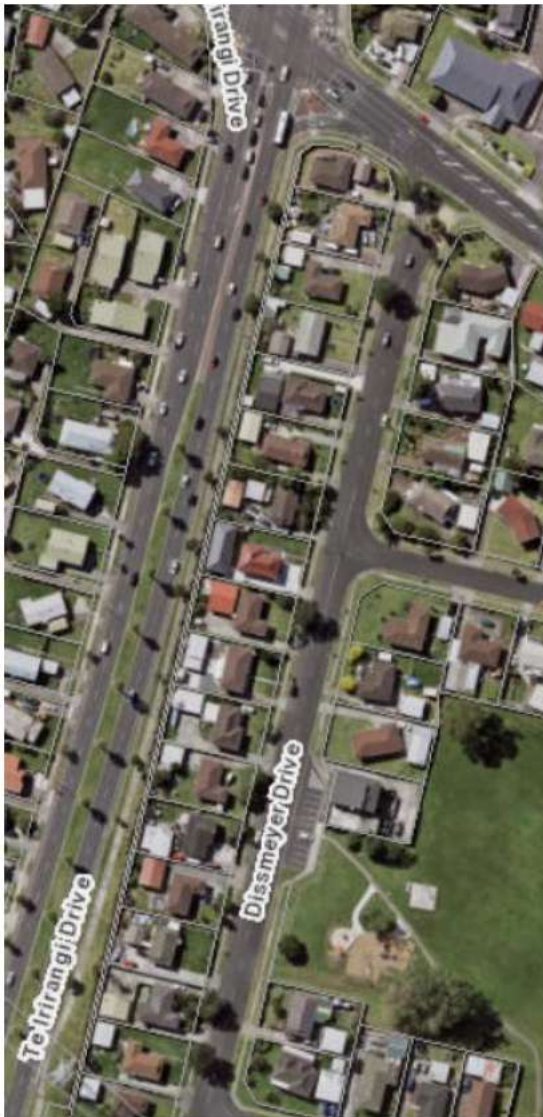
Figure 2: Dissmeyer Drive: example of rear access lane to reduce direct driveway accesses

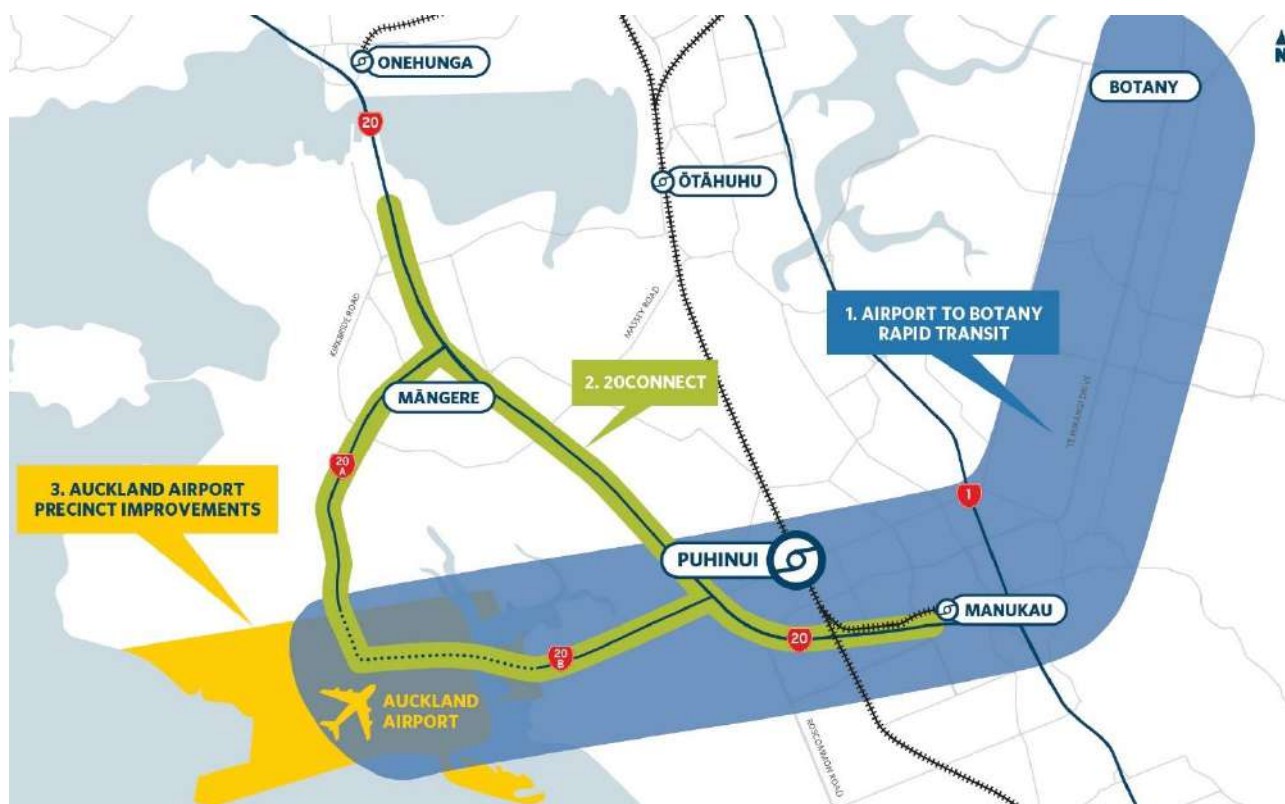
Figure 1-1: Southwest Gateway improvements

Error! Reference source not found. shows the extent of the Airport to Botany Rapid Transit Corridor (RTC) in relation to the wider Southwest Gateway improvements. The Airport to Botany RTC is intended to connect Auckland Airport to the Botany Area, via the corridor shown in Figure 1-2.

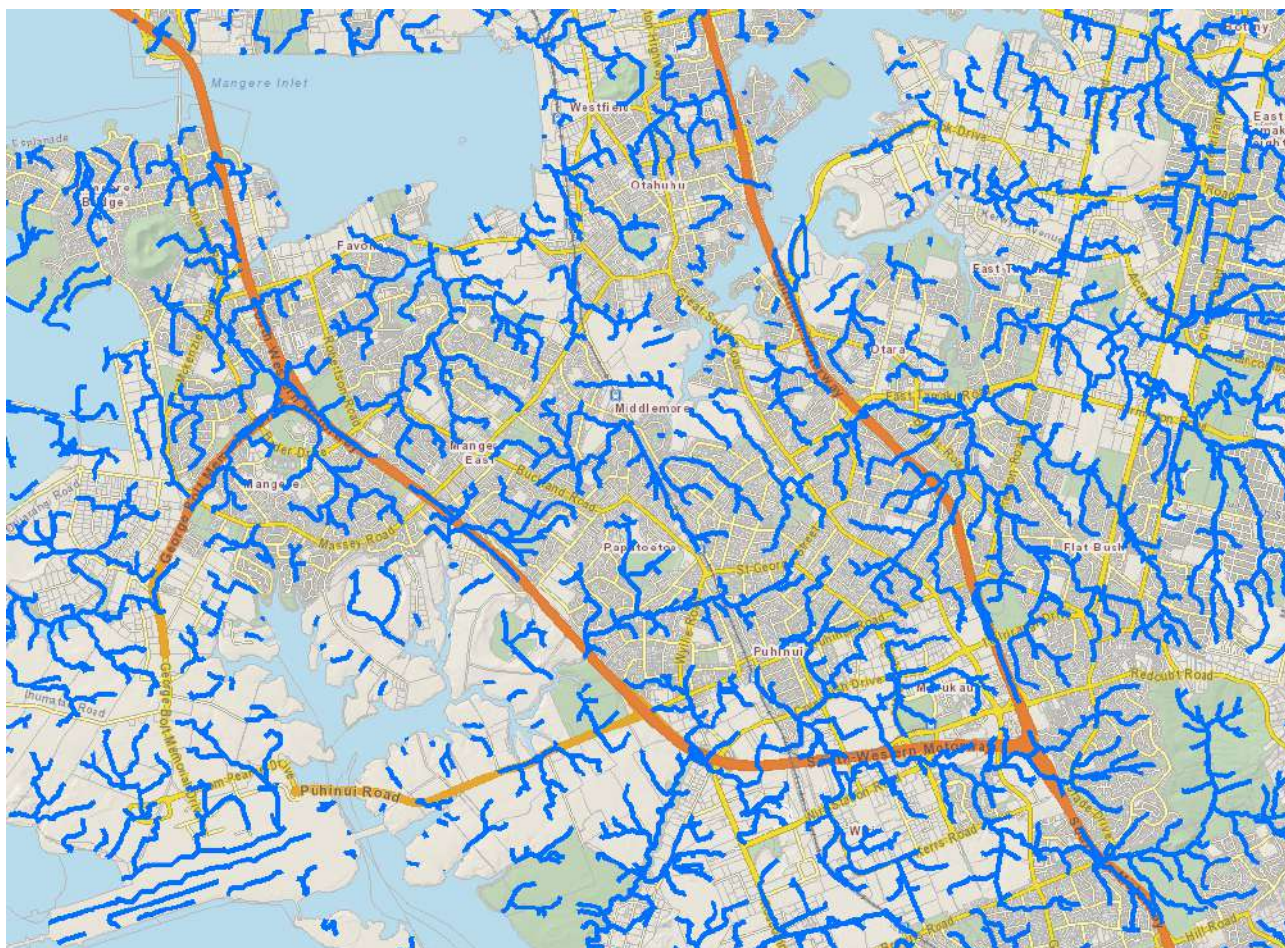
A representation of overland flow paths and drainage patterns is shown in Figure 2-2.

Figure 2-2: Major overland flow paths (Auckland Council Geomaps, 2019)

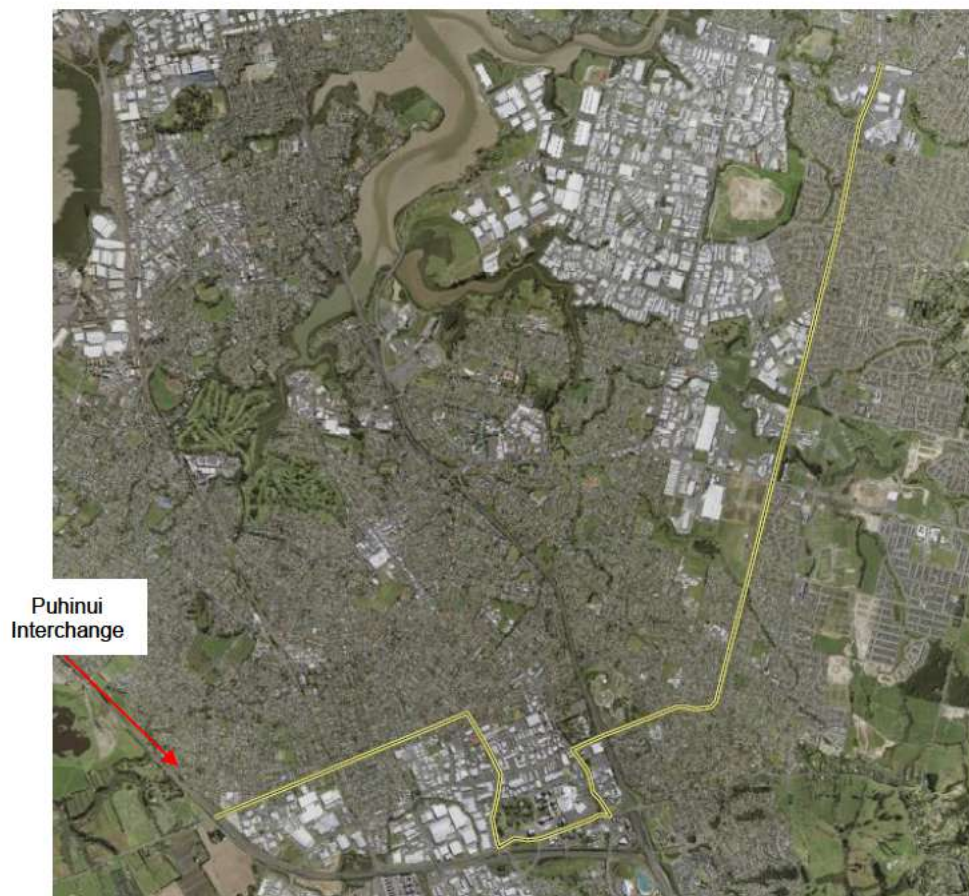
Figure 1: A2B PGAR and Contaminated Land Review Study Area

This work is an addendum to the Preliminary Geotechnical Appraisal Report (PGAR) (Aurecon ref. 502334-7000-REP-GG-0022) as confirmed in a Change Note issued to Auckland Transport (AT) by Aurecon dated 18 February 2019. The study area is shown in Figure 1.

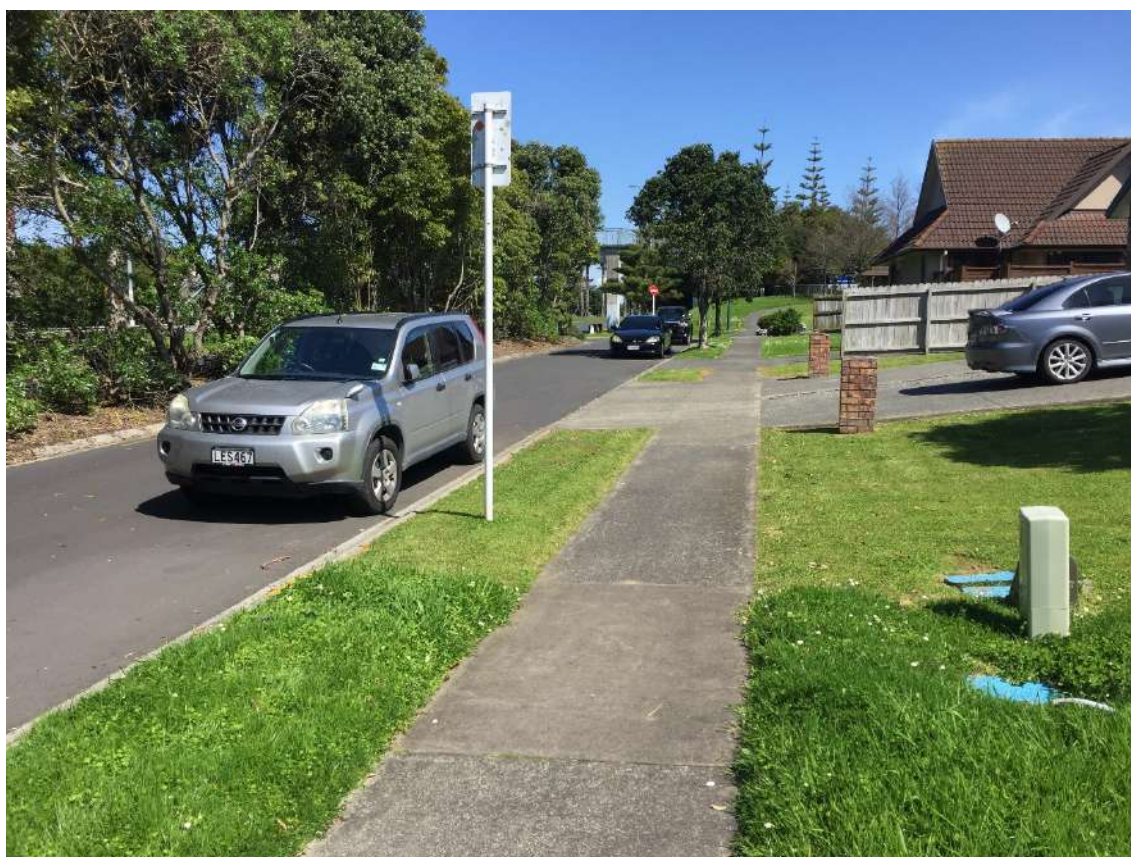
Most of the properties along the service roads have minimal or no front fence and rely on the substantial and mature verge planting to screen them from Te Irirangi Drive as shown in Figure 1. This leads the safety audit team to believe that the service roads are being and can be used as a relatively safe extensions of the play areas of each property, provided that the entry speeds into the service roads were low.

Figure 1: Typical residential frontage onto service road

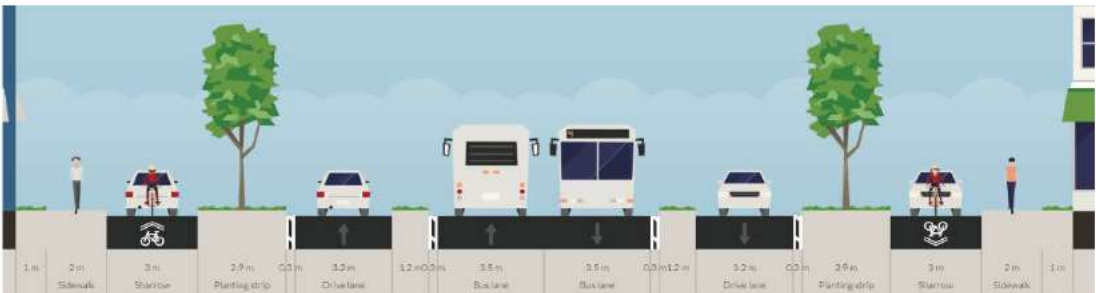
Safety Engineer comment	<p>The change proposed in the designer's response from one way separated cycle paths to access streets / bicycle streets allowing two way cyclist movement (as shown in the cross section above) is significantly different from the design presented for audit.</p> <p>I agree in principle that this arrangement is worthwhile investigating and might prove to be the preferred arrangement, however more work needs to be done to determine if this is the case. Areas which need to be considered include but are not limited to:</p> <ol style="list-style-type: none"> 1. How with the access streets / bicycle streets intersect with the main traffic lanes? 2. What will be the cross section near major intersections? Presumably additional auxiliary lanes will be needed for turn movements near signalised intersections.

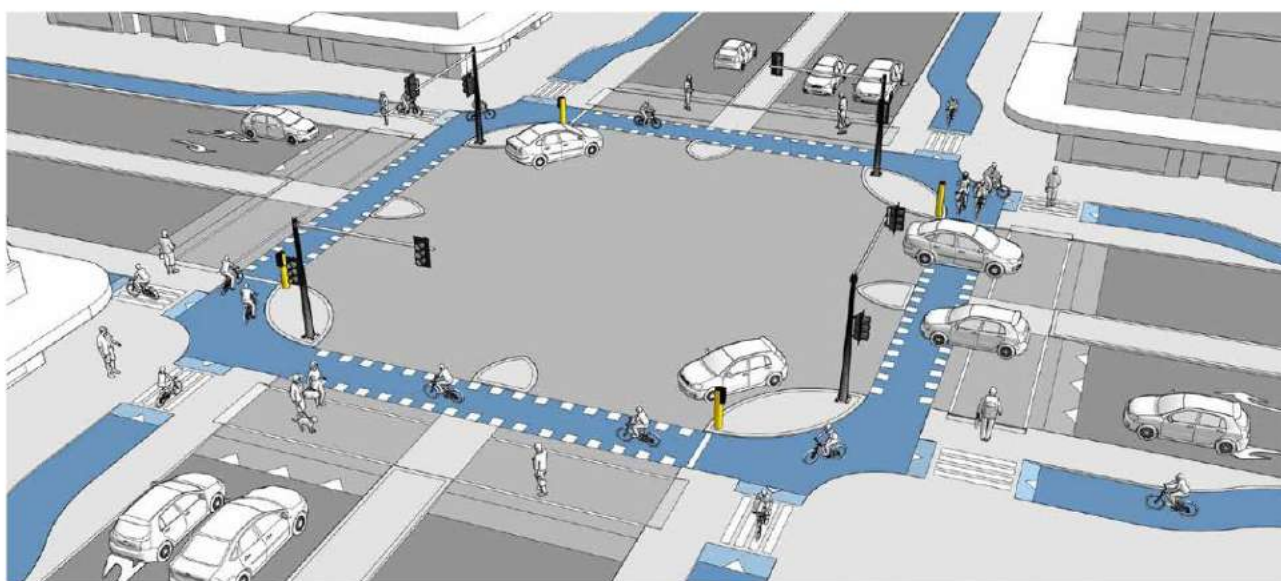
For the purposes of the business case, a generic fully protected signalised intersection has been applied to every major intersection along the route at this stage. No detailed analysis of the intersections has been undertaken, for example with regard to spatial requirements for pedestrians and cyclists. The SAT acknowledges that applying the generic intersection to each intersection is an appropriate approach at this stage as the proposed cross-section of the RTC is consistent along the entire route.

Figure 3: Typical fully protected signalised crossing as applied to the RTC

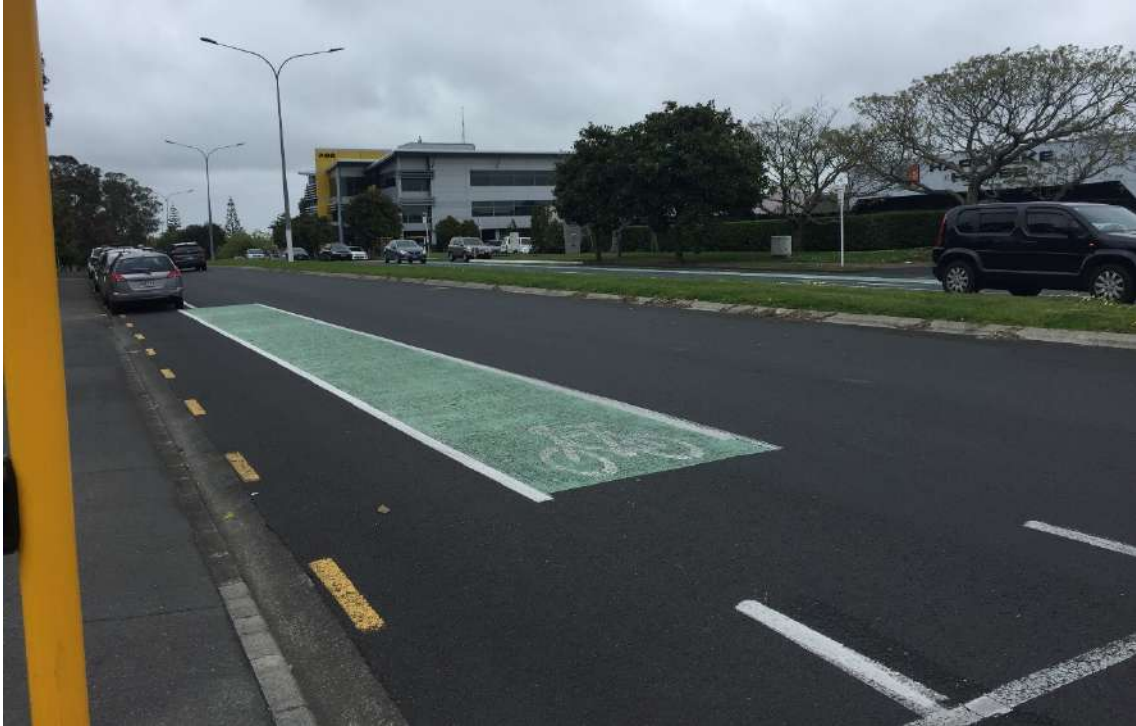
Three major signalised intersections could be avoided if the RTC ran from Lambie Drive left into Ronwood Avenue, left into Sharkey Street and right into Cavendish Drive to Great South Road. There seems to be enough width in Ronwood Avenue to provide the RTC without removing any trees as shown in Figure 4 and Figure 5.

Figure 4: Ronwood Avenue west of Davies Avenue (Google Street View, 2018)

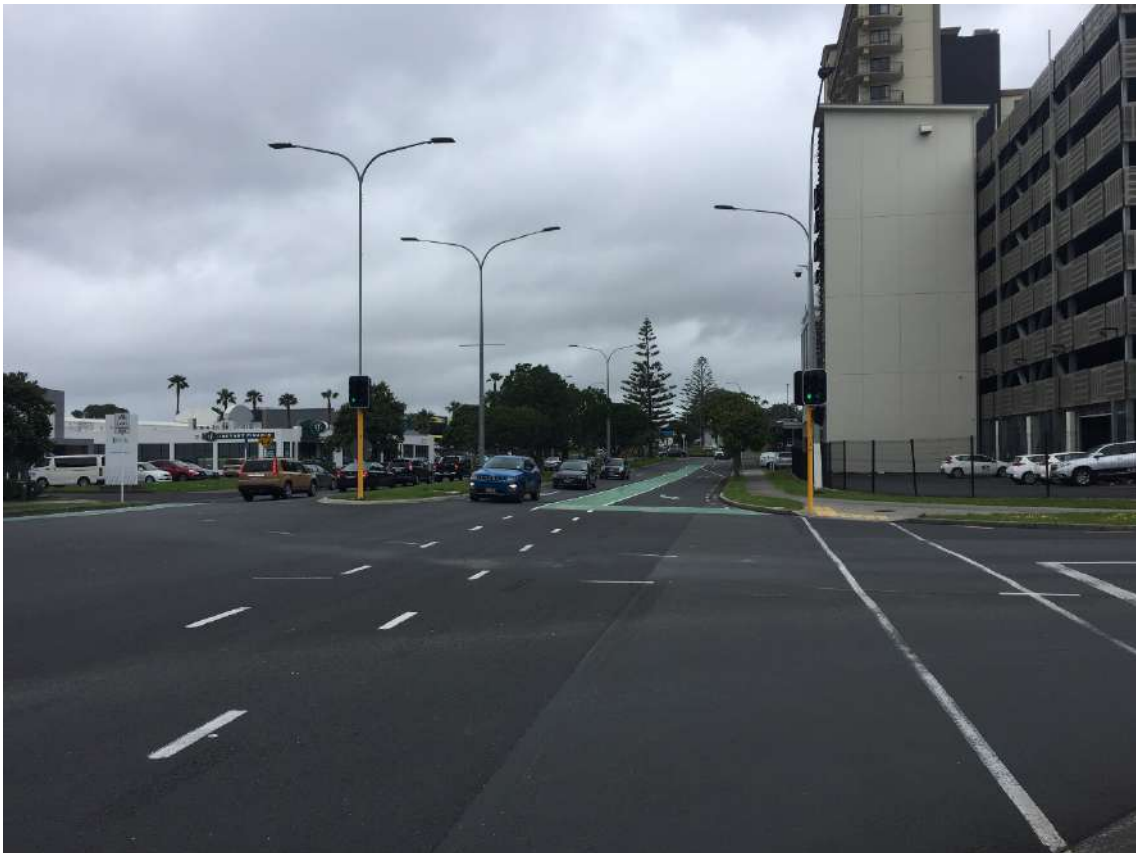
An RTC bus station could be provided next to the multi-storey carpark on the corner of Ronwood Avenue and Davies Avenue shown in Figure 5.

Figure 5: Ronwood Avenue east of Davies Avenue with car park building (Google Street View, 2018)

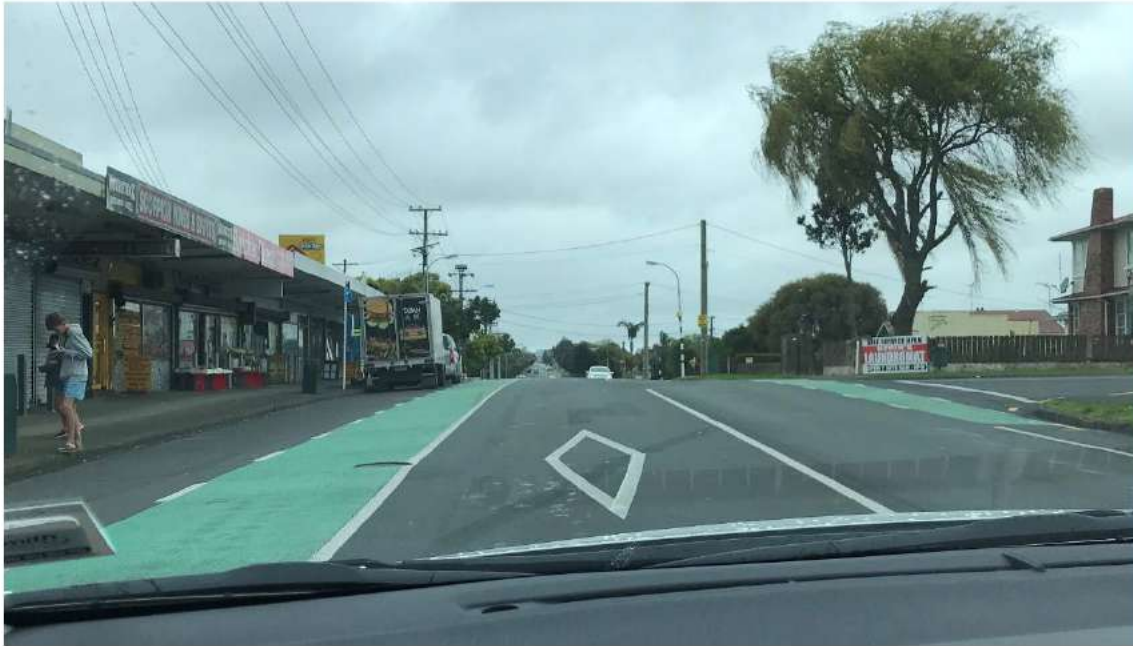
The existing vertical alignment along Puhinui Road is undulating with sharp crest vertical curves. Some of the crest curves are so sharp that there is inadequate stopping sight distance to the zebra crossings, and vehicles ahead are obscured in the subsequent sag curve.

Figure 6: Inadequate sight distance to zebra crossing

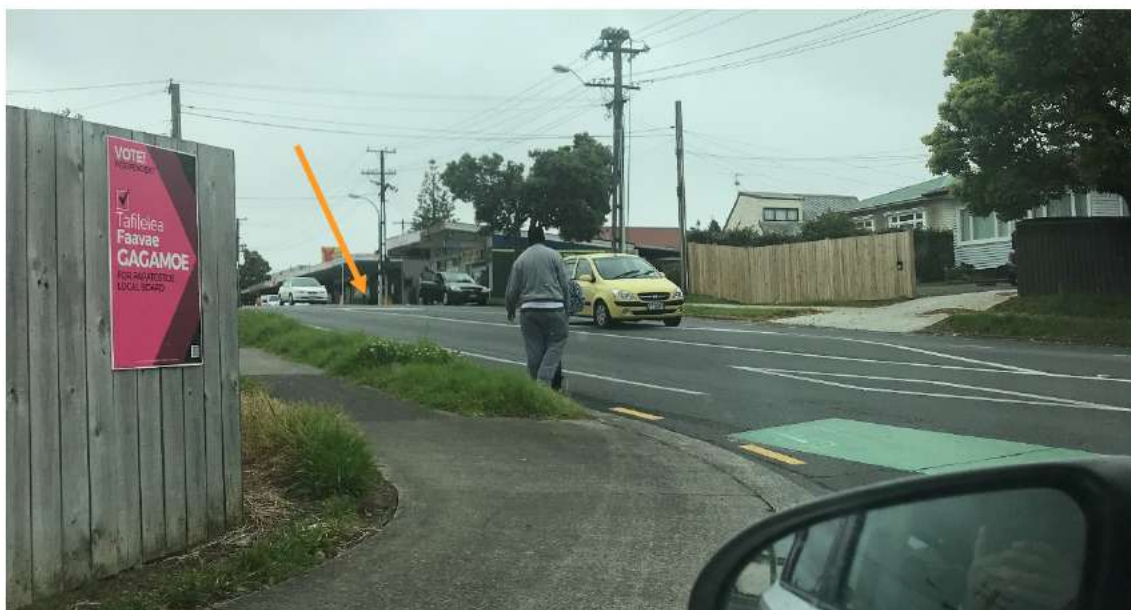
The drawings show very few formal opportunities to cross Puhinui Road, particularly where there are residential areas on either side of the road. The auditors observed twice while on site the difficulty that pedestrians have with crossing the existing road and also that they did not use the zebra crossings, preferring to jaywalk instead. The two pedestrians in Figure 7 progressed halfway across Puhinui Road, then retreated to the kerb for a second attempt. The arrow points to a zebra crossing that they could have used. From their vantage point, they might not have noticed that it was there due to the sharp crest vertical curve.

Figure 7: Pedestrians trying to cross the road

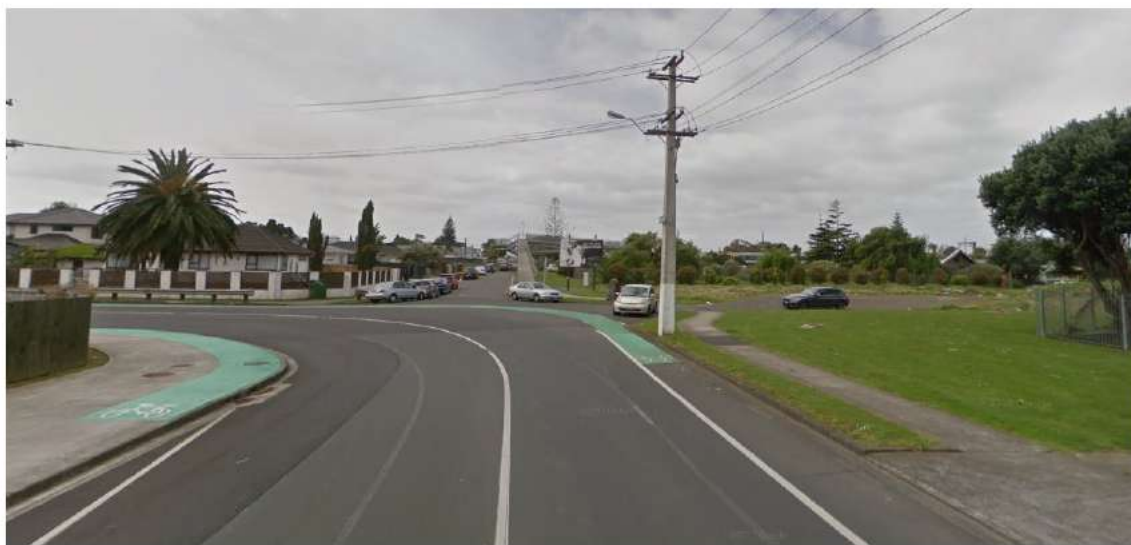
The intersections of Kenderdine Road and Cambridge Terrace with Puhinui Road under the RTC overbridge are unconventional. The SAT appreciates that the very small scale drawings of the intersections are conceptual only and has therefore grouped the safety concerns under one heading to be addressed together as the design proceeds.

- There would be quite a lot to be aware of for an unfamiliar driver. Both intersection layouts are unconventional and would be coupled with high pedestrian and cyclist activity, being so close to the Puhinui train station. Both intersections would also incorporate frequent U-turns as described in Section 2.2.4.
- At Kenderdine Road, the remaining two-way stub of Puhinui Road would align directly opposite the new eastbound carriageway. The intersection layout would need to prevent drivers from traveling the wrong way down the eastbound carriageway of Puhinui Road.

Figure 8: Intersection of Kenderdine Road and Puhinui Road (Google Street View, 2017)

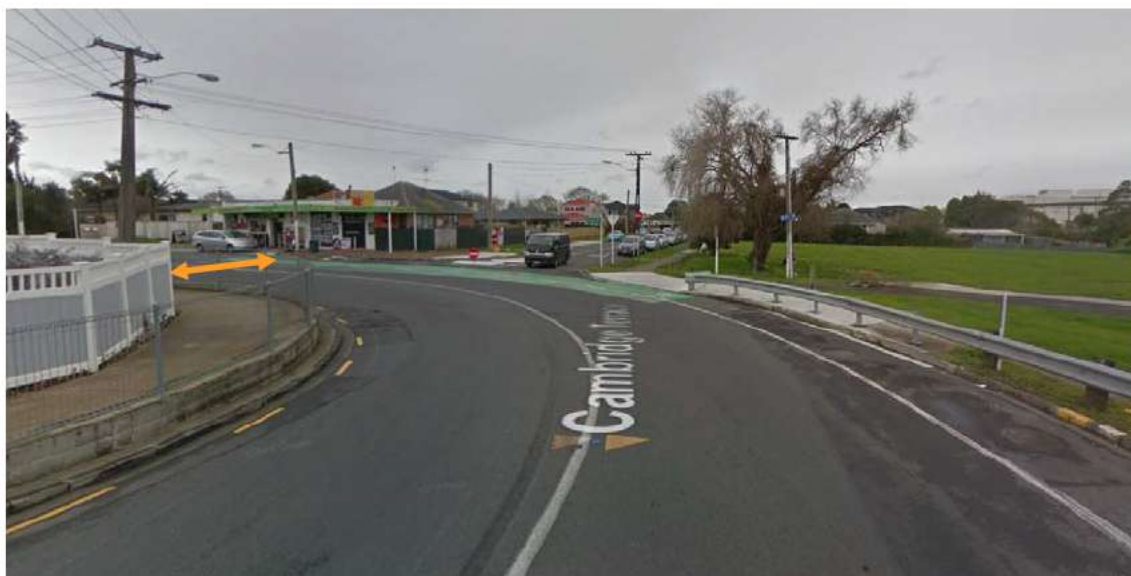
- At Cambridge Terrace, the stop line in Cambridge Terrace (northern approach) for the pedestrian crossing across Puhinui Road would be set back about 30 m from the actual crossing, which would be hidden around a left-hand curve as shown by the orange arrow in Figure 9.

Figure 9: Intersection of Cambridge Terrace and Puhinui Road (Google Street View, 2018)

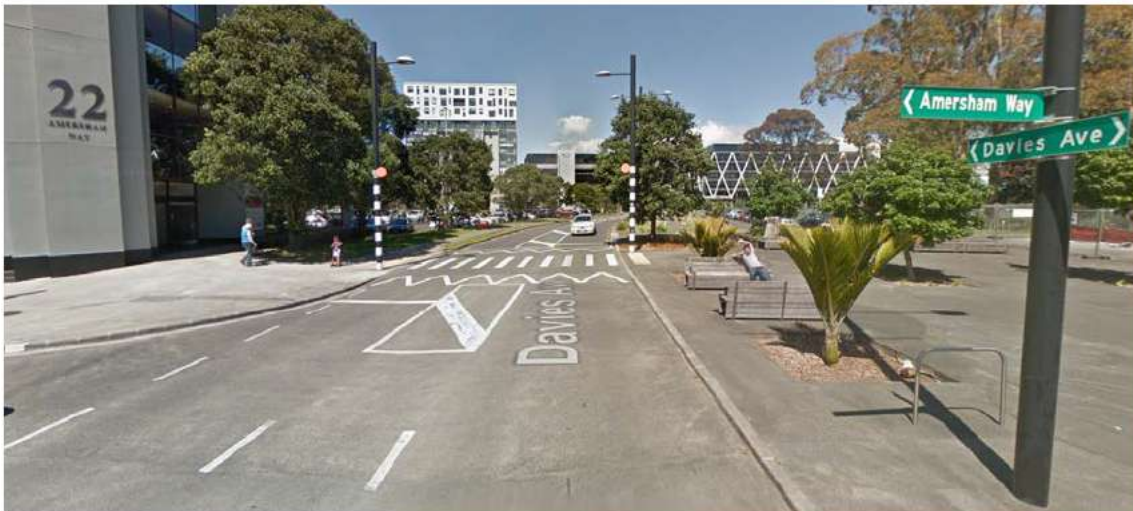
Three midblock crossings are proposed that correspond more or less with existing crossings and desire lines, one across Davies Avenue, and two across Ronwood Avenue as shown in Figure 11 and Figure 12. However, the spacing and waiting times to cross the RTC would not be conducive for pedestrians moving about a central business district. Currently the crossings are all zebra crossings with good amenity, but the proposed replacement crossings would be signalised and may be two-phase crossings. Given the separators and median strips that would provide informal refuge along the RTC, jaywalking between the crossings can be expected.

Figure 11: Zebra crossing across Davies Avenue at Amersham Way (Google Street View, 2018)

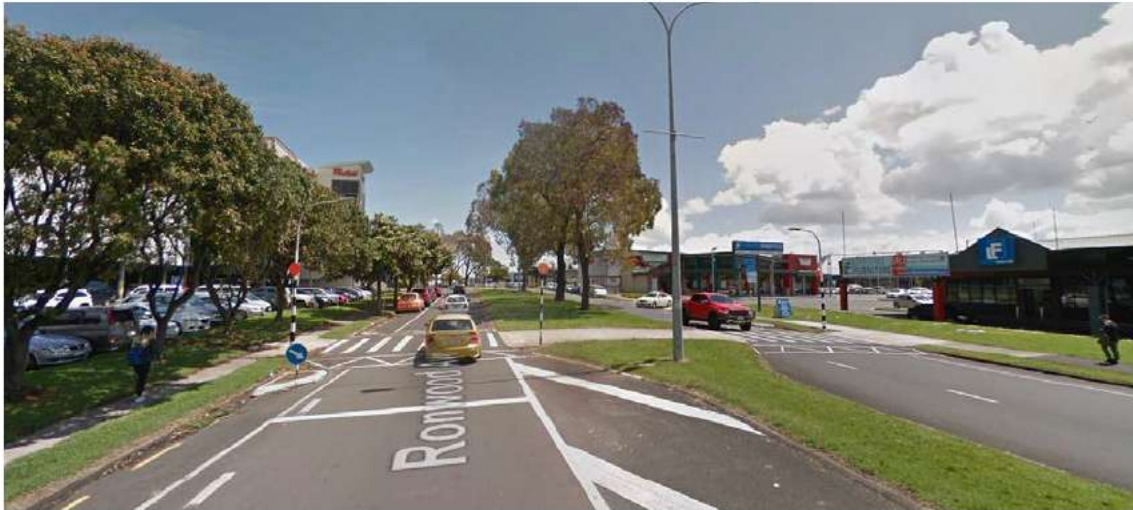
Figure 12: Zebra crossing across Ronwood Avenue near Leyton Way (Google Street View, 2018)

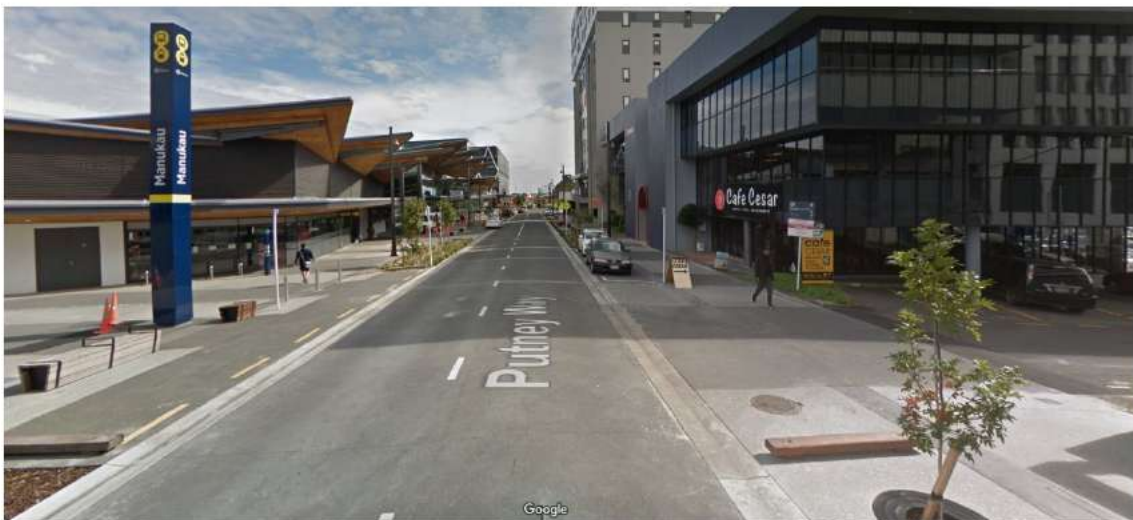
An RTC facility that looked and operated more like Putney Way would offer more crossing opportunities and would indicate that drivers should be on the lookout for pedestrians. The proposed cross-section indicates to drivers in no uncertain manner that buses and general traffic have priority over pedestrians, and that there is no need to be on the lookout for jaywalkers.

Figure 13: Putney Way (Google Street View, 2018)

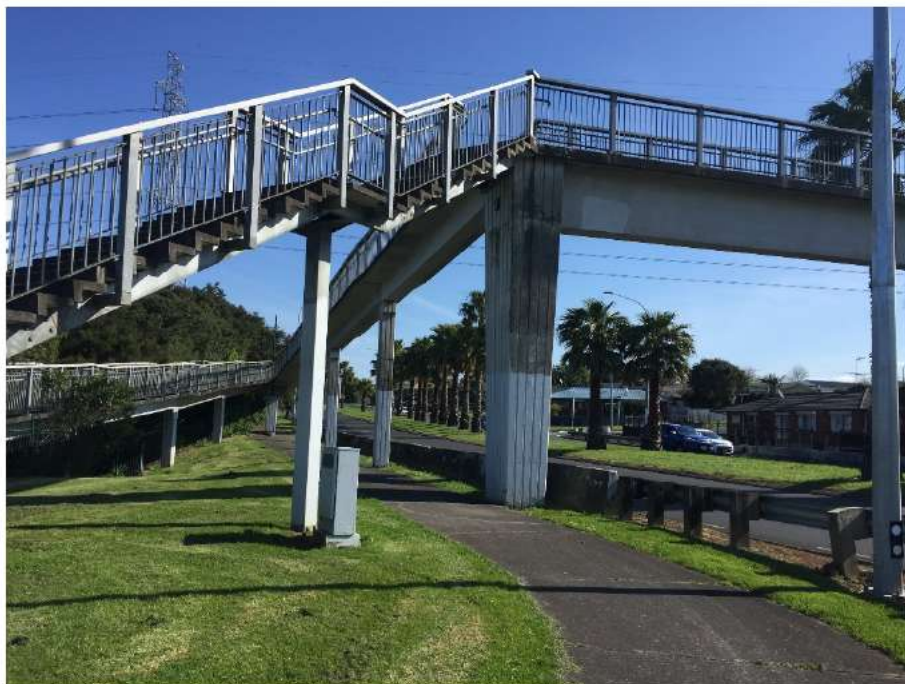
The proposed widening or upgrading of the existing footpaths along Te Irirangi Drive to create separated cycle paths requires the demolition of the two existing pedestrian bridges at Whetstone Road / Belinda Road and at East Tamaki Road / Banville Road. The bridges are not intended to be replaced due to perceived low patronage.

There does not seem to be any reason why the existing footpaths in the vicinity of the two bridges could not be widened for cyclists without having to demolish the bridges. The SAT did observe usage in the very short time spent at the bridges.

Figure 14: Footbridge at Whetstone Road / Belinda Road

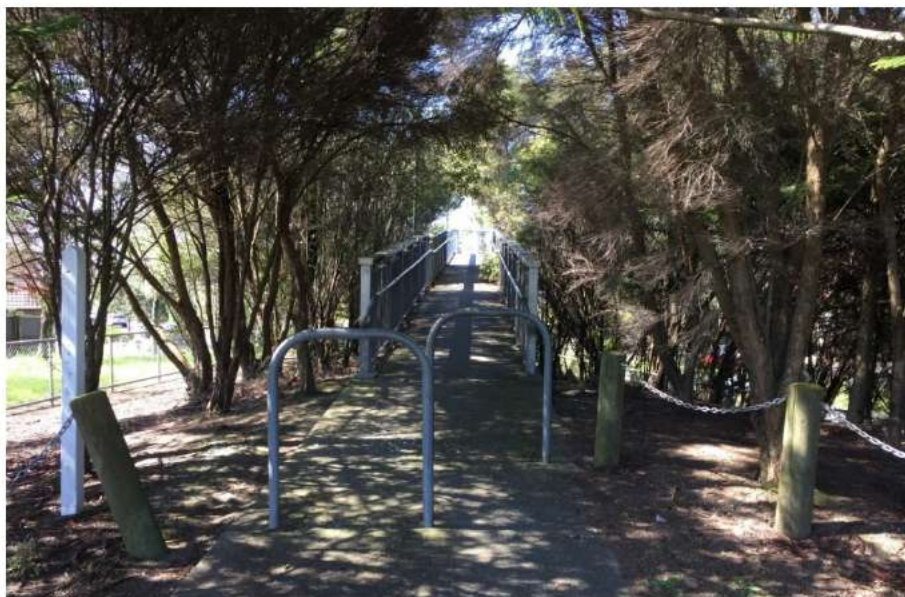
Manuka has grown up and is shielding the footpath, which does not create a safe or pleasant walking environment.

Figure 16: East Tamaki Road footbridge

The manuka should be cleared and replaced with a lower species of planting that will not shield the footpath or obscure users from passing traffic.

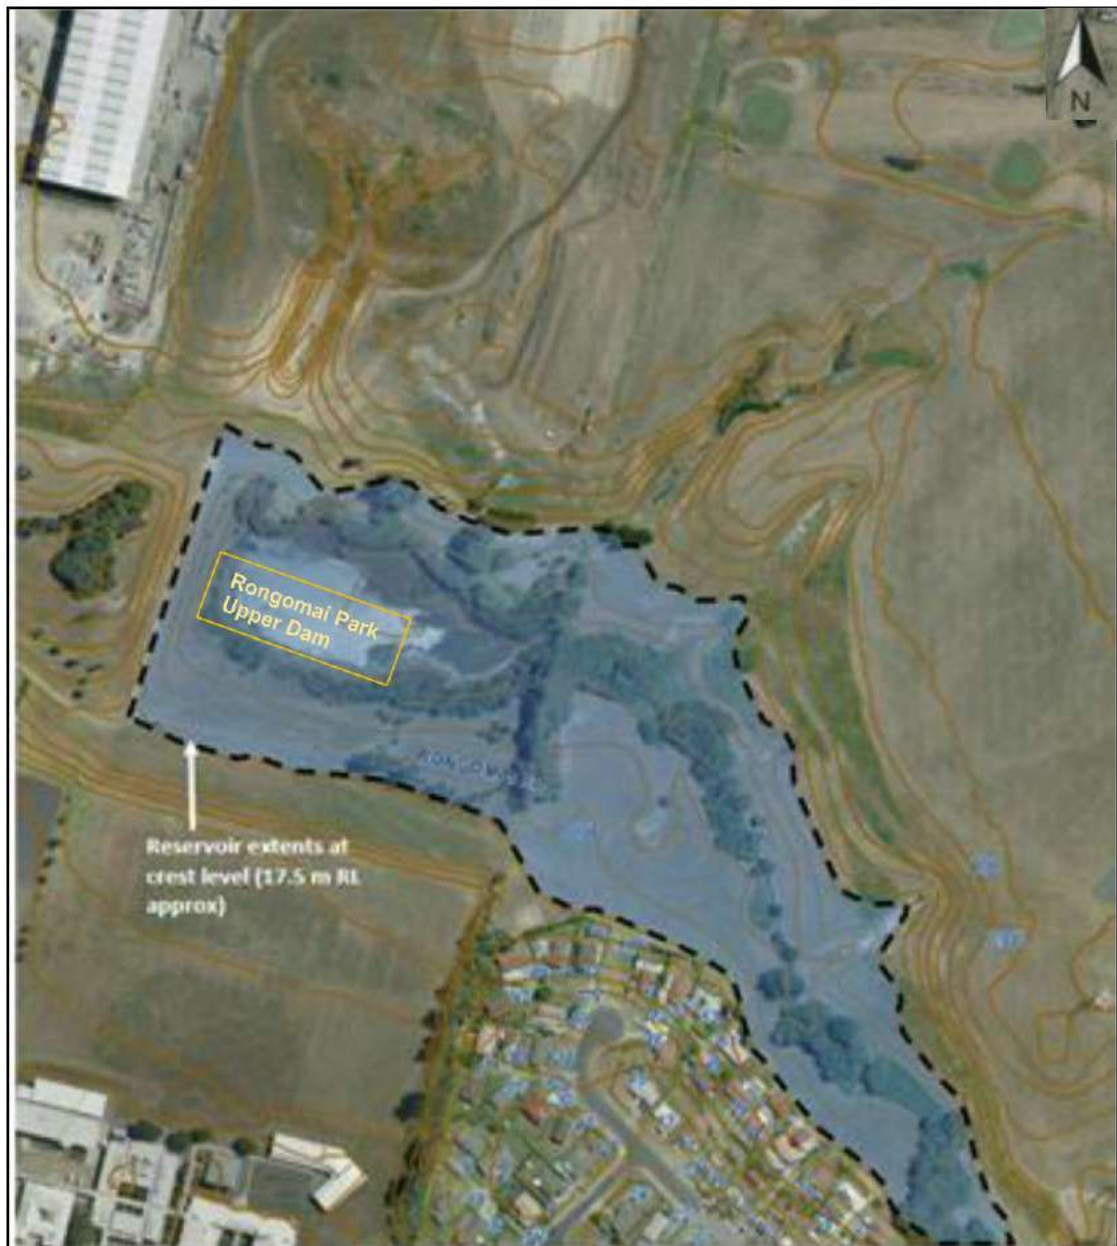
Figure 1 : Rongomai Park Upper Dam extension when water level is at the dam crest (Source: Tonkin&Taylor Rongomai Upper and Lower Dams Routing Analysis Report (2010))

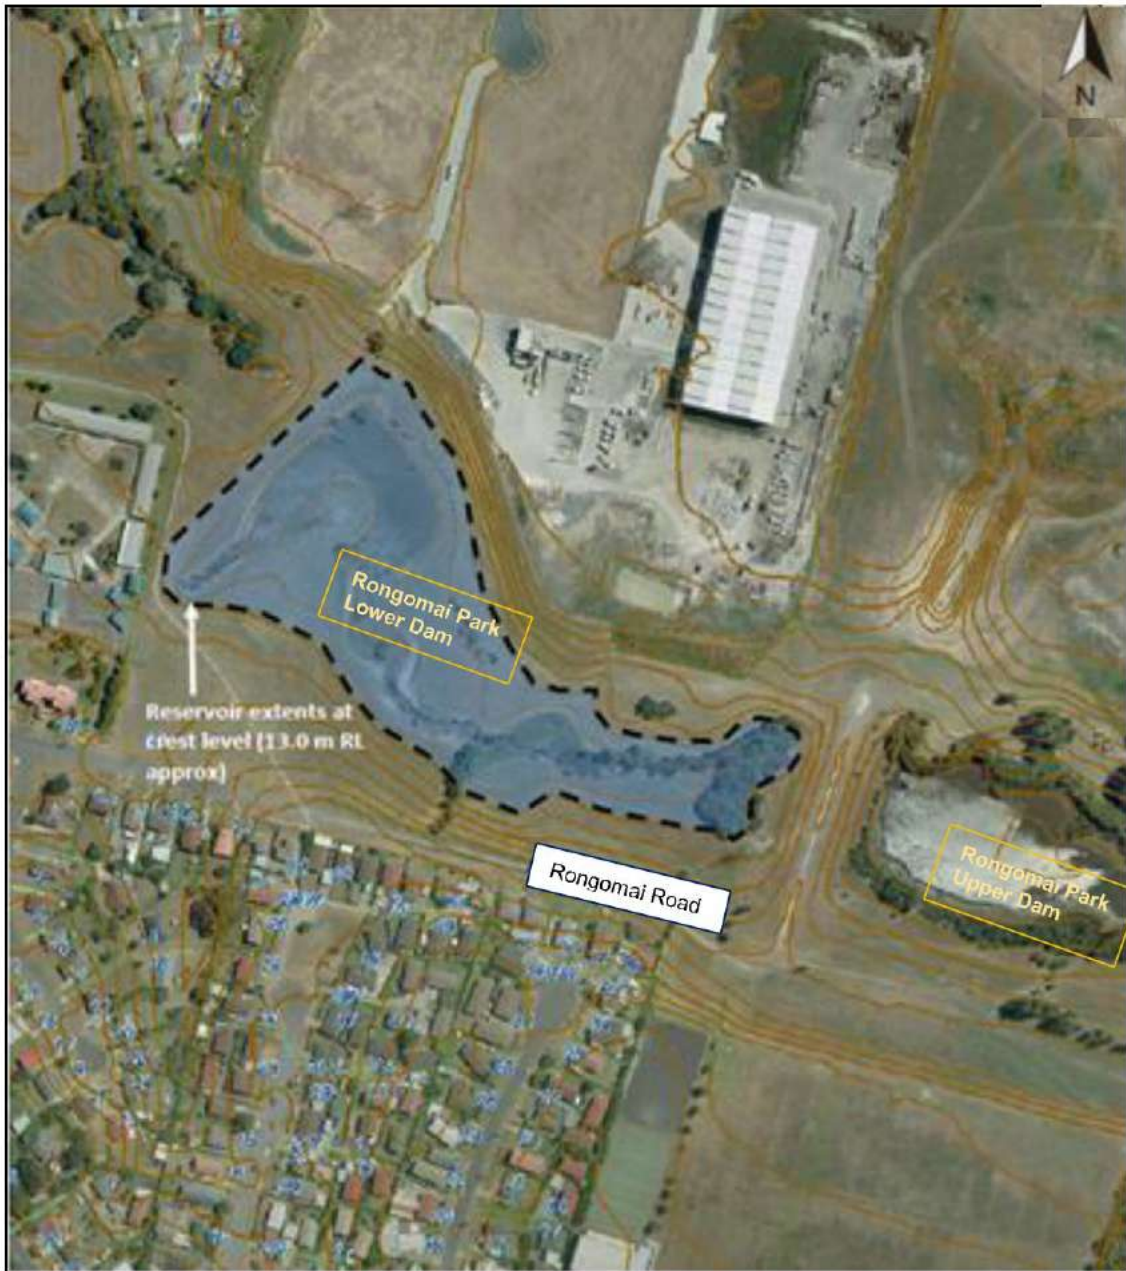
Figure 2 : Rongomai Park Lower Dam extension when water level is at the dam crest (Source: Tonkin&Taylor Rongomai Upper and Lower Dams Routing Analysis Report (2010))
