Under the Resource Management Act 1991  
In the matter of Notices of Requirement to enable the construction, operation and  
maintenance of the City Rail Link

**Statement of Evidence of Simon Percival Chapman**

## **Annexure B: Tree Maps (April 2013)**

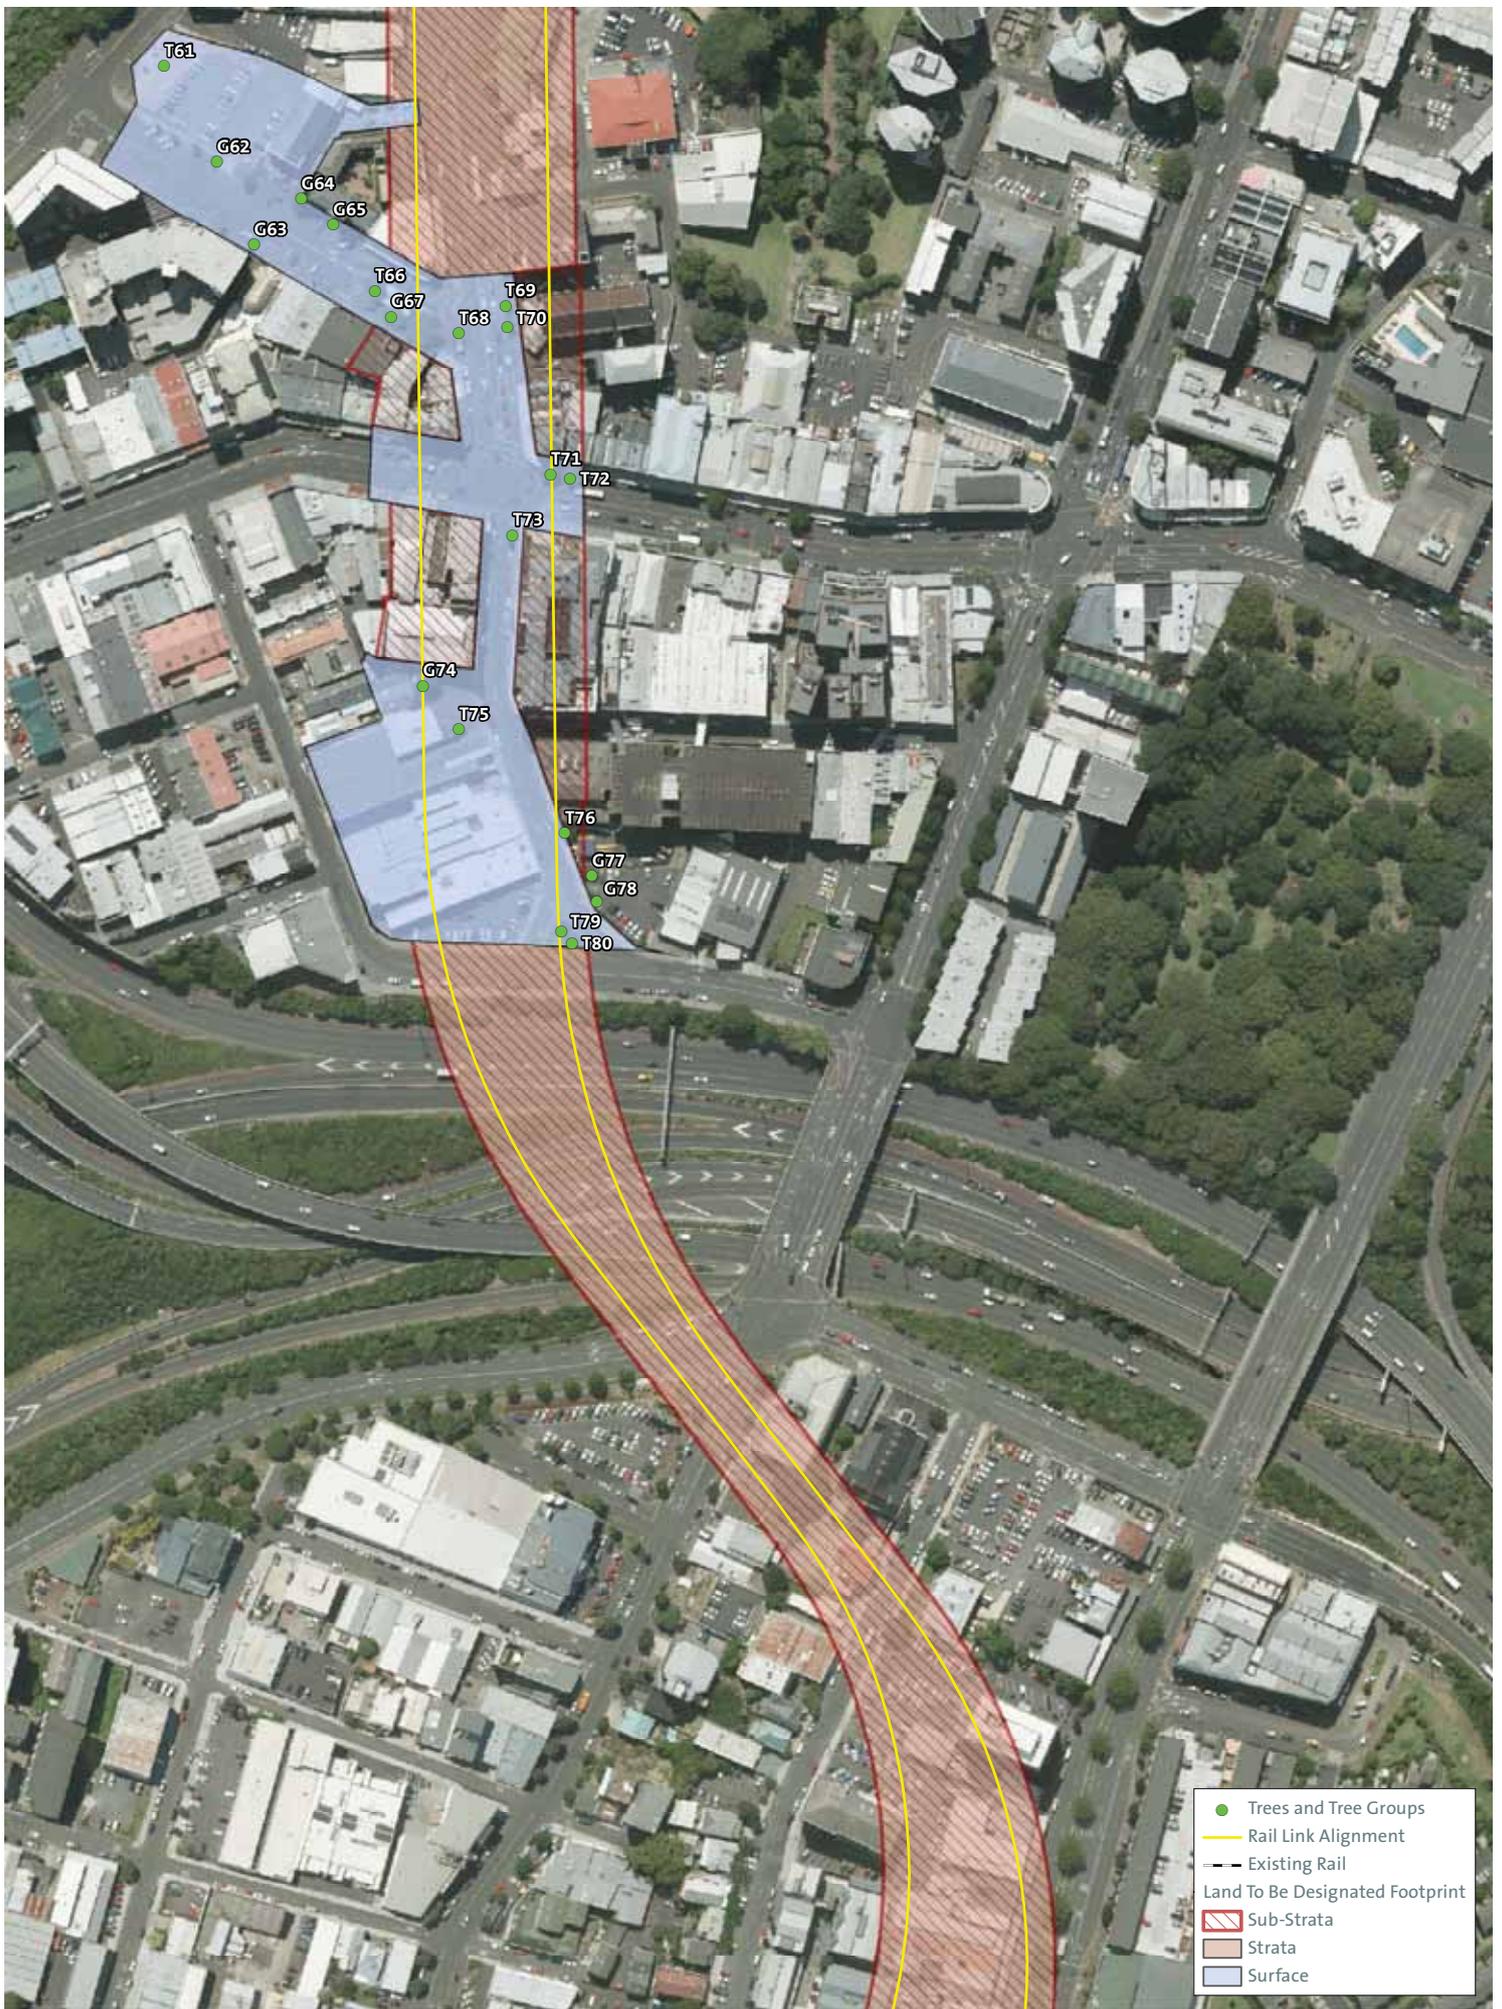
- Map Frames
- Trees and Tree Groups
- Rail Link Alignment
- Existing Rail
- Land To Be Designated Footprint
- Sub-Strata
- Strata
- Surface
