RURAL SCHOOL SPEED MANAGEMENT TRIAL

FINAL REPORT

PROJECT NAME: Rural School Speed Management Trial

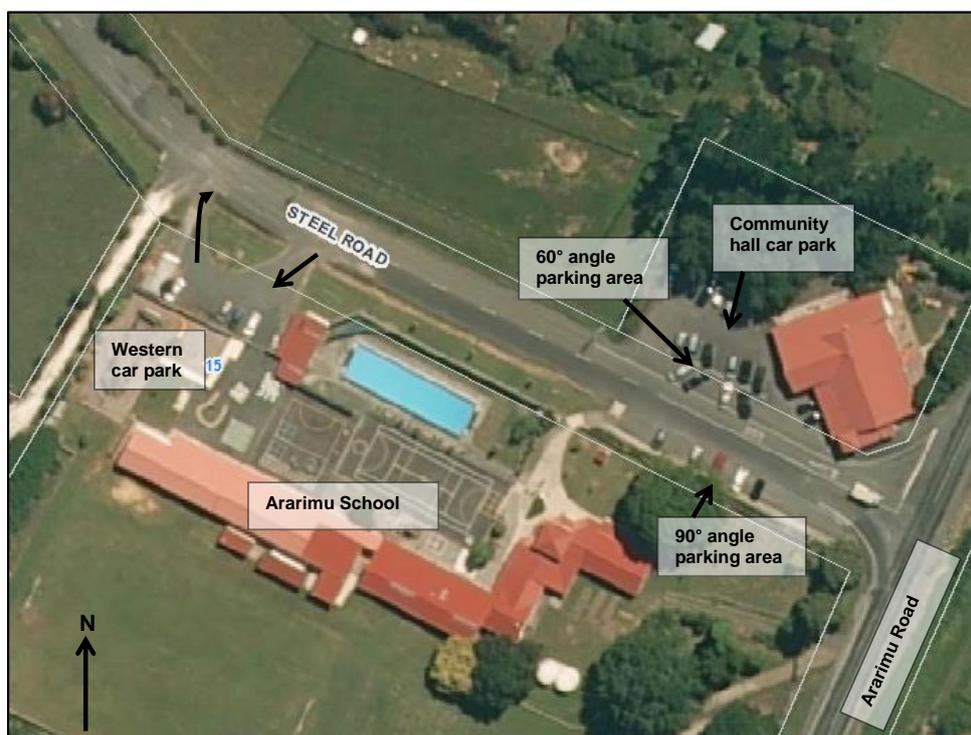
Figure 3-2 Ararimu School

The various parking areas and school layout is shown in Figure 3-2.

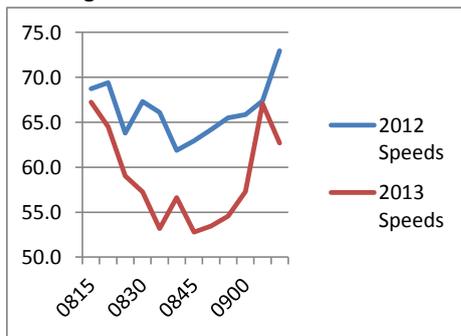
Figure 3-3 Northbound on Ararimu Road (South of Steel Road)

Results from the count taken on Ararimu Road (south of Steel Road) show a reduction in through speeds during the morning peak of typically 9-10km/h for northbound traffic and 5-6km/h for southbound traffic. These changes are summarised in Figure 3-3 and Figure 3-4 below, with the 2012 speeds recorded pre-implementation and the 2013 speeds recorded post the implementation of the signs. The mean speed for both directions during the period that the signs are activated is below the advisory 60km/h, although it clearly rises to pre-survey speeds following deactivation of the signs.

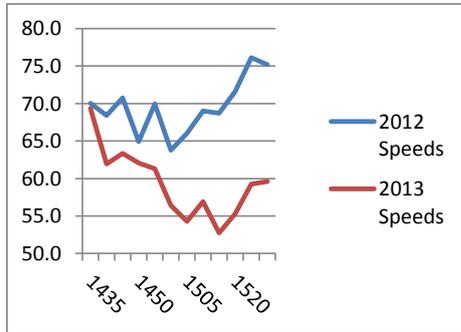
Figure 3-5 Northbound on Ararimu Road (South of Steel Road)

The afternoon school peak showed a similar pattern, with higher reductions for northbound traffic speeds. Both morning and afternoon mean speeds were well below 60km/h during the time when the signs are active (see Figure 3-5 and Figure 3-6). The one anomaly was northbound speeds, which did not recover to pre-installation speeds until well after the signs were switched off. By this time however, traffic volumes were low and this data could have been influenced by a particularly slow vehicle.

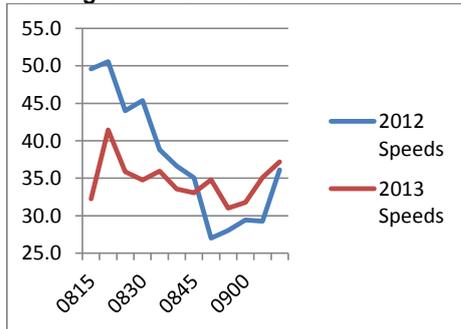
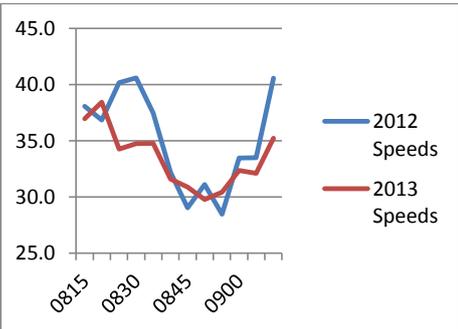
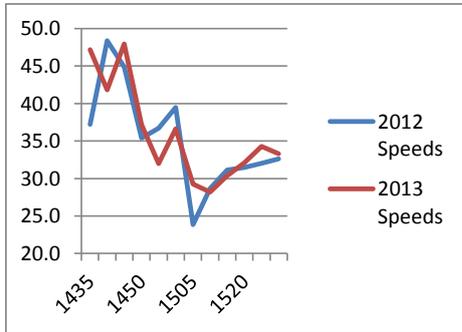
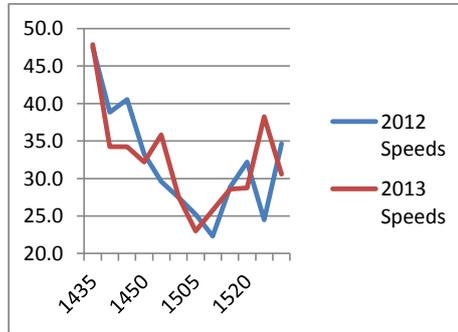
The results for morning and afternoon peak periods on Steel Road show that speeds are essentially unchanged after the inclusion of the electronic signs (see Figure 3-7 to Figure 3-10). This is not surprising as traffic on Steel Road at these periods is almost entirely composed of school related vehicles that are manoeuvring into or around on road parking spaces.

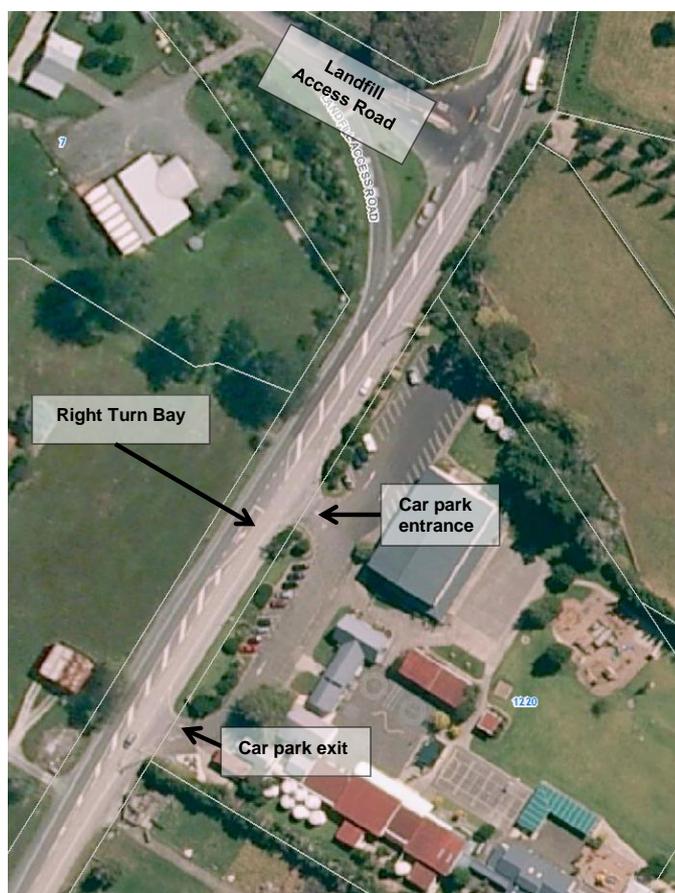
Figure 4-2 Dairy Flat School

On Dairy Flat Highway in front of the school there is a flush median and right-turning lane for access into the main car park from the south. There is also a wide shoulder which vehicles turning left into the school can use to access the school car park without delaying the through traffic. There are separate right and left-turning lanes for vehicles exiting the school car park.

The school car park is reasonably well hidden from the road behind earth mound and planting. During observations there was a mobile dental surgery parked at the southern end of the school car park, which may have affected the parking availability but only to a minor degree. Figure 4-2 shows the layout of Dairy Flat School.

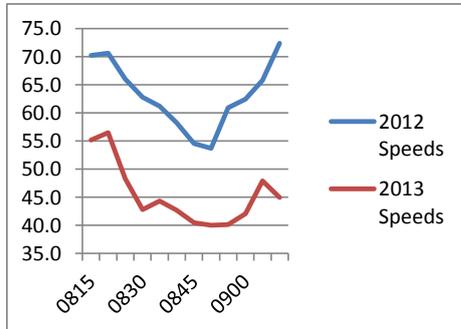
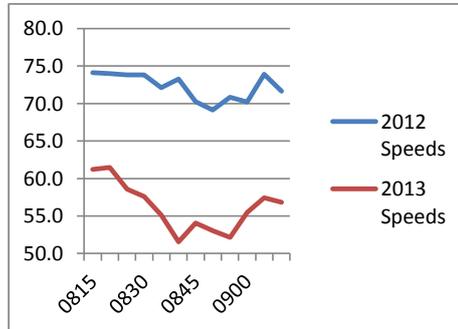
The pre-trial implementation had mean speeds of around 60km/h for northbound and 70km/h for southbound traffic during the morning peak period. This dropped to almost 40km/h for northbound and below 55km/h for southbound vehicles. Figure 4-3 and Figure 4-4 demonstrate this with a clear difference between the pre- implementation (2012 Speeds) and the post-implementation (2013 speeds) data.

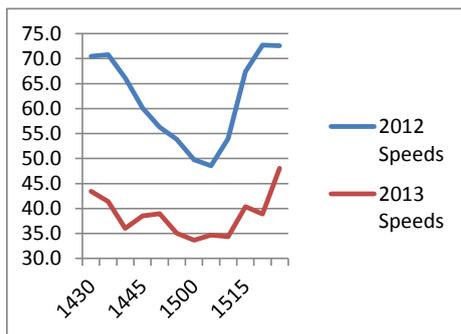
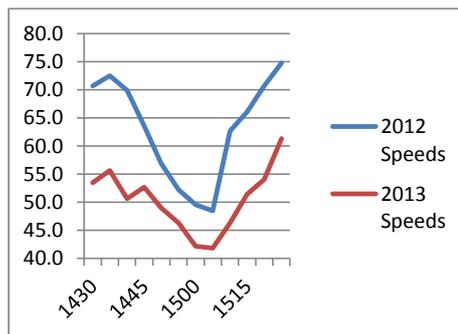
The afternoon school peak showed similar patterns to the morning, with the northbound mean reducing from 50-55km/h to 35-40km/h. The effect on southbound through traffic was less noticeable with the reduction in speeds around 6-8km/h with the post implementation mean speeds around 40-45km/h. Figure 4-5 and Figure 4-6 demonstrate this.

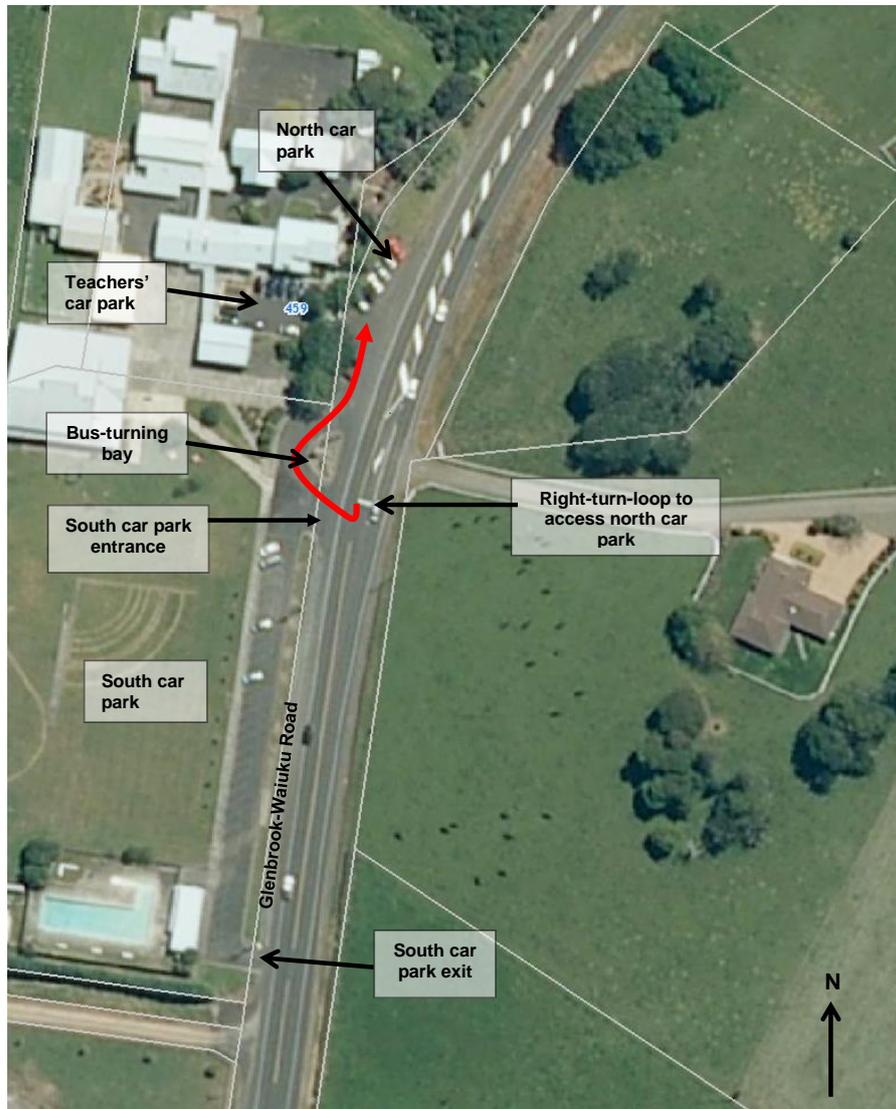
Figure 5-2 Glenbrook School

Waiuku Road has one lane in each direction with a separate right turn bay provided to assist access into the school. There are white edge-lines on both sides of the road and a double yellow centre line outside the school. The school has an on-site teachers' car park at the northern end of the site outside the main administration building. There are two parking areas for, one in front of the teachers' car park (North car park) and the other further south, alongside Waiuku Road (South car park) (see Figure 5-2). The South car park is fenced from the fields, with a short 5m break on the car park side at the main entry to the school to allow children to enter and leave the school. In between the two car parks is a small island with a bus-turning bay. In addition to these formalized areas, parents driving north can pull off the road onto a wide sealed/metaled shoulder area to drop off and pick up. The layout is shown in Figure 5-2.

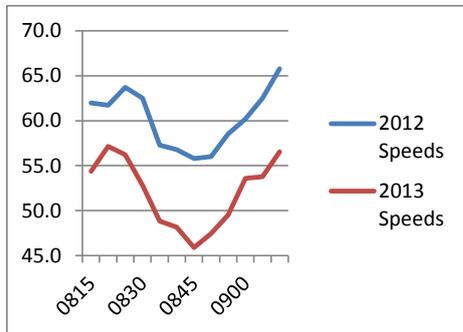
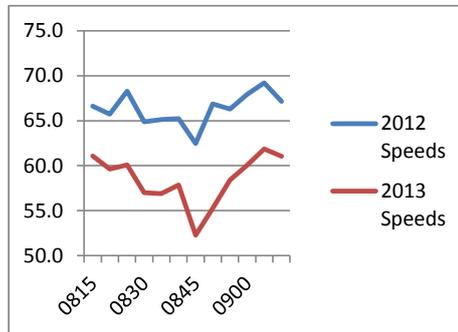
The speed survey results showed a reduction in vehicle speeds during both the morning and afternoon peak periods. The morning peak speeds reduced by 8-10km/h in each direction, with the mean speeds dropping to below 50km/h for northbound and 60km/h for southbound vehicles. Figure 5-3 and Figure 5-4 demonstrate this with a noticeable difference between the pre-implementation (2102 Speeds) and post-implementation (2013 Speeds) data.

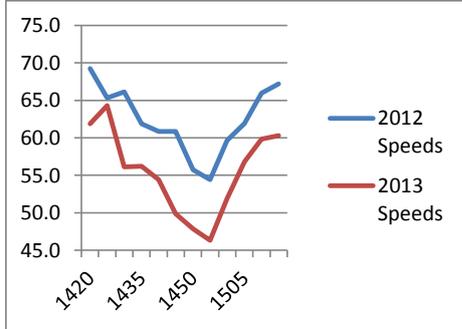
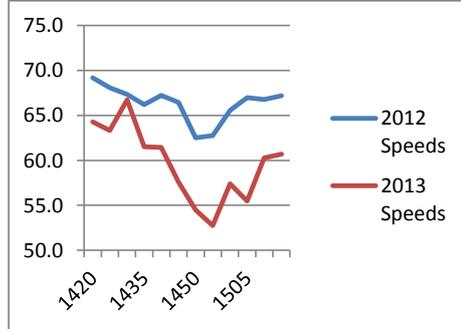
The afternoon peak showed a similar pattern, with northbound mean speeds reducing to below 50km/h at the lowest point and below 55km/h for southbound vehicles at the corresponding time. Figure 5-5 and Figure 5-6 demonstrates this. The typical reductions in comparison to the pre-implementation speeds were 6-8km/h reduction for both directions.

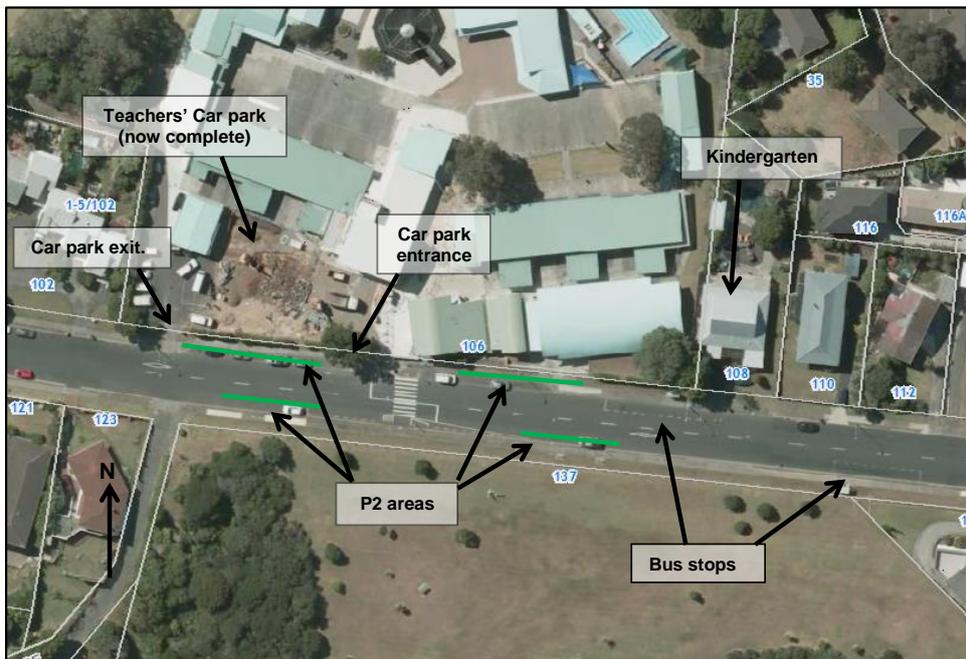
Figure 6-2 Halsey Drive School

Halsey Drive has a regular (approximately every 15 minutes) bus service (route 267). The bus stops are shown in Figure 6-2. There are no NSAAT's before or after the bus stops.

Halsey Drive School is located on Halsey Drive which is classified as a Local Road in the District Plan. Along the length of the school frontage on both sides of the road are areas of P2 parking signs with the supplementary stating '8 – 9am and 3 – 3:30pm school days only'. Figure 6-2 demonstrates this. There is a pedestrian crossing outside the school and a kindergarten east of the school. There is no street lighting specifically for the crossing and it therefore intended purely for school use. There is a school patrol which operates on the pedestrian crossing located immediately in front of the school. The patrol is comprised of an adult and two children and is present between 8:25-8:55am and 2:50-3:10pm.

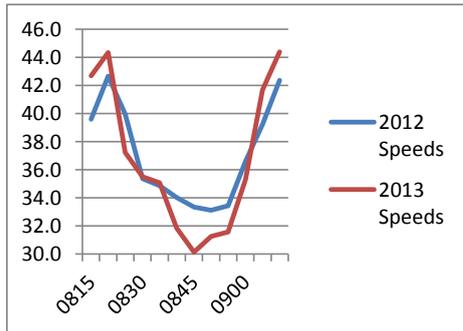
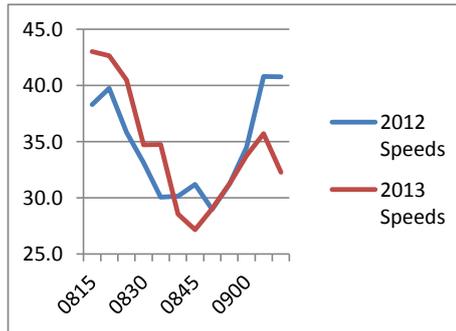
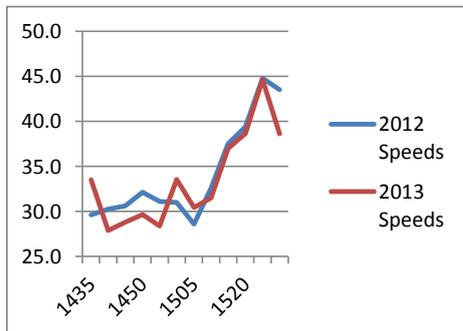
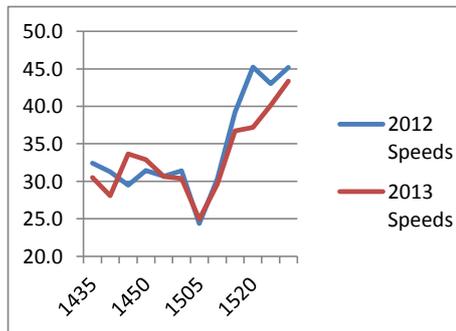
The initial and post installation observations identified that speeds were controlled by school traffic and not through traffic and hence little if any change in operating speeds at the critical times was expected. Figure 6-3 to Figure 6-6 show the results with little difference between the pre-implementation (2012 Speeds) and post-implementation (2013 Speeds) data.

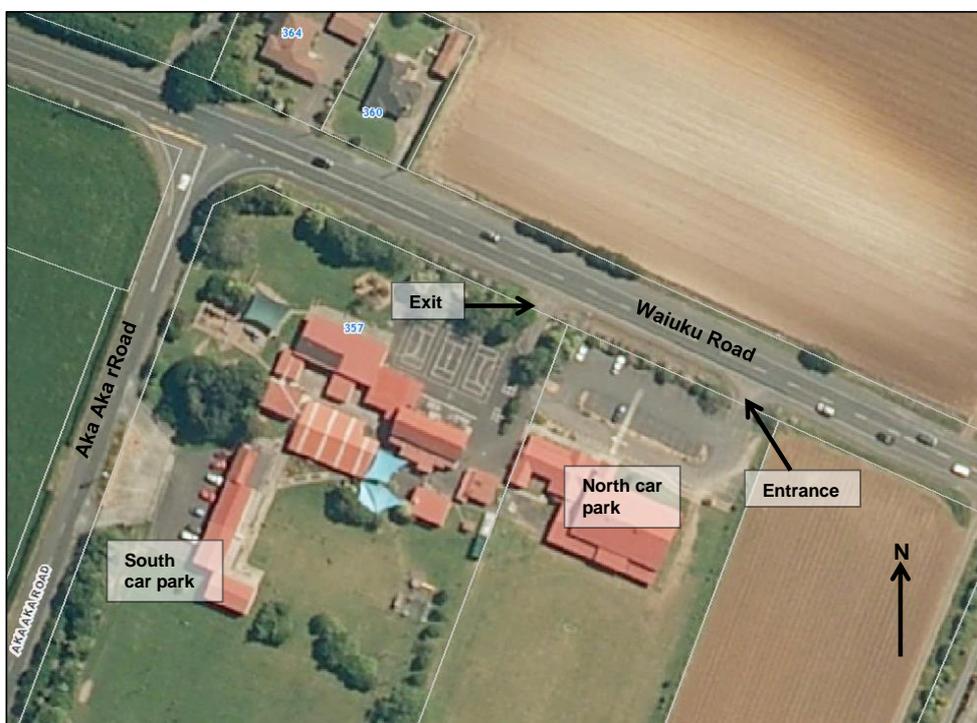
Figure 7-2 Puni School

Puni School is situated on the corner of Waiuku Road and Aka Aka Road and tends to blend into the rural landscape. There is virtually no pedestrian interaction or visibility of the school from the road except for vehicles turning in and out of the site. Consequently, there is little incentive for through vehicles to slow down. Figure 7-2 demonstrates the site layout.

Two car parking areas are provided, one off Waiuku Road (North car park) and one off Aka Aka Road (South car park). There is generally good visibility to both car park driveways with one restriction for northbound through vehicles. The North car park has a one-way loop access. High speeds were observed outside the school on Waiuku Road. Speeds are lower on Aka Aka Road primarily due to the school being close to the intersection. Waiuku Road has wide shoulders and Aka Aka Road, narrow shoulders. The only possible visibility is to the west on Waiuku Road when there are vehicles travelling at high speeds. There is a relatively long vertical curve that can restrict visibility.

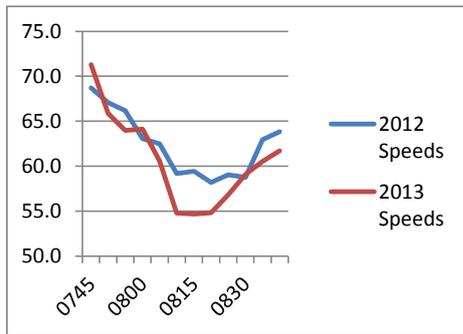
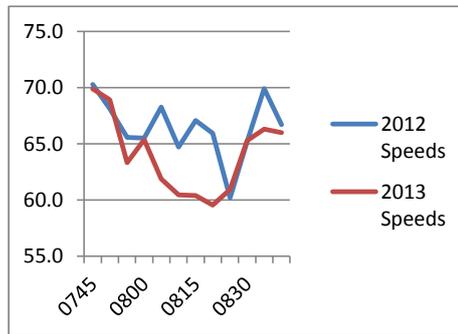
The morning peak results showed a reduction in mean speeds for westbound vehicles, with reductions of 4-6km/h for traffic in both directions. The mean speeds for westbound traffic dropped to around 60km/h and below 55km/h for eastbound vehicles. Figure 7-3 and Figure 7-4 demonstrate the comparative results with some differences between the pre-implementation (2012 Speeds) and post-implementation (2013 Speeds) data.

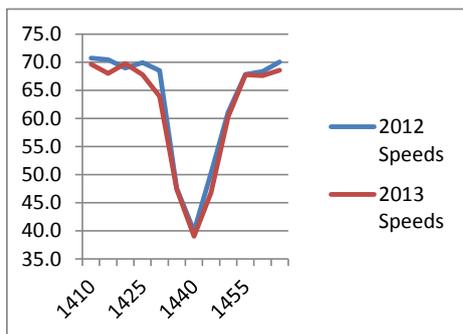
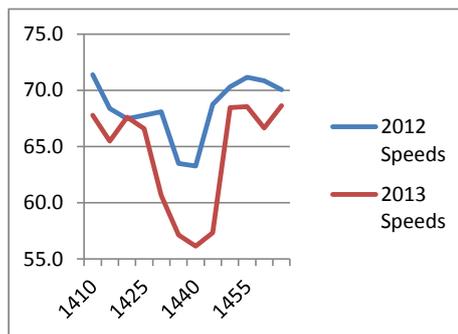
The afternoon peak data showed a similar pattern. Westbound speeds dropped by 6-8km/h to a mean of below 60km/h when the signs were activated. Eastbound speeds reduced by a lesser degree at around 2-4km/h, with the profile following a very similar reduction in speeds during the school peak period, as shown in Figure 7-5 and Figure 7-6

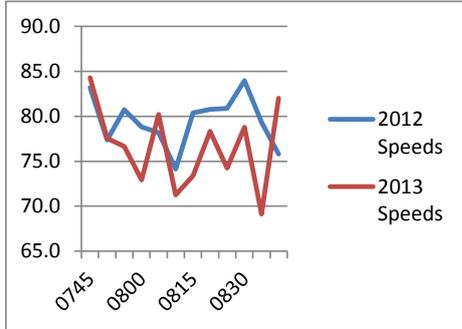
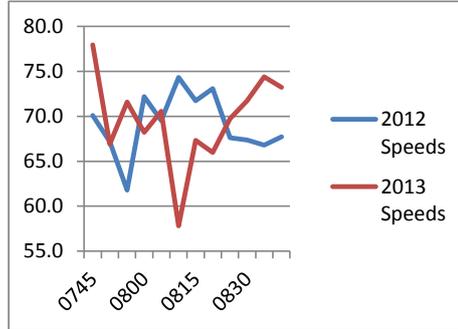
The morning peak results on Aka Aka Road showed a small but consistent reduction on vehicle speeds of 2-4km/h in each direction, as shown in Figure 7-7 and Figure 7-8

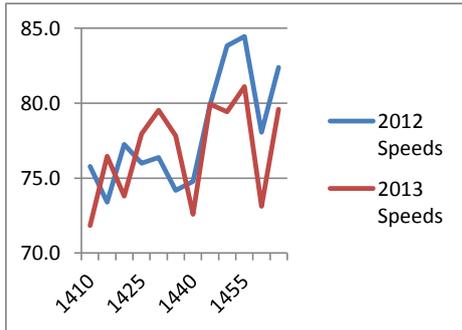
Figure 7-9 Northbound on Aka Aka Road

The afternoon results showed more fluctuation, with some speeds actually increasing at specific comparative time periods. The mean speeds in both directions during both time periods were typically at or above 70km/h, even though the counter was located between the signs and the intersection with Waiuku Road. Figure 7-9 and Figure 7-10 show the relative results.

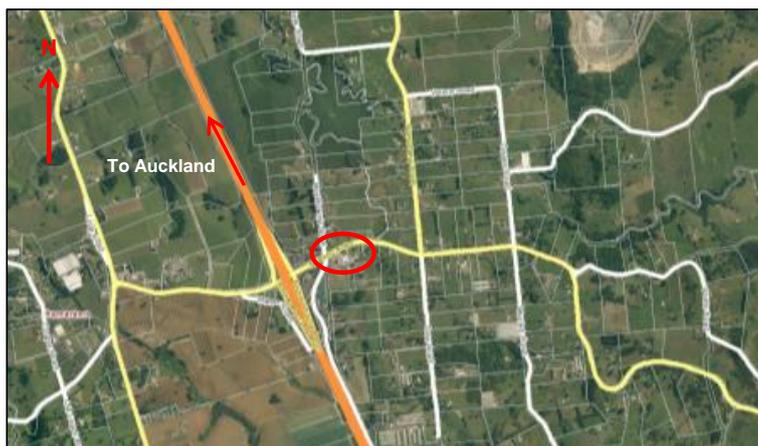
Figure 8-1 Ramarama School, Ararimu Road

Ramarama School is situated on a slight to moderate curve on the corner of Ararimu Road, Hilview Road and McEldownie Road, as shown in Figure 8-1. The school is approximately 200m east of the Ramarama exit on the Southern Motorway. Ararimu Road is classified as a Collector Road in the District Plan and carries approximately 2,900vpd. School starts at 8:50am and finishes at 2:50pm. Ramarama School has a roll of 220 students, from Year 1 to Year 8.

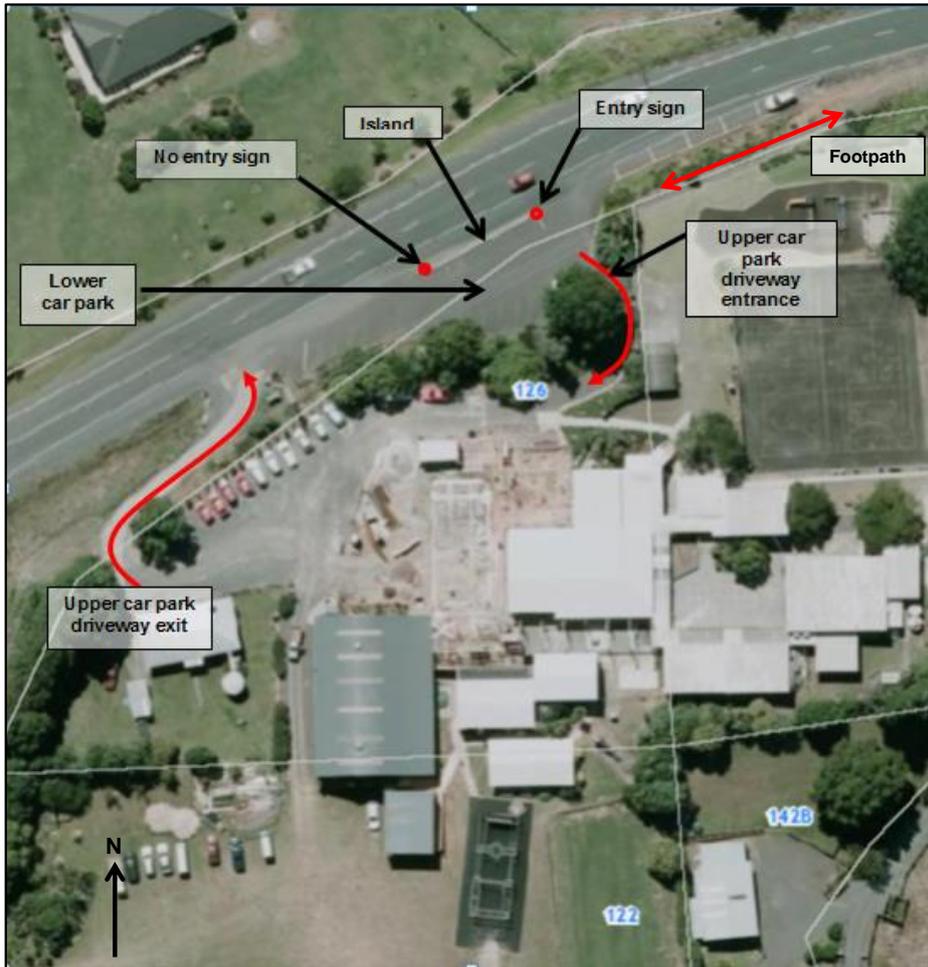
Figure 8-2 Ramarama School

The other two parking areas are located on the school grounds. There is an upper car park which is accessed via a driveway just in front of the on-road parking spaces mentioned above. This driveway is also the entrance for the smaller, lower car park (adjacent to the road). Vehicles wishing to access the upper car park do so by using a driveway which goes around the back of the lower car park. It is not possible for vehicles wishing to use the upper car park to see if it is full from the driveway. To leave the upper car park vehicles use the exit driveway, which is at the western end of the upper car park. This exit driveway reaches the road at the eastern end of the lower car park. Figure 8-2 shows the layout for Ramarama School.

The lower car park is separated from the road by a small unlit island, which has signs for 'entry' and 'no entry' at its eastern and western ends respectively. The width between the island and the road is 3m. The exit area for both upper and lower car park is wide enough for cars from the upper and lower car park to exit at the same time. There is a 'no right turn' sign from the exit area near the island. There is no school bus for this school and the school operates in a 70km/h zone

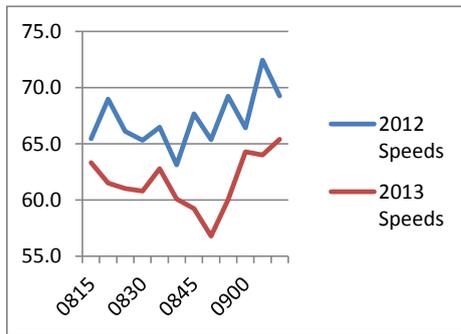
Figure 8-3 Eastbound on Ararimu Road

The morning peak results show a reduction in through speeds of typically 4-5km/h in both directions. The speeds at both the start and the end of this observation period are also slightly lower following installation of the signs. This is shown in Figure 8-3 and Figure 8-4 with the 2012 speeds recorded pre-implementation and the 2013 speeds recorded post the implementation of the signs

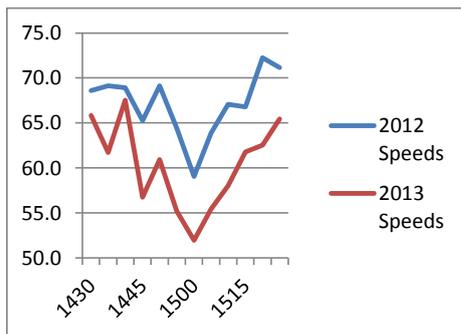
Figure 8-5 Eastbound on Ararimu Road

The afternoon school peak showed a similar pattern, with reductions of around 8-10km/h recorded over the 15-20 minutes of peak activity at the school. Outside of these peak-of-the-peak periods, the speed reduction is less, typically in the 3-4km/h range. Figure 8-5 and Figure 8-6 show these relative results.

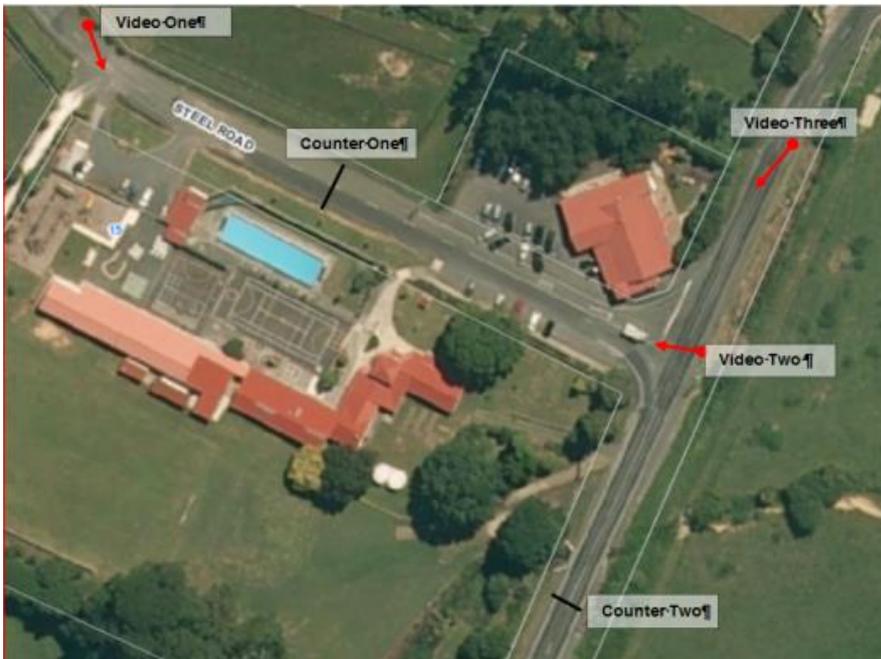
Figure A1 Ararimu School - Location of Video Cameras

The locations of the videos and the traffic counters are demonstrated in Figure A1.

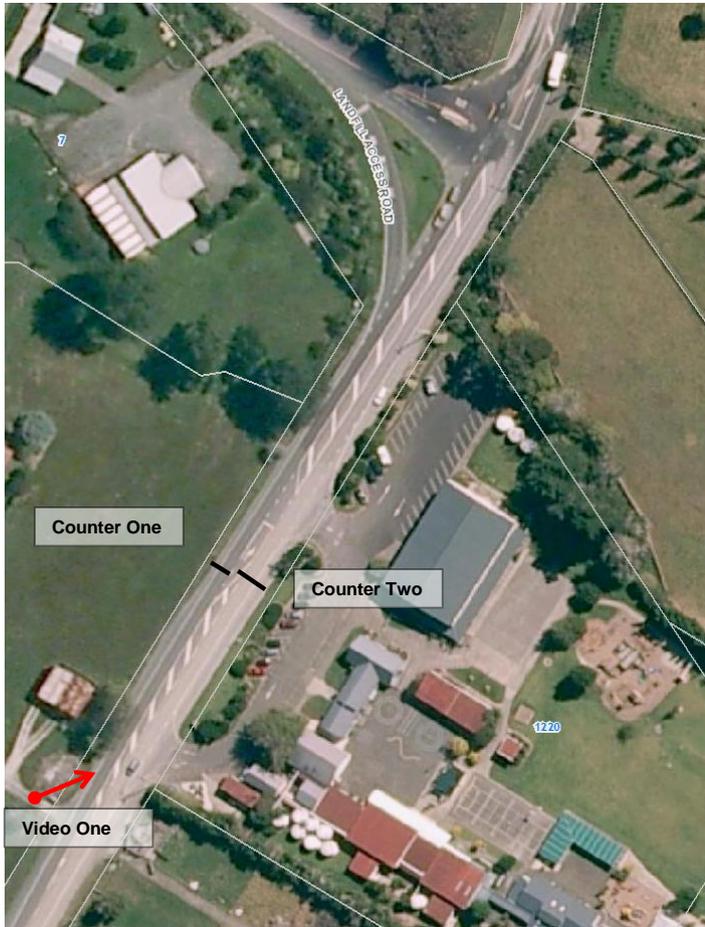
Figure B1 Dairy Flat School - Location of Video and Counter

Figure B1 demonstrates the location of the speed counters and the the video.

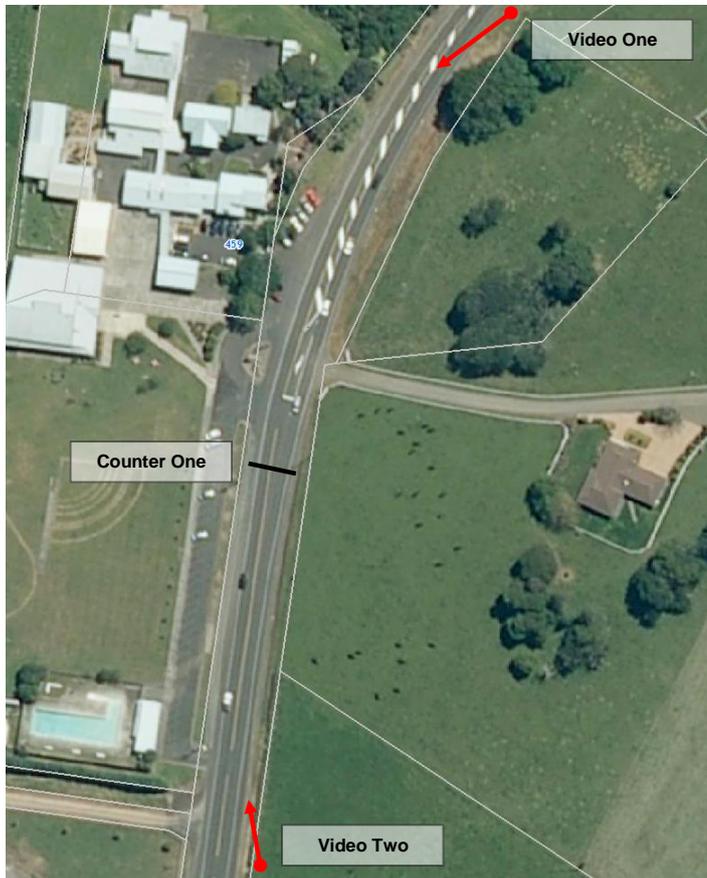
Figure C1 Glenbrook School Location of Cameras and Counters

Figure C1 demonstrates the locations of the speed counters and video cameras.

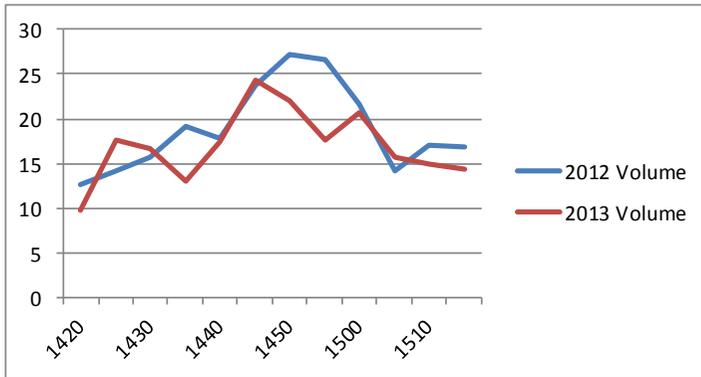
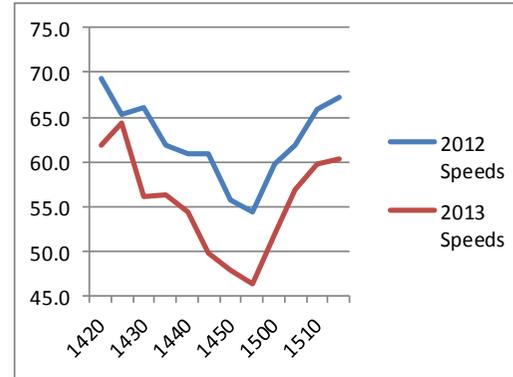
Glenbrook-Waiuku Road 2013
5 Day Average

Time	Direction	Average volume	Average mean speed
1420	N	9.7	61.9
1425	N	17.7	64.3
1430	N	16.7	56.1
1435	N	13.0	56.2
1440	N	17.3	54.4
1445	N	24.3	49.9
1450	N	22.0	47.9
1455	N	17.7	46.3
1500	N	20.7	51.9
1505	N	15.7	56.8
1510	N	15.0	59.8
1515	N	14.3	60.3

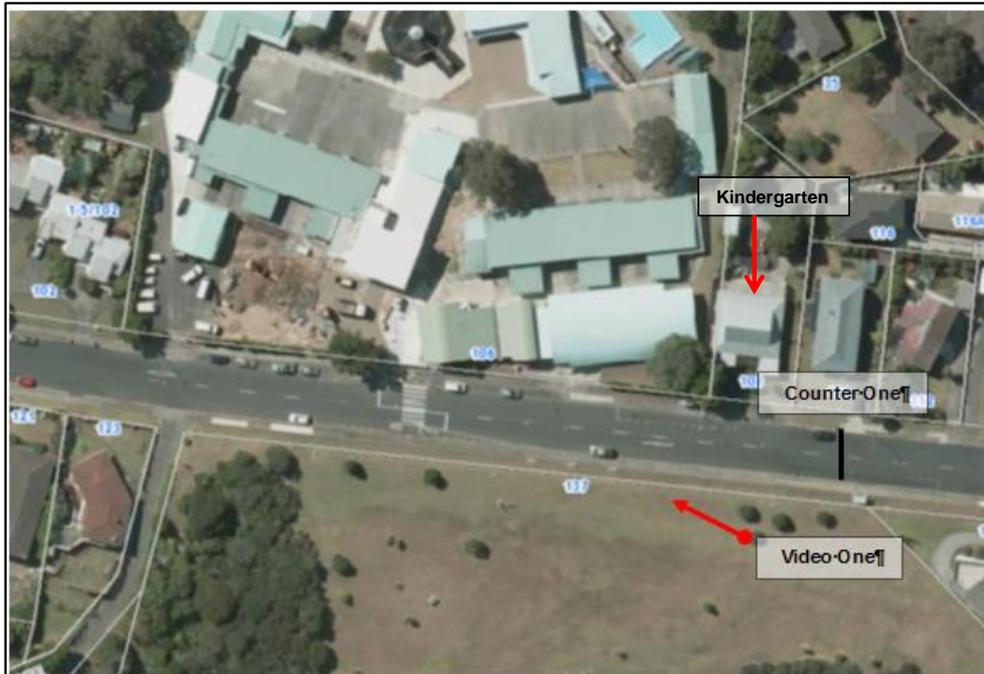
Figure D1 Halsey Drive Location of Camera and Counter

Figure D1 demonstrates the locations of the speed counters and video cameras.

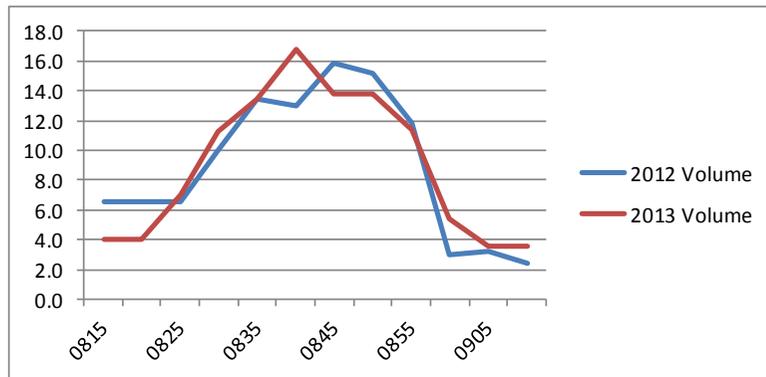
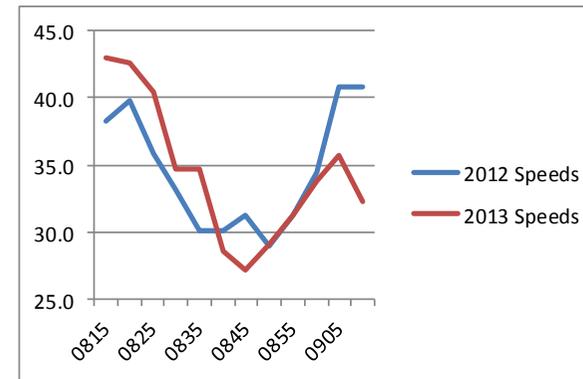
Halsey Drive 2013
5 Day Average

Time	Direction	Average volume	Average mean speed
0815	W	4.0	43.0
0820	W	4.0	42.6
0825	W	7.0	40.5
0830	W	11.2	34.7
0835	W	13.4	34.8
0840	W	16.8	28.6
0845	W	13.8	27.2
0850	W	13.8	29.0
0855	W	11.4	31.2
0900	W	5.4	33.8
0905	W	3.6	35.7
0910	W	3.6	32.3

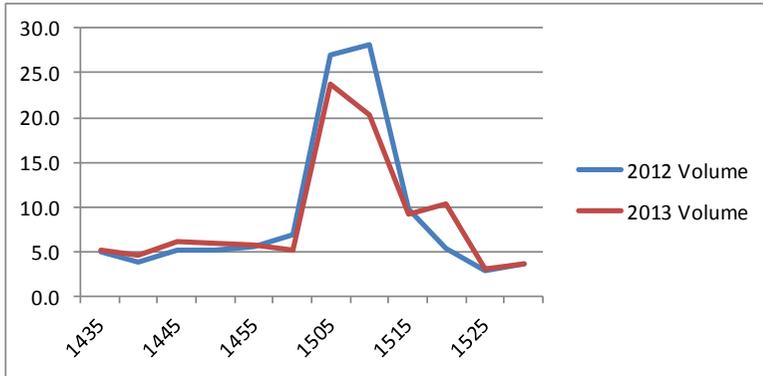
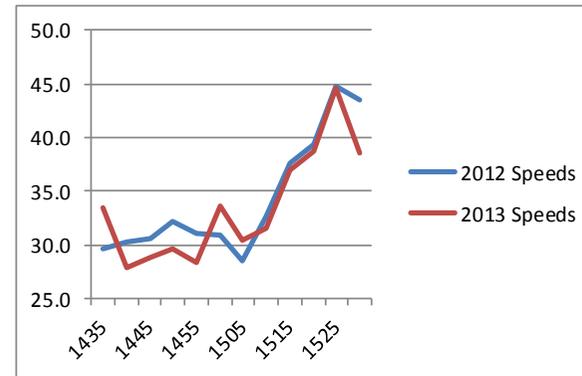
Halsey Drive 2013
5 Day Average

Time	Direction	Average volume	Average mean speed
1435	E	5.2	33.5
1440	E	4.6	27.8
1445	E	6.2	28.8
1450	E	6.0	29.6
1455	E	5.8	28.4
1500	E	5.2	33.5
1505	E	23.8	30.4
1510	E	20.2	31.5
1515	E	9.2	37.0
1520	E	10.4	38.6
1525	E	3.0	44.7
1530	E	3.6	38.6

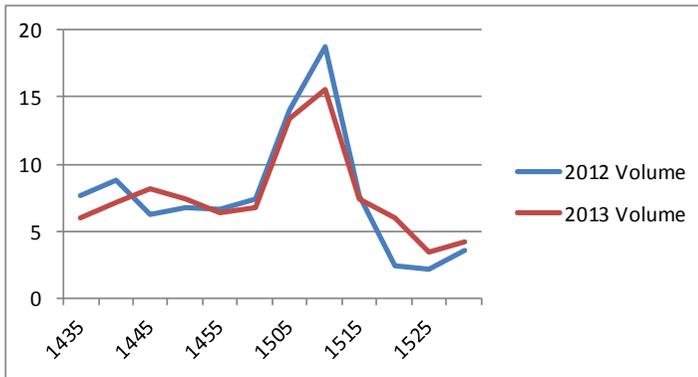
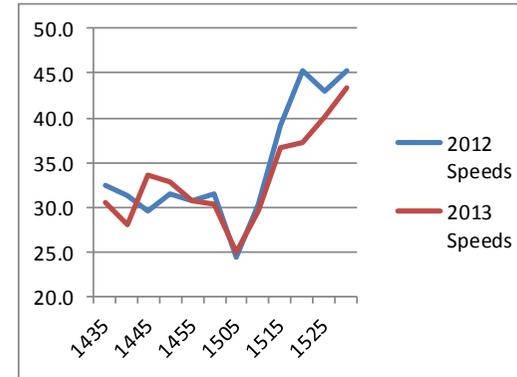
Halsey Drive 2013
5 Day Average

Time	Direction	Average volume	Average mean speed
1435	W	6.0	30.5
1440	W	7.2	28.1
1445	W	8.2	33.6
1450	W	7.4	32.9
1455	W	6.4	30.6
1500	W	6.8	30.4
1505	W	13.4	24.9
1510	W	15.6	29.6
1515	W	7.4	36.7
1520	W	6.0	37.2
1525	W	3.4	40.1
1530	W	4.2	43.4

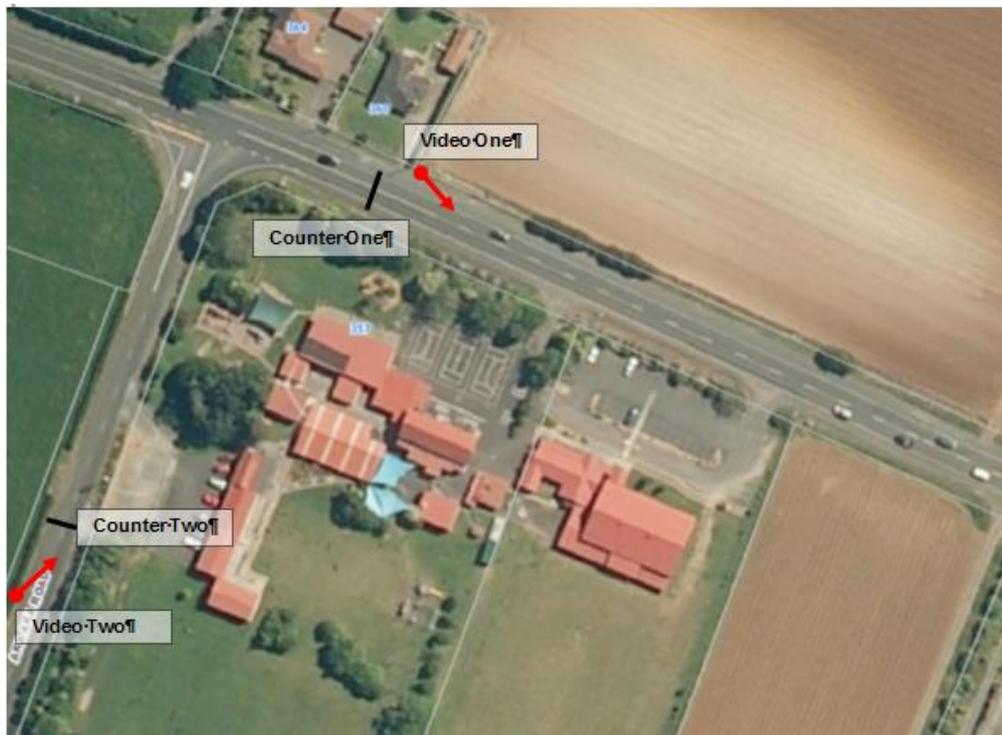
Figure E1 Puni School - Location of Cameras and Counters

Figure E1 demonstrates the locations of the speed counters and video cameras.

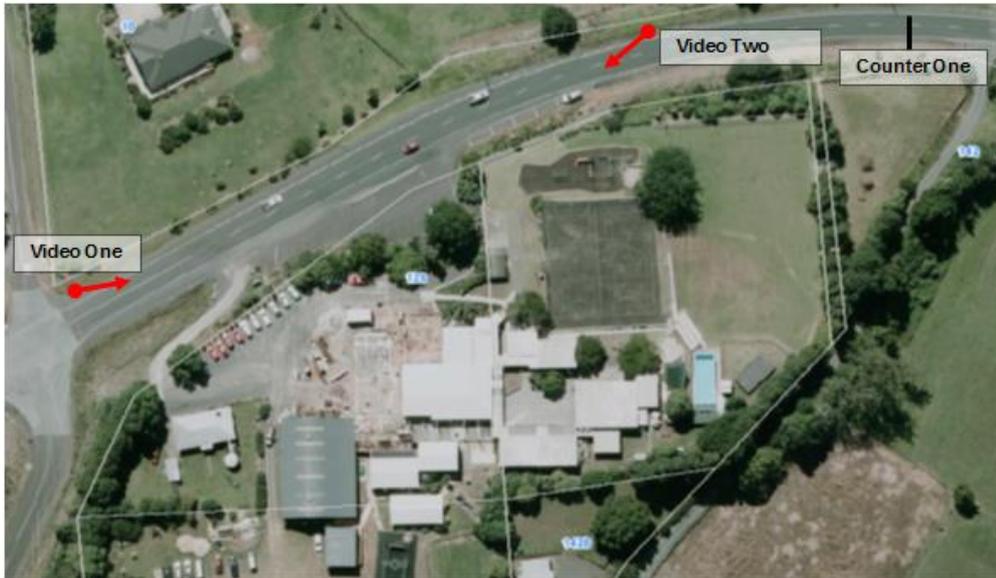
Figure F1 Ramarama School - Locations of Cameras and Counters

Figure F1 demonstrates the locations of the speed counters and video cameras.

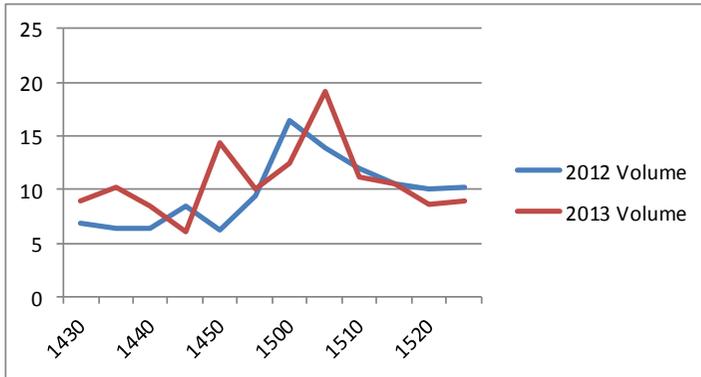
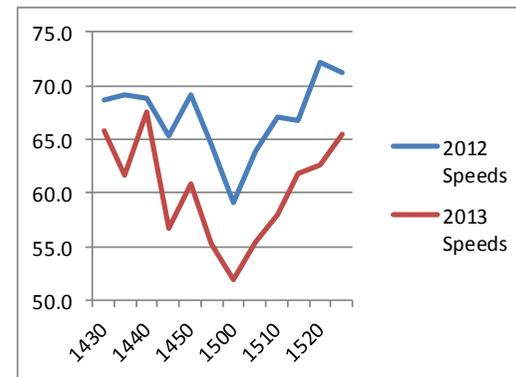
Ararimu Road, Ramarama 2012

5 Day Average

Time	Direction	Average volume	Average mean speed
1430	E	9	65.8
1435	E	10.2	61.7
1440	E	8.4	67.5
1445	E	6	56.8
1450	E	14.4	60.9
1455	E	10	55.2
1500	E	12.4	51.9
1505	E	19.2	55.4
1510	E	11.2	58.0
1515	E	10.6	61.8
1520	E	8.6	62.5
1525	E	9	65.4

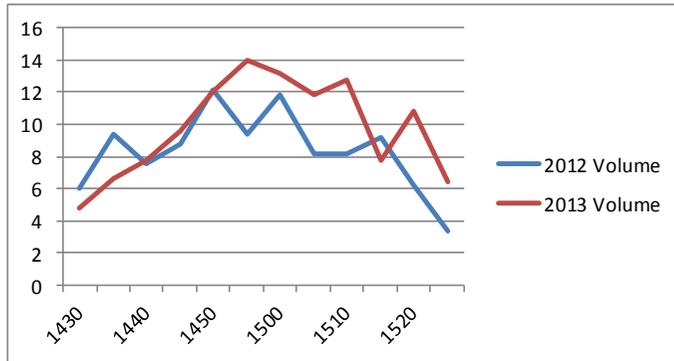
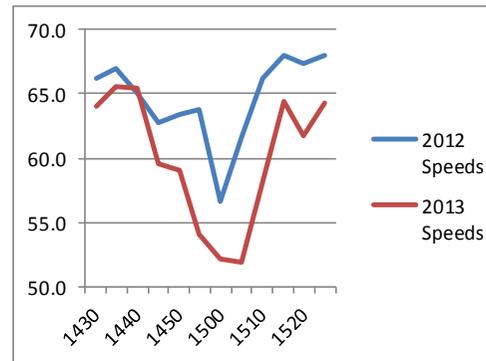
5 Day Average

Time	Direction	Average volume	Average mean speed
1430	W	4.8	64.1
1435	W	6.6	65.5
1440	W	7.8	65.4
1445	W	9.6	59.6
1450	W	12	59.1
1455	W	14	54.1
1500	W	13.2	52.1
1505	W	11.8	51.8
1510	W	12.8	58.2
1515	W	7.8	64.4
1520	W	10.8	61.8
1525	W	6.4	64.3
